Issue 6-2013

Date: 19/12/2013

Airworthiness Information

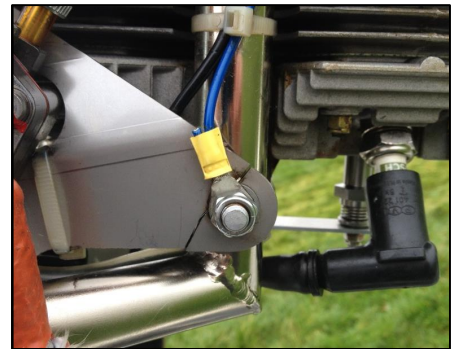
1 **Alexander Schleicher ASW 28-18E**

Fuel pump support bracket cracked. Originally replaced under TN2 but still having problems. Check on DI and annual inspections. We are advised that there is now a composite version that solves the problem.

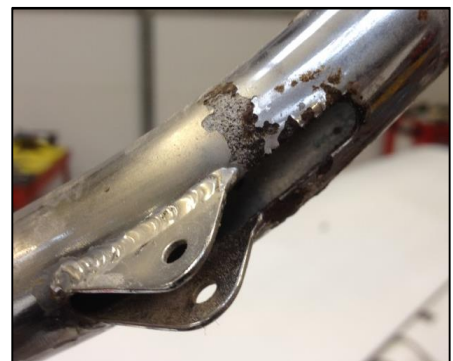
2 **Alexander Schleicher ASW27**

Heavily corroded control column.
The corrosion was hidden under layers of paint and tape.

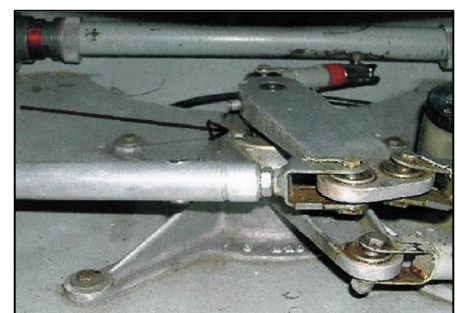
3 **Grob G103**

Air brake bell crank mounting in centre fuselage
loose mounting bolts causing excessive free play.

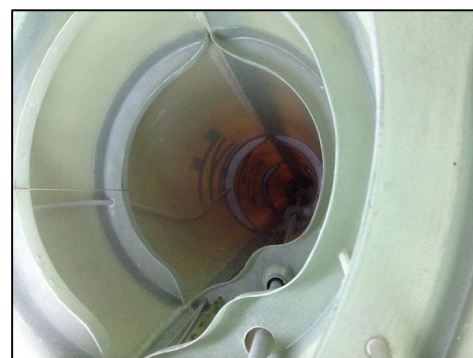
5 LS8-18 Rudder Cable Hang Up (applicable to other gliders) (Advisory)

The rudder pedals were found off-centre with rudder aligned. It was found that the tail ballast dump cable had caught on a lump of thickened resin attached to the right rudder cable in the rear fuselage and pulled the rudder cable outer tube down and out of the rear attachment.

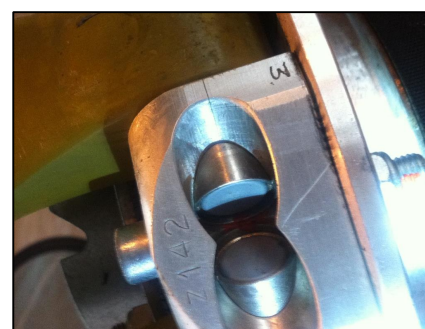
Propellers**8 Ingrid Oehler TB GmbH Propeller fitted to Duo Discus xT (Advisory)**

Cracking of the propeller bald attachment blocks continues to be an issue.

AD 2013-0054 and TN 890-13 refer and require inspections at each DI and annual inspection.
