**BRITISH
GLIDING
ASSOCIATION**

Technical News Sheet

Issue 2-2015

Date: 12/06/2015

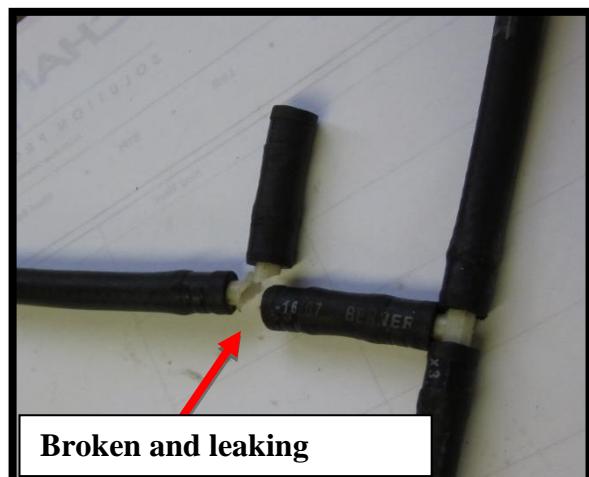
9 All Scheibe Motorgliders**Advisory**

Broken T piece in fuel line. Scheibe supply a choice of Nylon T pieces or metal ones.

The nylon ones break easily and are more brittle so metal T pieces recommend.

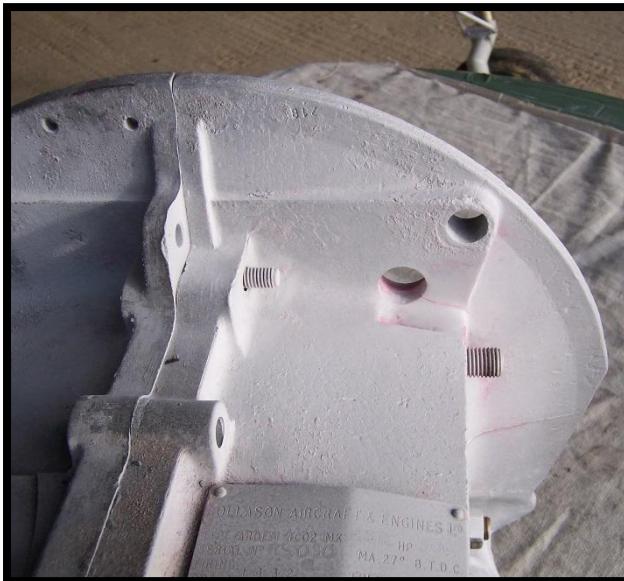
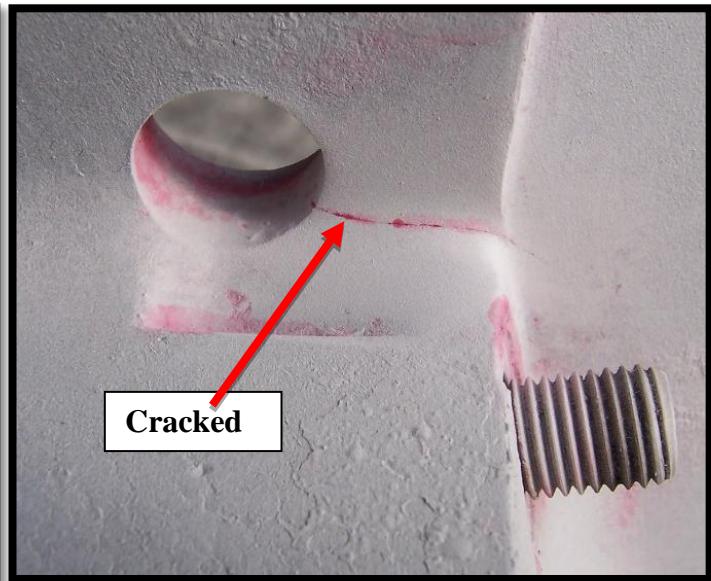
10 All Engines Require NDT Check after Prop Strike (except some Rotax 912/914) Mandatory

This was found on a crankcase engine mount, after a prop strike on a Rollason VW engine with a wooden prop. Do not ever be tempted to just change the prop and perform a run out check after a prop strike. Crankcase and crankshaft should always be NDT checked and issued a Form 1 prior to going back into service.

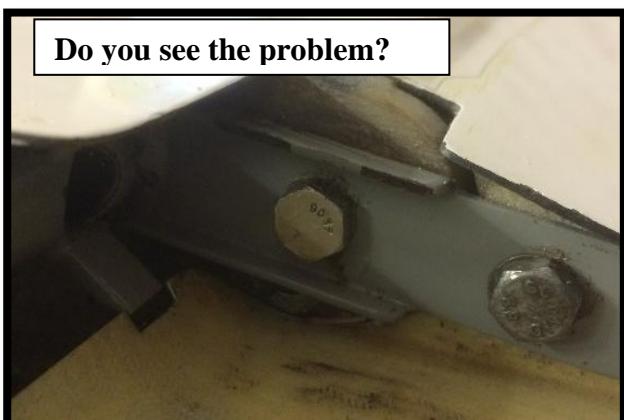
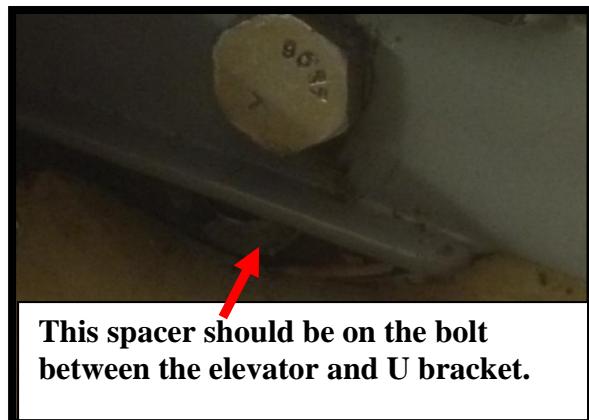
This is on a Nimbus 4 but could equally be an issue on most fixed tailplane gliders that rely on spacers to get the correct fit. They rely on the correct number and thickness of spacers to work smoothly and not bend/crack the hinges and brackets. In this case whoever reassembled it last did not spot that the spacer had dropped out of place.

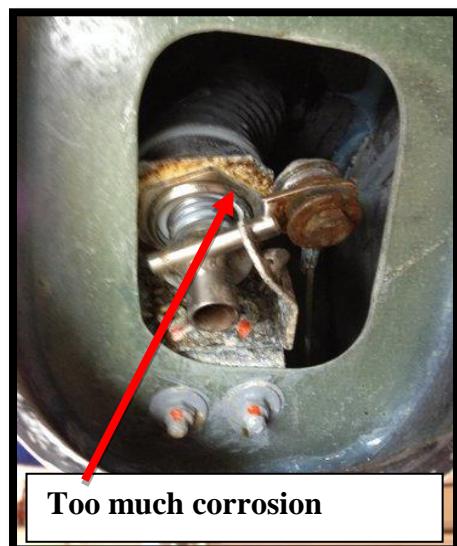
12 Tail Water Ballast Dumps on Schempp-Hirth Gliders**Advisory**

These must be checked for operation at every annual. Frequently owners have problems with them seizing during the soaring season. This is often the result of neglect and lack of maintenance.

Corrosion of the fuselage mounted lower rudder hinge is often associated with a corroded dump valve assembly.

Don't just check they work but actually look at them. If they are rusty like this one then remove it, de-corrode, repaint and refit with new seals if required.

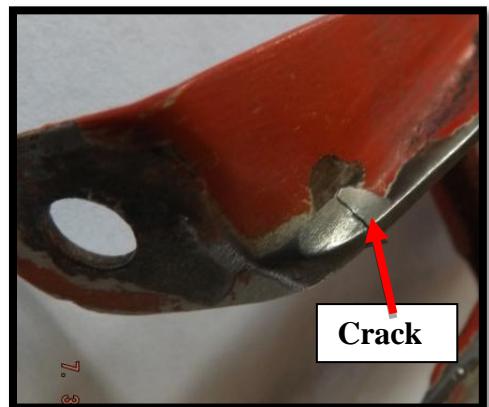
**13 Schleicher Wooden Gliders K series, Lower Rudder Hinge Crack****Advisory**

This is a very well known problem. After very heavy landings and at every annual thoroughly check this for cracks.

By virtue of the location, cracks are not easy to spot.

This cannot be repaired and must be replaced.

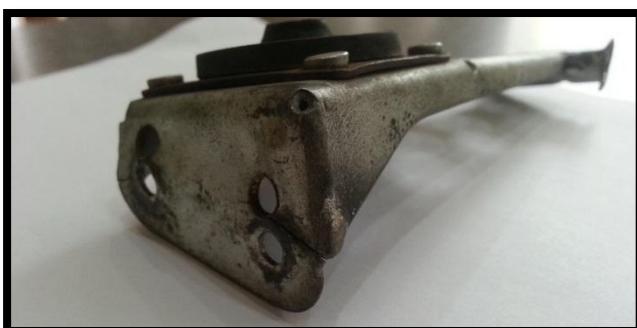
**14 PZL Glider SZD-50 Puchacz and Possibly Other SZD/PZL Types****Advisory**

This bracket supports the instrument panel and the cable release. The fractures/splits in the brackets could potentially result in the bracket coming completely apart resulting in the pilot having the panel in his or her lap. More importantly, the pilot may not be able to release the cable under pressure. Also ensure the rubber is not perished. This particular example appears to have been modified with non-standard extra holes.

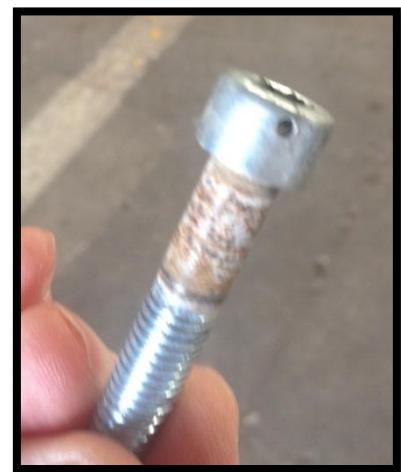
15 SF25C New Tailplane Bolts**Advisory**

These bolts, as supplied recently with new SF25C motorgliders, have a problem with their plating that leads to significant corrosion only a few months after installation. Contact Scheibe if this affects you.
