**Issue 5-2014**

**Date: 8/12/2014**

## *Airworthiness Information*

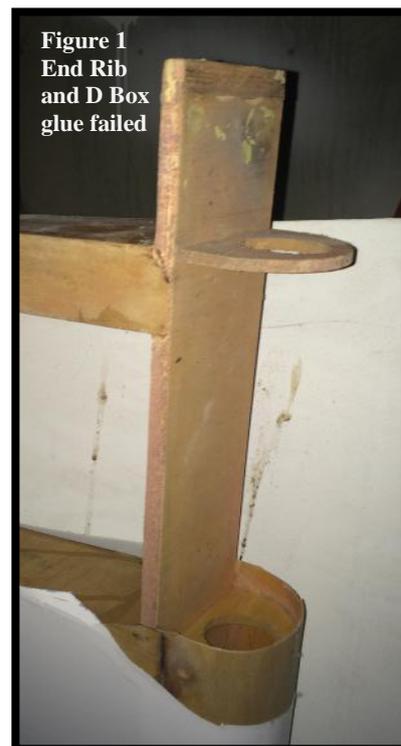
See image (figure 1) of the remains of a K8 elevator. This elevator came off in the hands of the person doing the DI check.

Not only had the end rib come adrift but a lot of the D box bonding had also failed.

The glider had previously been recovered and overhauled to a high standard one year before, when the full BGA wood inspection was done. It had a new annual shortly before this DI.

Apart from having no drain holes in the fabric, the elevator visually looked in very good condition after the end rib came off. When you put the rib back in the D box it was a perfect fit with virtually no gaps. There was little sign of staining from moisture/fungus and the wood is in reasonable condition. Only the glue had failed. If this had happened in flight the results are obvious.

**1a** Kaurit (pink) glue does not last forever. The rest of this glider was built at the same time with the same batch of glue. If one part has failed, unless there is a good reason for the failure (moisture in brake box perhaps), then all the glue is suspect. This glider needs a **VERY** thorough check and, even if is satisfactory, its longevity might be very limited.

**1b** Do not rely only on visual inspection; it did not work in this case. The inspection advice in the AD might not always find this problem. **Apply significant sideways force to the end rib, span-wise away from the spar** at every annual.

**1d Put split pins in the outer elevator hinges.**

This way the elevator cannot move sideways if the glue fails in flight and become disengaged.

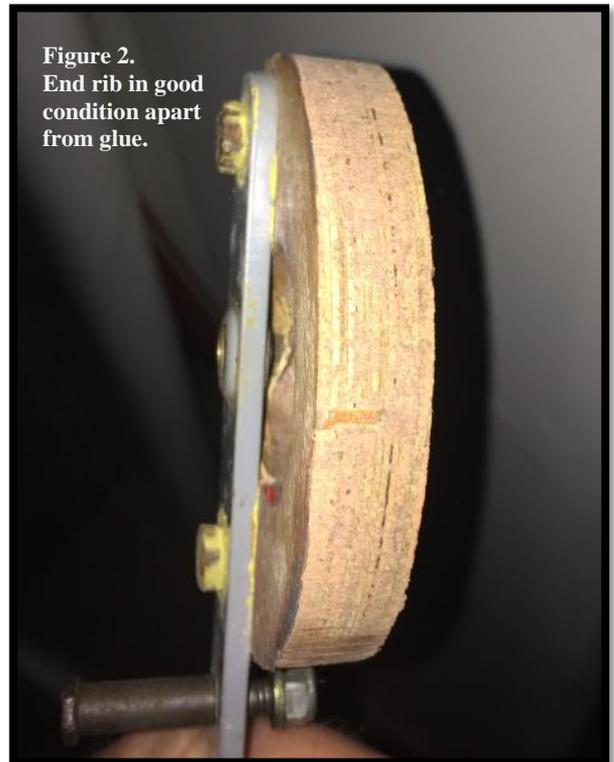
Figure 2.  
End rib in good condition apart from glue.

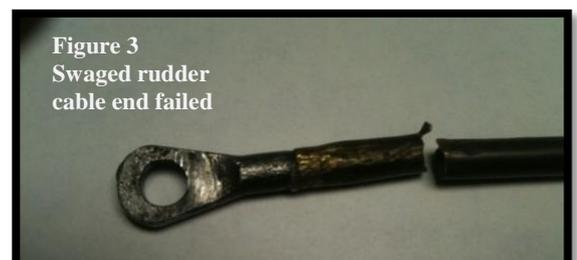
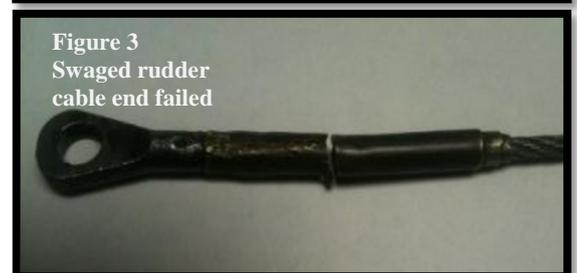
This relates to a steel cable end that cracked while it was well within the 1500 hour and 12 year life.

Figure 3  
Swaged rudder cable end failed

The Maintenance Manual requires a 22lb tension check (section 3.2) every 100 hours.

Make sure the tension is not too high (too much strain on fittings) or too low (flutter risk).

Juniors require 50 hour and other checks as per section 15.11 of the manual. Please make sure the rudder cable checks are done very diligently.

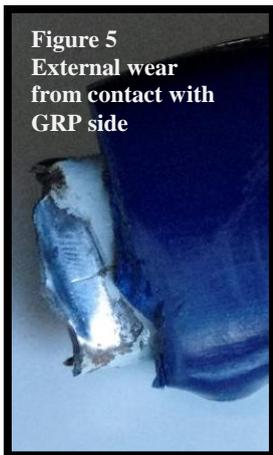
Figure 5  
External wear  
from contact with  
GRP side

This could affect any well-used ASK21. Check for cracks and wear regularly

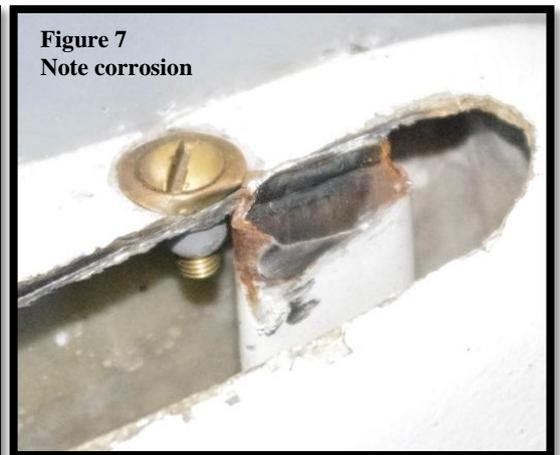
Figure 7  
Note corrosion

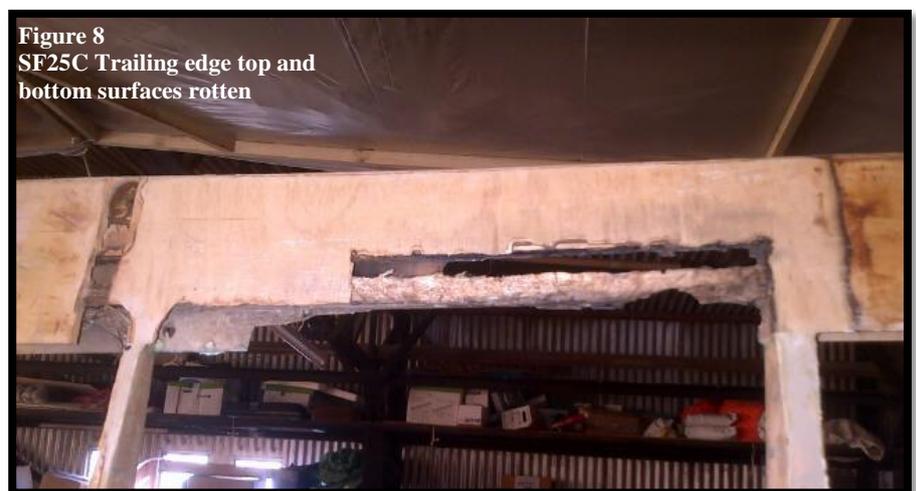
The drain holes were not at the lowest point. So, after 20 years of service, the wood was rotten at top and bottom.

All the other rotten panels had the drain hole on at the highest point with no drain hole at the lowest point.

Figure 8  
SF25C Trailing edge top and  
bottom surfaces rotten

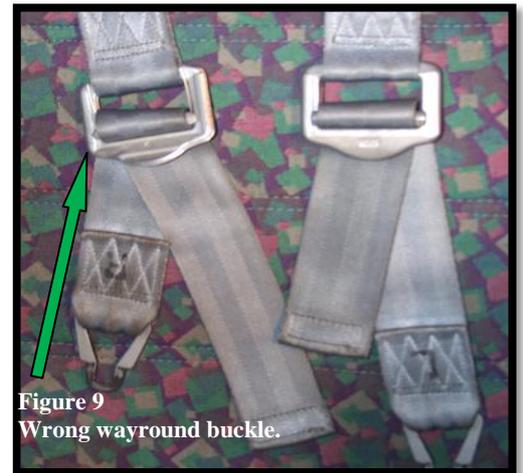
In the event of an accident, the buckle (Figure 9) would have let the R strap slip. A number of reports of similar incorrectly routed straps have been reported.

Figure 9  
Wrong wayround buckle.

Do not assume that strap overhaul companies do not make mistakes.

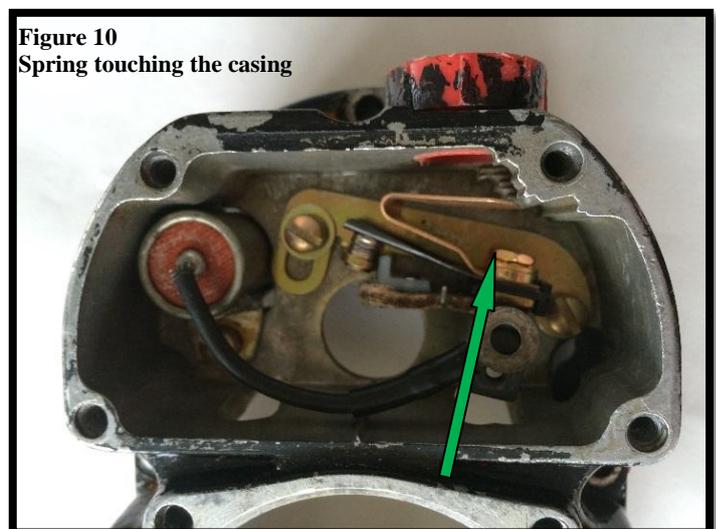
Some Slingsby T61F Bendix magnetos have a grounding spring incorporated into the points (figure 10).

If the magneto has the direct wire connection to the points, the grounding spring is redundant and it must be bent well clear of the magneto casing to prevent inadvertent grounding and loss of power.

Figure 10  
Spring touching the casing

It is recommended that this spring is checked at every annual inspection or if the magneto is overhauled or points replaced. The purpose of the grounding spring is to ground the magneto whenever the "P" lead is removed thus preventing a LIVE magneto.

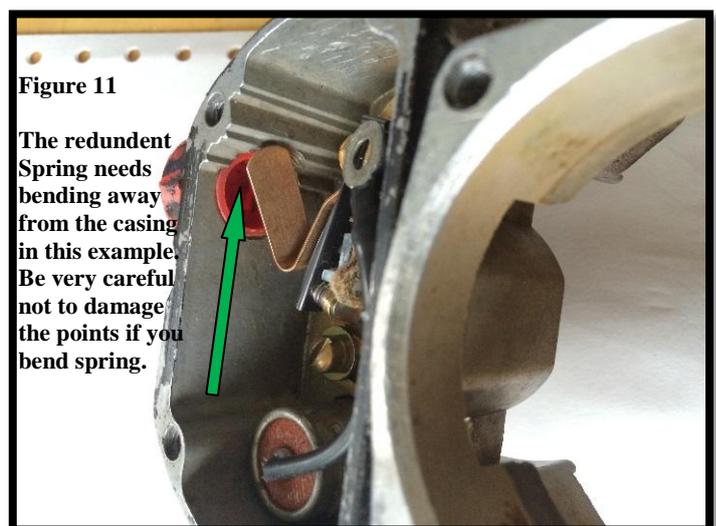
Figure 11  
The redundant Spring needs bending away from the casing in this example. Be very careful not to damage the points if you bend spring.

In the second picture (figure 11) the plug is not used, so the spring serves no purpose; bend it well away from the casing. Do not remove the spring as the chance of damaging the points is very high.
