Issue 1-2014

Date: 10/03/2014

Airworthiness Information

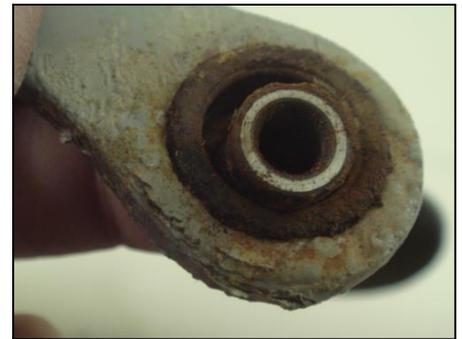
1 **Alexander Schleicher ASW 20 (applicable to many types)**

Reported by Tim Dews, Airborne Composites
Play was observed in an ASW 20 Elevator circuit. On investigation it was found that the bell crank at the base of the fin was corroded and the bearing was falling apart.

Access is difficult for inspection and lubrication but may be achieved through the rudder cable openings.

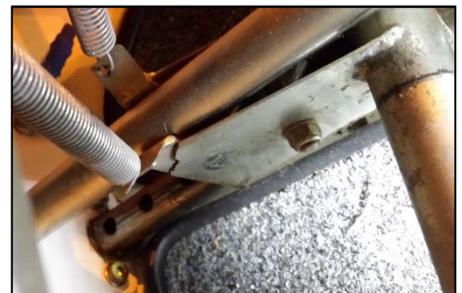
3 **DG1000**

Cracks were found in the Neutral Bias+spring attachment points on the rudder pedal assembly.

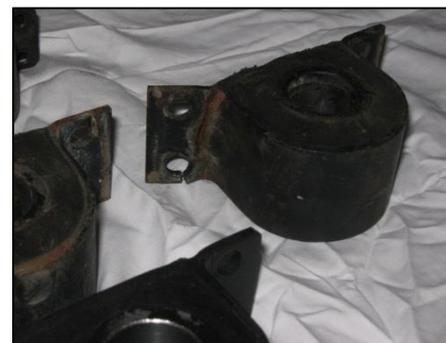
- 5 DG LS4b** **Advisory**
 Reported by Gordon Walker, Wyvern Gliding Club

The glider was noticed sitting lower than usual. Investigation found all of the main landing gear mountings badly distorted with one broken.

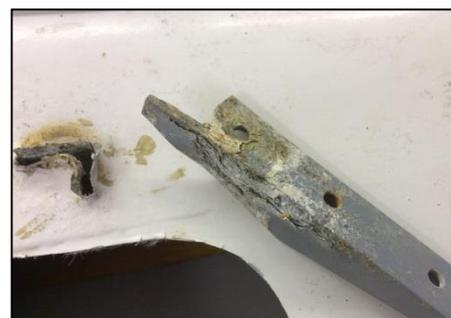
- 6 Corrosion (Fournier RF5)** **Advisory**
 Reported by Ian Mitchell, D&SGC

A typical example of corrosion found on many light aircraft components. Please be vigilant during inspections and ensure that the paintwork is in good condition.
