Issue 2-2014

Date: 06/05/2014

Airworthiness Information

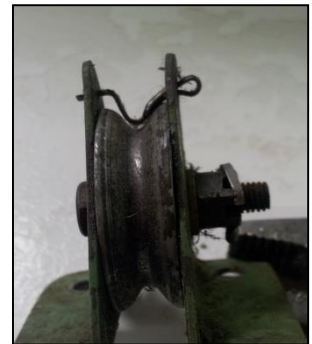
1 Cables 1

The result of not routing cable under guide pin. The cable had also sawn a slot in the other end of the mounting bracket as a result of coming off the guarded pulley. This design of cable pulley has two split pins that are used as cable guides to prevent the cable from coming off the pulley. The split pins need to be removed to allow the cable to be removed and refitted then replaced on completion.

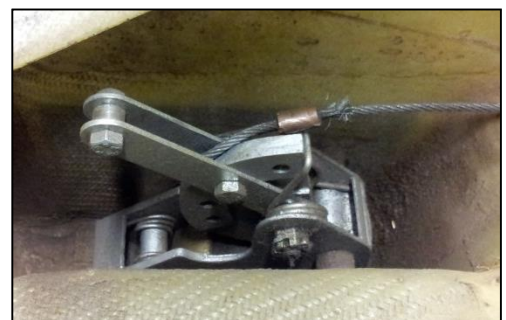
2 Cables 2

Lack of thimble used when making up cable means there was nothing to prevent the cable riding over the top of the release arm. The thimble would have fitted snugly around the spacer retaining it in position. The release would have been hard to operate due to the reduced mechanical advantage. The cable itself is poorly made with far too much protruding from the sleeve.

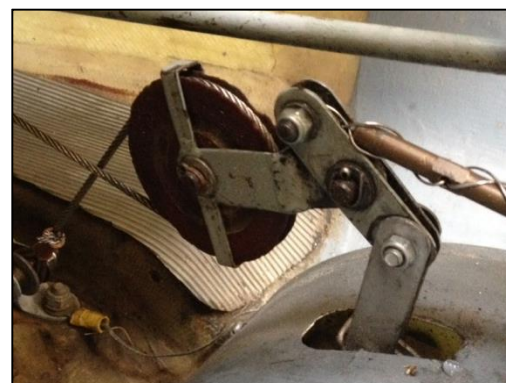
3 Cables 3

Incorrectly adjusted nose release cable means the equaliser ran out of movement before the hook was fully released. Failure to check the adjustment of the cables in all modes of operation of the release control system.

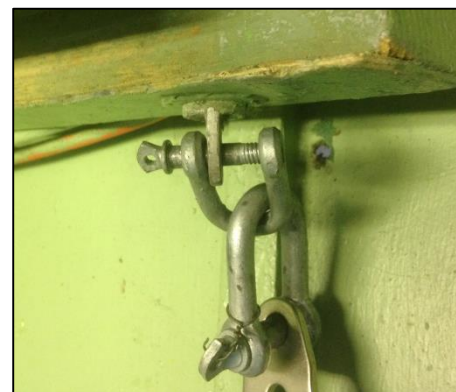
- 12 Seat Harness Attachment** **Advisory**
 Reported by Les Blows, Southdown GC
 Small shackles are used to secure many older glider seat harnesses. The example in the picture shows a shackle where the threaded hole was stripped and the pin was only retained by thin locking wire (removed). It is worth remembering that in older gliders these items may have been undone and done up many times and may be worn beyond safe limits.
