**Issue 4-2014**

**Date: 10/09/2014**

## Airworthiness Information

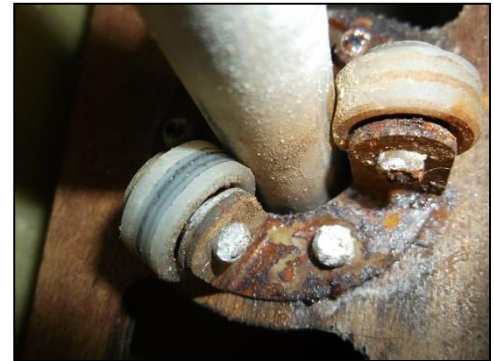
**1 Alexander Schleicher ASW 20  
Reported by Robin Willgoss**

Corrosion found on controls and bearings probably caused by condensation in inaccessible areas.

Rod ends and hardware also found corroded.

Inspection in closed areas is difficult; the use of a flexible borescope will aid inspection.

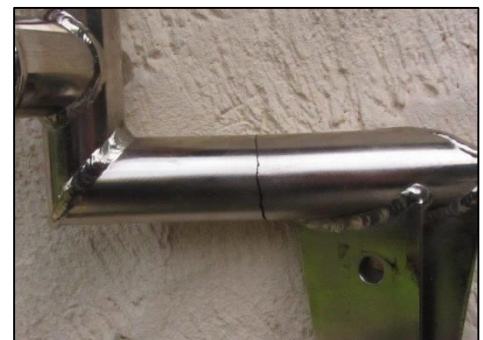
**3 Alexander Schleicher ASW28-18E**

Several reports of cracked engine pylons.

BGA recommendation; not to use engine until later design pylon is fitted or issue resolved by manufacturer.

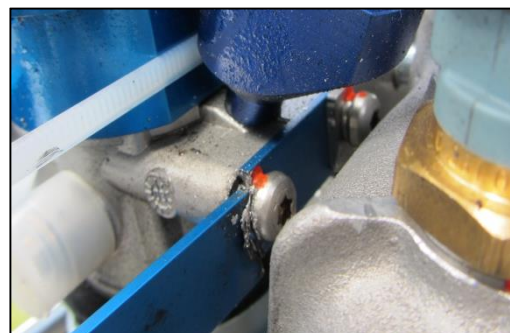
- 6 **Schempp-Hirth ARCUS M** **(Advisory)**  
Reported by Ian Cook

Excessive wear and failure of the throttle assembly retaining rails.

It is understood that a revised design rail is being supplied.

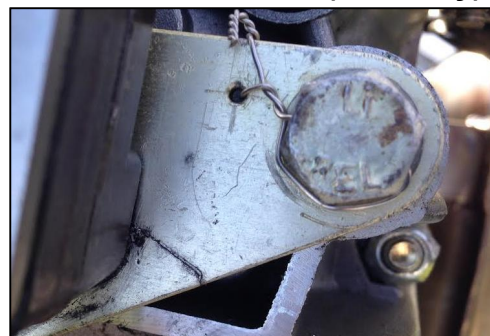
- 9 **Solo 2350 installed in LAK 19T** **(Advisory)**  
Reported by Barry Kirby  
Fuel pump bracket found cracked.

It is suspected that this area is subject to high vibration.

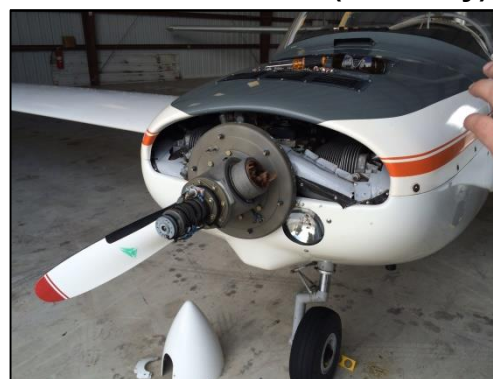
- 10 **Taifun MT Propeller Failure** **(Advisory)**  
Report from USA

It is suspected that the engine was operated in the prohibited RPM range causing a high resonance resulting in the detachment of one propeller blade in flight. Engine damage was extensive but stayed attached to the airframe fortunately.  
Aircraft with prohibited operating range must have tachometers marked with a red arc indicating the prohibited range.
