ACCIDENT

Aircraft Type and Registration:	ASH 25 Glider, 925 (BGA 3909)	
No & Type of Engines:	Not applicable	
Year of Manufacture:	1992	
Date & Time (UTC):	2 September 2007 at 1512 hrs	
Location:	Tomintoul, Morayshire, Scotland	
Type of Flight:	Private	
Persons on Board:	Crew - 2	Passengers - None
Injuries:	Crew - 1 (Fatal) 1 (Serious)	Passengers - N/A
Nature of Damage:	Glider destroyed	
Commander's Licence:	None	
Commander's Age:	51 years old	
Commander's Flying Experience:	750 hours on all types (estimated) Last 90 days - 30 hours Last 28 days - 24 hours	
Information Source:	AAIB Field Investigation

Synopsis

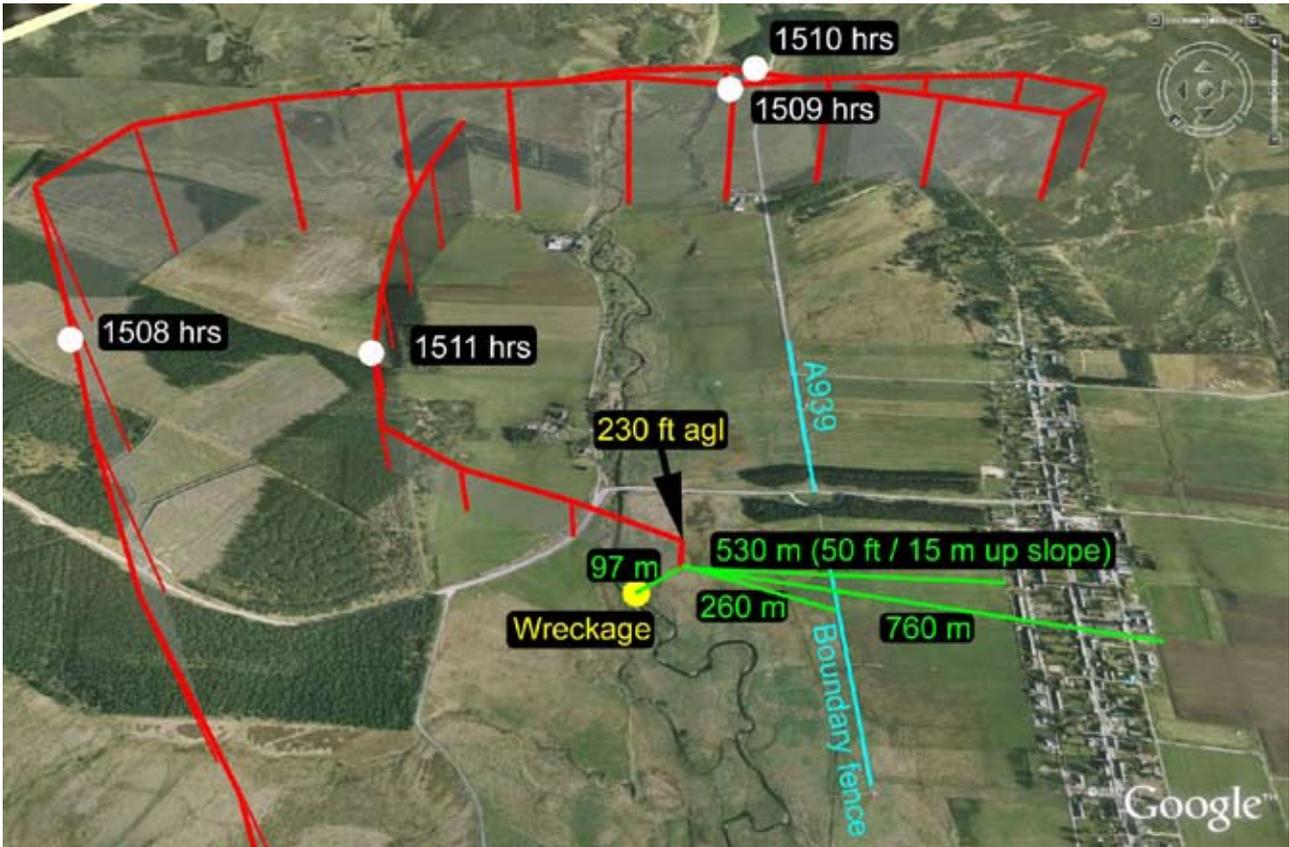
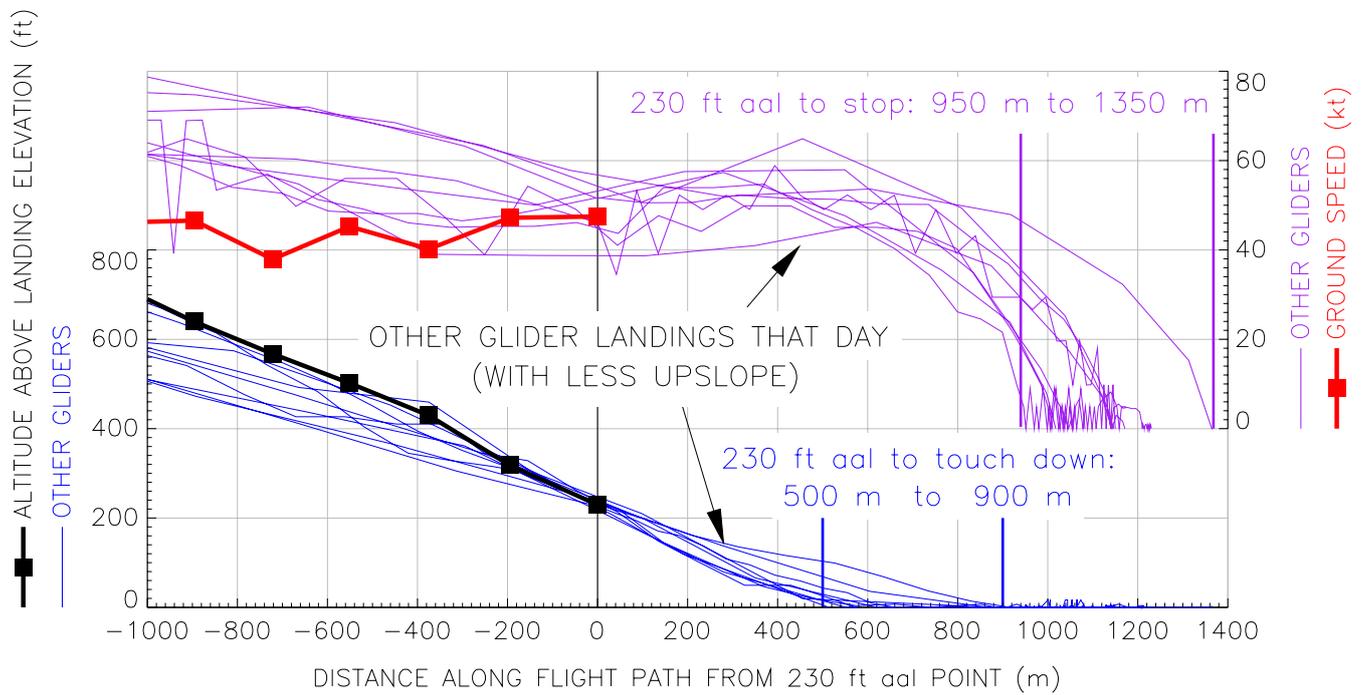
A motorcyclist, travelling north-west towards Tomintoul on the A939, witnessed the accident (see Figure 1). He described seeing Glider 925 straight ahead of him, at approximately 2-300 ft agl, in a steep turn, when he was approximately one mile from the accident site. The glider then "quickly" entered a near-vertical dive before he lost sight of it just before it crashed.

site and the transmission lines ran in the direction 145°/325°M. A second row of pylons, carrying 11 Kv electrical transmission lines, were sited approximately 80 m west of the accident site; these pylons were approximately 29 ft high and ran towards Tomintoul in the direction 200°/020°M. (See Figure 1).

The log commenced at 1158 hrs at Aboyne Airfield. The glider was airborne at 1209 hrs and climbed to nearly 12,500 ft whilst manoeuvring over terrain approximately 4 km north-west of the airfield. The glider then flew north to Huntly, south-west to Kirkmichael, north to Grantown-on-Spey and then south-east to the accident site near Tomintoul. Figure 1 shows the end of the accident flight together with a comparison with other landings recorded on the day by other gliders of various types. Note that the vertical red poles indicate the actual recording points; the straight lines joining the top of these poles give the average track between these points and are not indicative of the heading of the glider at the recording points. It is thus quite possible that the glider was in a turn at the last recorded point rather than tracking straight.

The last recorded point was at 1511 hrs. The glider was 230 ft agl and descending at approximately 500 ft/min with a ground speed of just under 50 kt. The GPS accuracy was recorded as good. Comparisons with other glider landings that day indicate that the ground speed and rate of descent at the end of the recording were not unusual.

The distance from the last recorded point to the boundary of the nearest field was approximately 260 m. The field was 270 m in length and sloped up, so that the far end of the field was approximately 50 ft higher than the terrain the glider was over at its last recorded point. The shortest recorded distance from a height of 230 ft to touchdown of the other gliders that day was approximately 500 m, indicating that a straight-in approach to land on the field ahead was not viable.

- a) Glider path at the end of the flight as recorded by the glider logger
- b) Landing data from other gliders flying during the competition

Beyond the field were houses and then further fields. Taking into account the fact that the last recorded point was only approximately 180 ft above the elevation of the field beyond the housing, a landing there would not appear to have been a viable option since the furthest distance to touchdown recorded on the day was approximately 900 m, and this was over relatively flat terrain.

The wreckage was located 97 m from the last recorded point, to the rear and right of the track direction at that last point. This would indicate that a turn took place after the last recorded point. A circular orbit with a diameter of 97 m would have a track distance of 305 m, making a subsequent approach to the field directly ahead of the glider viable if the descent rate did not decay during the orbit.
