ACCIDENT

Aircraft Type and Registration:	Schleicher ASW 20L glider, BGA 4354	
No & Type of Engines:	None	
Year of Manufacture:	1979	
Date & Time (UTC):	23 September 2006 at 1032 hrs	
Location:	Keevil Airfield, Trowbridge, Wiltshire	
Type of Flight:	Private	
Persons on Board:	Crew - 1	Passengers - None
Injuries:	Crew - 1 (Fatal)	Passengers - N/A
Nature of Damage:	Aircraft destroyed	
Commander's Licence:	BGA glider pilot's certificate	
Commander's Age:	67 years	
Commander's Flying Experience:	1,116 hours (of which 215 were on type) Last 90 days - 7 hours Last 28 days - 3 hours	
Information Source:	AAIB Field Investigation and information provided by the British Gliding Association

Synopsis

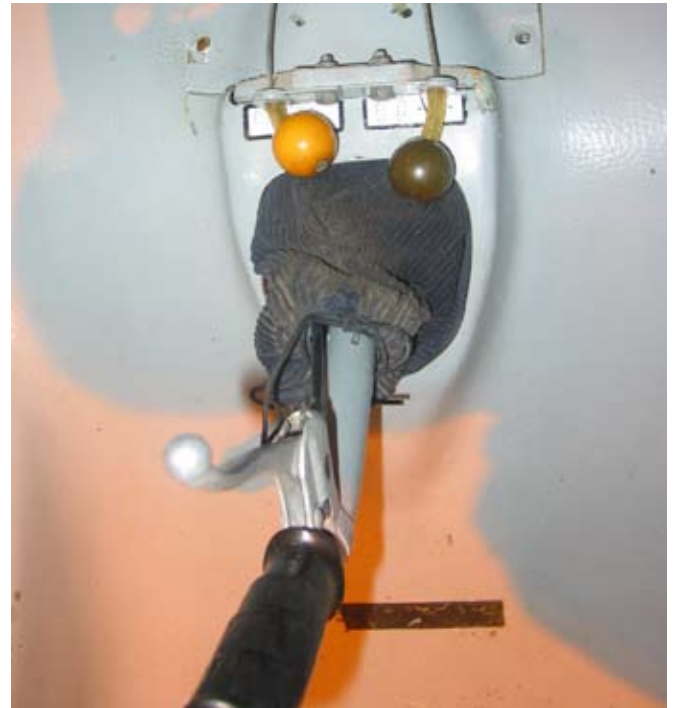
The cable release control was located to the left of the aircraft centreline, at the base of the instrument binnacle and ahead of the control column. An adjacent control, used to adjust the rudder pedals, was located just to the right of the aircraft centreline. The two control handles terminated in spherical knobs approximately 30 mm in diameter and were identical except that the cable release control was yellow and the rudder pedal adjustment control was brown (see Figure 2). Both controls were designed to operate when pulled. A more detailed description of these controls is given under the heading 'Additional information'. The Safety Member of the Gliding Club considered that during a winch launch there

Yellow cable release control on BGA 4354

Cable length is limited to prevent the knob fouling the control column (a problem which is reported to arise on some other glider types) and in the case of BGA 4354 it was approximately 15 mm (visible in Figure 2 and shorter than on the similar configuration ASW 19 shown in Figure 5). The Safety Member of the RAFGSA considered that this combination of factors may have reduced significantly the pilot's ability to operate the cable release control in response to the right wing drop.

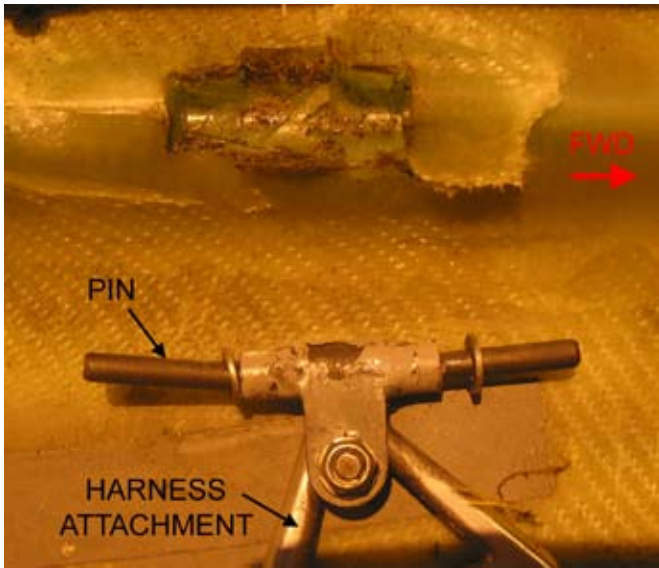
Figure 3

The aircraft was fitted with a four-point shoulder and lap strap safety harness with each of the four ends attached to a fitting that was secured within the fibreglass structure by a pin. The fitting from the left lap strap had separated from the aircraft structure as a result of a failure of the fibreglass skin that retained the pin (see Figure 3). The steel pin had also bent which indicated that the limit load of the pin was exceeded. The aircraft manufacturer was consulted regarding this failure and they stated that the lap strap was designed to withstand a maximum deceleration of -4.015g with a 1.33 fitting factor and assuming a pilot mass of 115 daN (117 kg). The design limit load of each lap strap fitting was thus 307 daN³. The manufacturer carried out tests on this fitting type which demonstrated that it could withstand a load of 460 daN without any damage to the pin, fitting or surrounding structure (a safety factor of $460/307 = 1.5$). In this accident the pin was deformed so it probably experienced a load in excess of 460 daN during the accident sequence.

Overload failure of pin from left lap strap attachment

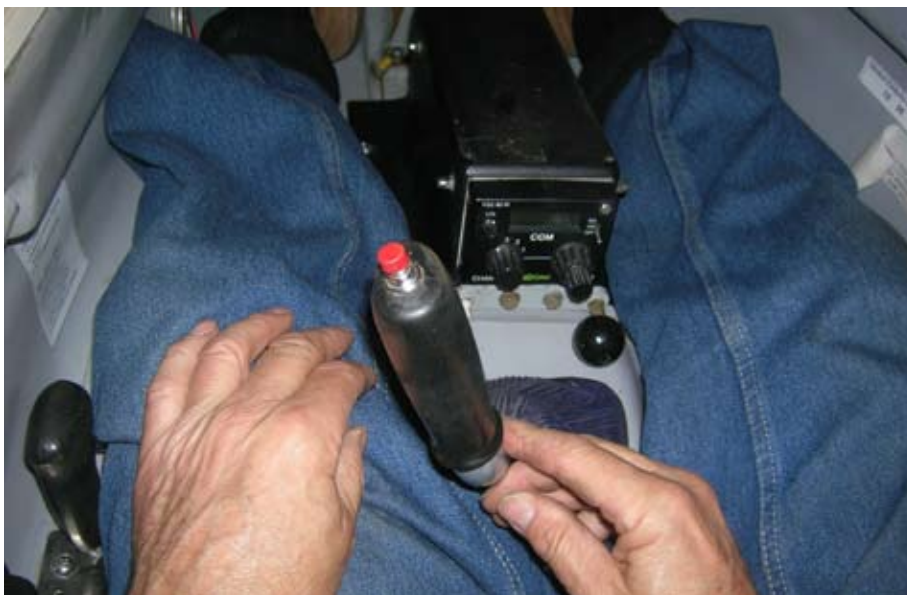
Figure 4 shows full left deflection of the control column in the ASW 19 using the right hand. During launch and in flight the right hand would usually be holding the hand-grip of the control column, but in this picture it is shown lower than usual to avoid obstructing the camera view. With the right hand on the hand-grip and with the control column deflected fully left, the pilot's right arm would obstruct his view of the cable release knob.

Full left deflection of control column in similar configuration ASW 19

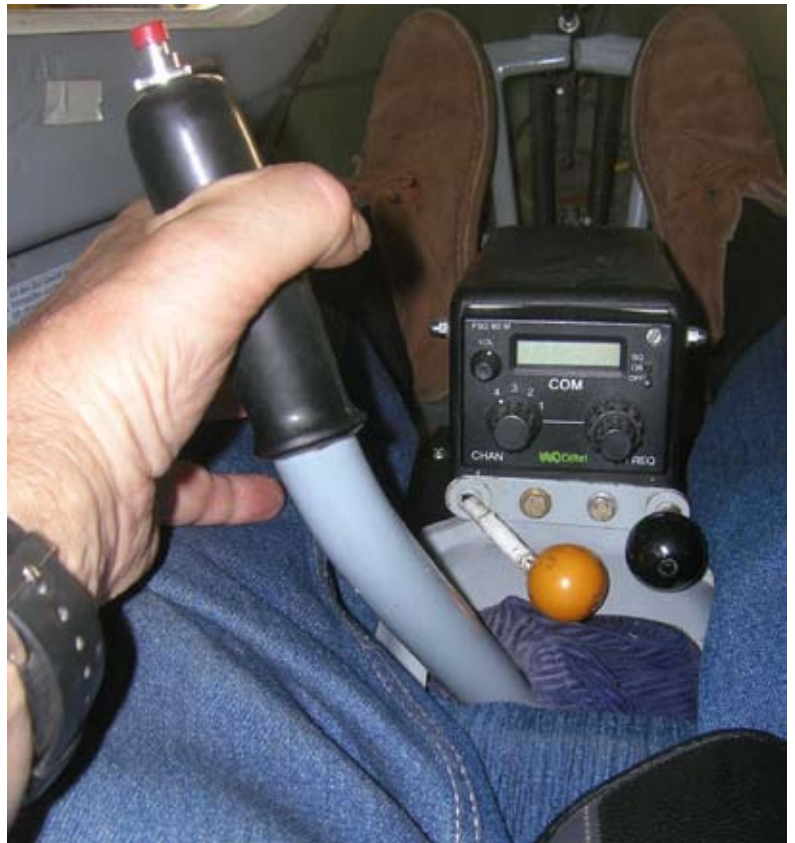
Figure 5

In Figure 5, the yellow cable release knob is only visible to the right of the control column because the control column is being held by the left hand, which would not usually be the case during the launch or in flight.

In order to release the cable in flight, with the control column deflected fully left, the pilot would need to reach around the front of the control column with his left hand and pull the release control at an angle to the control panel. The difficulty of reaching around the control column would require the pilot to apply this force using the strength of his wrist rather than through a direct pull using the strength of his arm. The shorter the length of protruding cable the greater the angle and the greater the problem. Additionally, whereas the pilot should ideally be able to grip the control with his full fist, a short protruding cable might inhibit the pilot from doing so.

Cable release visible with full left control deflection
