## ACCIDENT

<b>Aircraft Type and Registration:</b>	Schleicher ASW 20 L, G-LYSA	
<b>No &amp; Type of Engines:</b>	None	
<b>Year of Manufacture:</b>	1978 (Serial no: 20054)	
<b>Date &amp; Time (UTC):</b>	18 June 2014 at 1618 hrs	
<b>Location:</b>	North Hill Airfield, Sheldon, Devon	
<b>Type of Flight:</b>	Private	
<b>Persons on Board:</b>	Crew - 1	Passengers - None
<b>Injuries:</b>	Crew - 1 (Fatal)	Passengers - N/A
<b>Nature of Damage:</b>	Aircraft destroyed	
<b>Commander's Licence:</b>	BGA Gliding Certificate	
<b>Commander's Age:</b>	73 years	
<b>Commander's Flying Experience:</b>	Approximately 12,000 hours (of which 11 were on type) Last 90 days - 24 hours Last 28 days - 12 hours	
<b>Information Source:</b>	AAIB Field Investigation

## Synopsis

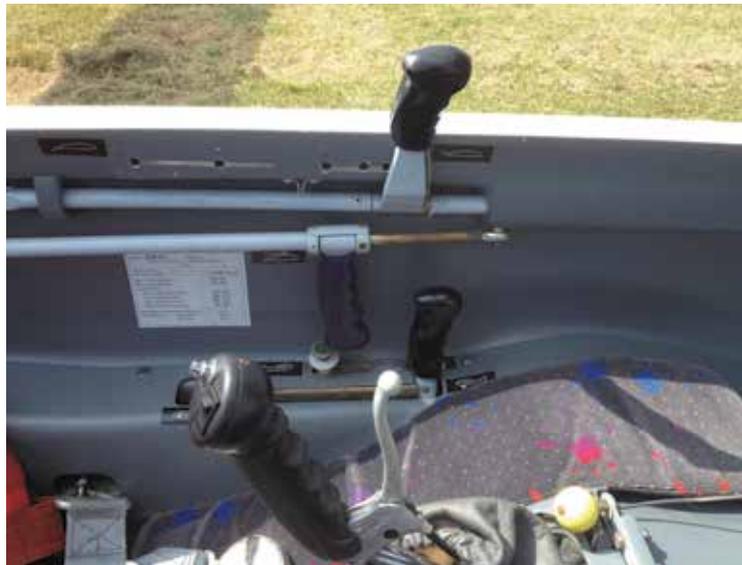
**Figure 1**

In the last year, the pilot had flown ASK13, ASK21, SZD51 Junior, DG505 and ASW20 gliders. Apart from the ASW20, these gliders have a single lever control on the left side of the cockpit and this controls airbrake operation. The ASW20 has three levers on the left side of the cockpit controlling landing gear, airbrake and flap operation. The flap lever is uppermost and has a pin that engages with holes in a plate on the canopy rail to retain the lever at discrete flap settings. The airbrake lever is coloured dark blue, operates in the conventional sense and the lever hangs down from the horizontal operating rod on which it is mounted (see Figure 1). However, the pilot can rotate the lever handle around the operating rod so that it can be conveniently positioned; often this will be with the lever in a horizontal orientation resting on the top of the pilot's left leg. The landing gear lever protrudes vertically out of a slot in the sidewall. The lever is retained at each end of the travel by a gate that locks the landing gear in the chosen position; rearwards movement of the lever retracts the landing gear. The handles on the three control levers are similar in size, shape and feel.

The landing gear lever handle is black and the airbrake lever handle is dark blue; although they are different colours, the visual contrast between the two lever handles is small. After

the landing gear is extended, with the airbrake still retracted, the two co-responding control levers are very close to each other in the cockpit. In addition, the landing gear lever and, in its natural position, the airbrake lever, would both be orientated vertically.

In Figure 1, the flap lever is shown in the high-speed position ( $-11^\circ$ ), the airbrake lever is shown in a partially extended position and the landing gear lever is in the down position.

Left internal side wall of an ASW20 glider  
(This is not an image of G-LYSA.)

As a result of this accident, the BGA re-issued a Safety Alert letter to owners of ASW 15, ASW19, ASW20 and Pegase gliders to inform them of the risks of using the wrong control whilst attempting to operate the airbrake lever.

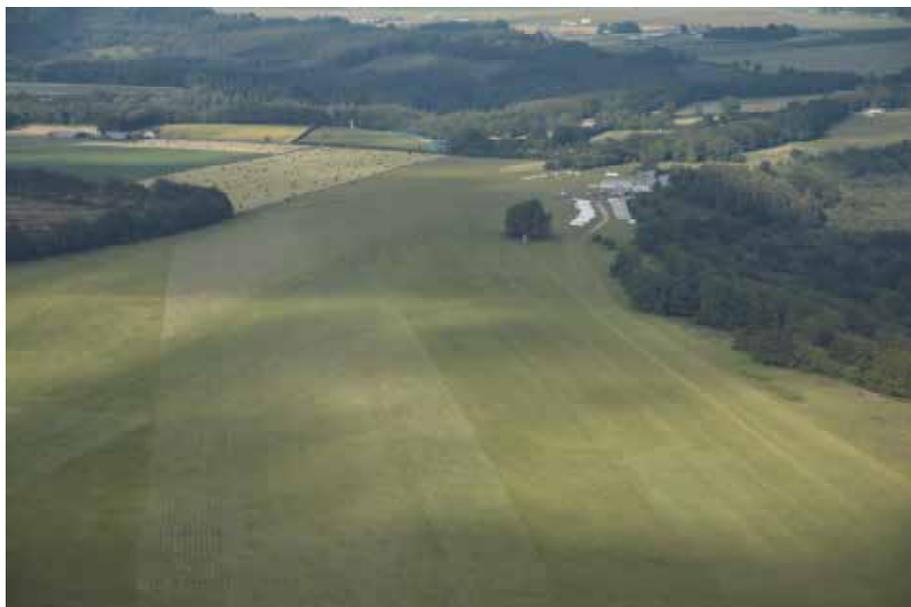
**Figure 2**

A view of the airfield from the direction of the final approach  
(The accident site is at the far end of the field, beyond the isolated tree.)

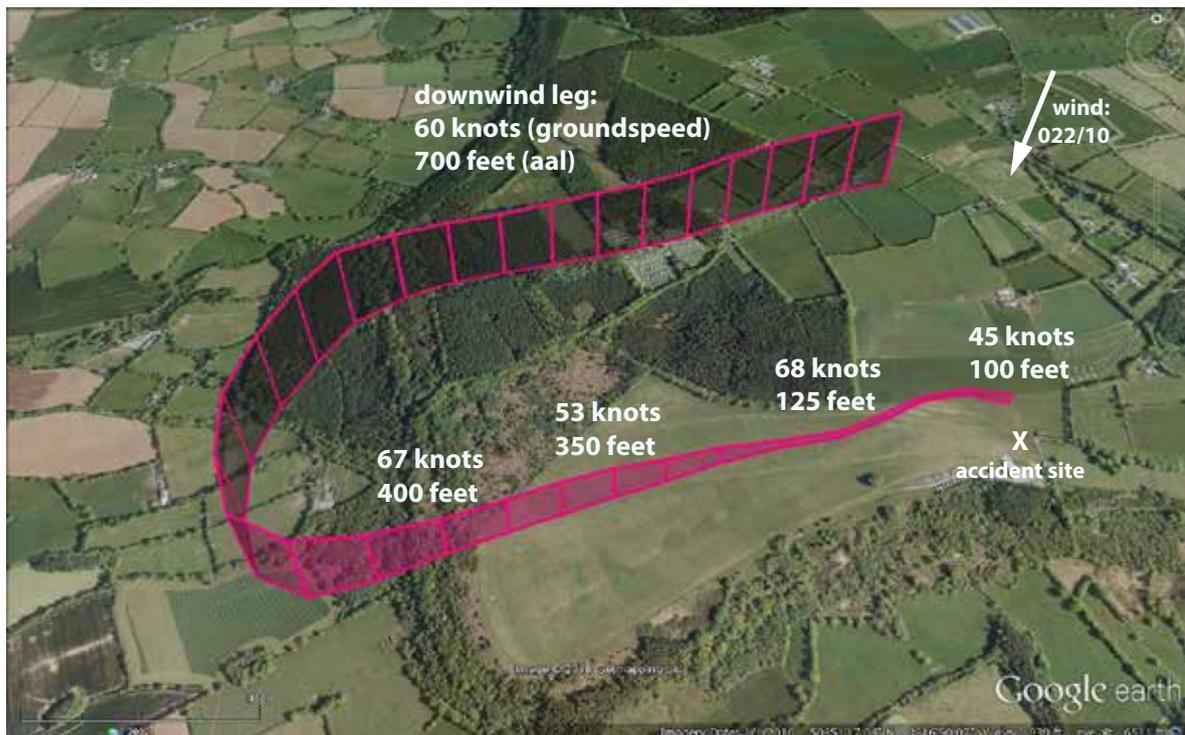
**Figure 3**  
G-LYSA approach to North Hill

Figure 3 shows the final part of the track, in profile, with spot heights and groundspeeds (averaged between successive points). Figure 4 shows the ground track as a time history. These Figures indicate that the glider was downwind abeam the airfield at 700 ft aal, with a groundspeed of 60 kt, and descended to 400 ft aal above the airfield perimeter when established on final approach. Over the next 12 secs, there were minor variations in the glider's height, before it descended at about 1,250 ft/min to 125 ft aal, above a point just east of the airfield's two launch strips. Over the last 20 secs (to the last recorded point), the glider descended to 70 ft aal and then climbed back to 100 ft aal as it commenced a turn to the right. The groundspeed for this last point had reduced to 45 kt. Using the surface wind measured at the site two minutes before the accident, the airspeed at this point was estimated to have been between 52 and 55 kt. The data indicates that the drag of the glider increased during the approach; this is evident from the reversal in the increasing speed trend, while the descent continued.
