ACCIDENT

Glider Type and Registration:	Glaser Dirks DG600 Glider, BGA 3445 (Tail No 656)	
No & Type of Engines:	None	
Year of Manufacture:	1988	
Date & Time (UTC):	18 September 2005 at 1230 hrs	
Location:	Ridgewell Airfield near Great Yeldham, Essex	
Type of Flight:	Private	
Persons on Board:	Crew - 1	Passengers - None
Injuries:	Crew - 1 (Fatal)	Passengers - N/A
Nature of Damage:	Glider destroyed	
Commander's Licence:	FAI Gold C Certificate (August 1981) and 3 Diamonds completed July 1985	
Commanders Age:	74 years	
Commander's Flying Experience:	4,186 hours (estimated 2,000 on type)	
Information Source:	AAIB Field Investigation with BGA assistance

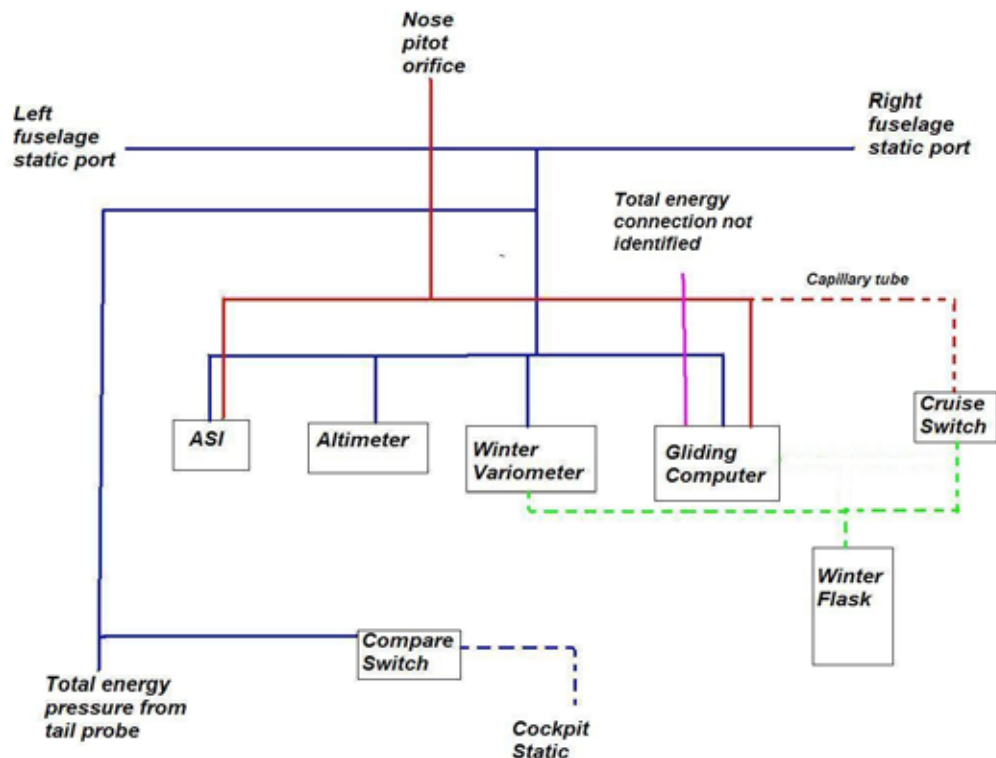
Figure 3

A reconstruction of the pitot static system showed that the gliding computer, flask variometer and the primary flight instruments were connected to the same pitot and static sources, including a static pressure input from the tail mounted total energy probe, see Figure 3.

During the reconstruction it was not possible to identify a connection to the separate total energy input of the gliding

computer. However, it was found that the computer fitted to this glider was capable of being programmed to generate an equivalent total energy signal using pitot and static pressure inputs. Therefore, it is possible that there was no total energy input to the gliding computer.
