Aircraft Type and Registration:	ASK13 Glider, FWN
No & Type of Engines:	N/A
Year of Manufacture:	1969
Date & Time (UTC):	6 August 2004 at 1645 hrs
Location:	Booker, Wycombe Air Park, Buckinghamshire
Type of Flight:	Trial lesson
Persons on Board:	Instructor - 1 Student - 1
Injuries:	Instructor - 1 (Minor) Student - 1 (Serious)
Nature of Damage:	Aircraft destroyed
Commander's Licence:	British Gliding Association Pilot's Certificate with Instructor Rating
Commander's Age:	58 years
Commander's Flying Experience:	577 hours (of which 85 were on type) Last 90 days - 74 hours Last 28 days - 25 hours
Information Source:	AAIB Field Investigation

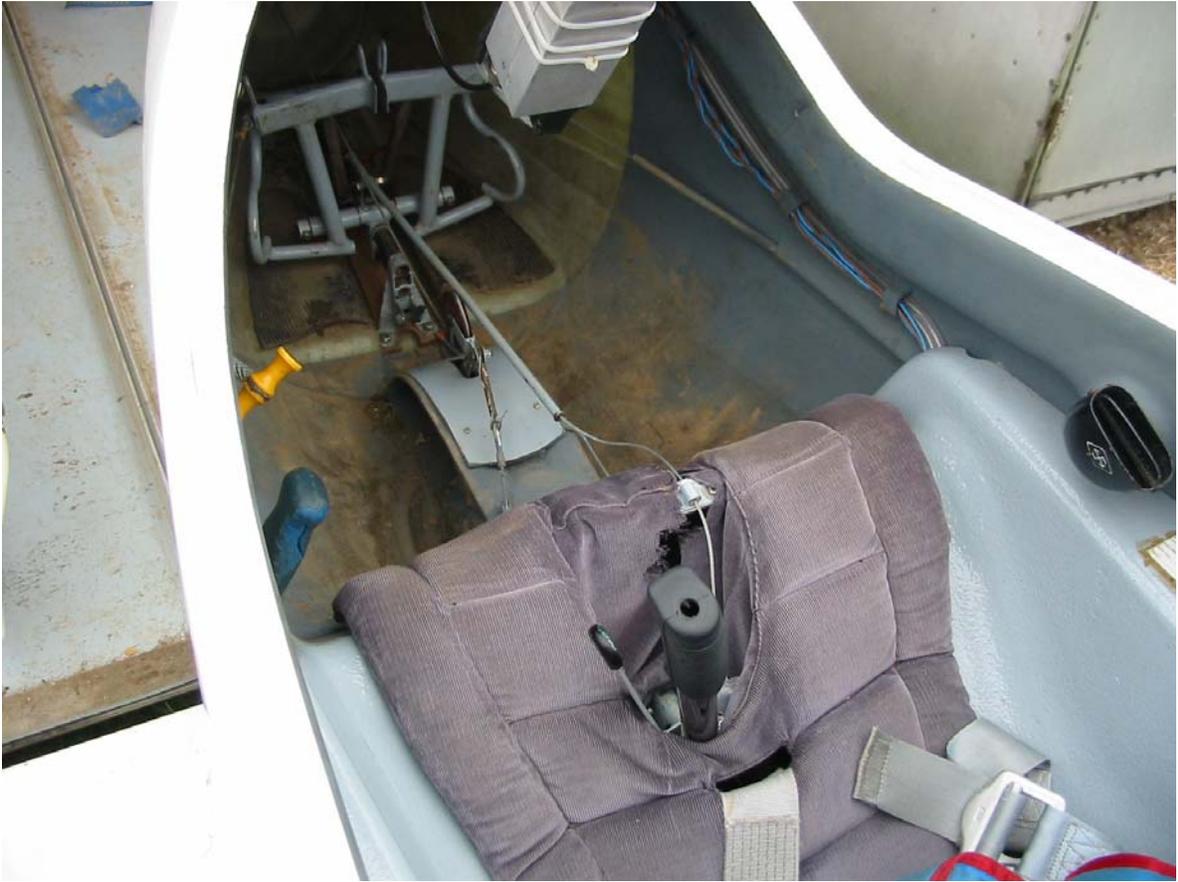
Figure 1

the same instructor in the same glider. The first student had taken a camera with him but did not recall being briefed specifically on what to do with it. The design of his glider's cockpit probably encouraged him to hold the camera in his hands (see Figure 1). There was then a pause of about three quarters of an hour before the third student was paired up with another instructor who had just completed a solo 3½ hour cross country flight. This instructor had not been nominated as an instructor for the day's instructional programme but was asked to assist because the instructor who was due to carry out the flight was feeling tired. Apparently it was not unusual for an instructor who had not been rostered to be asked to step in at short notice. However, this instructor could not remember conducting many instructional flights at short notice after a lengthy solo cross country flight. He subsequently commented that he had conducted at least 174 trial lessons.

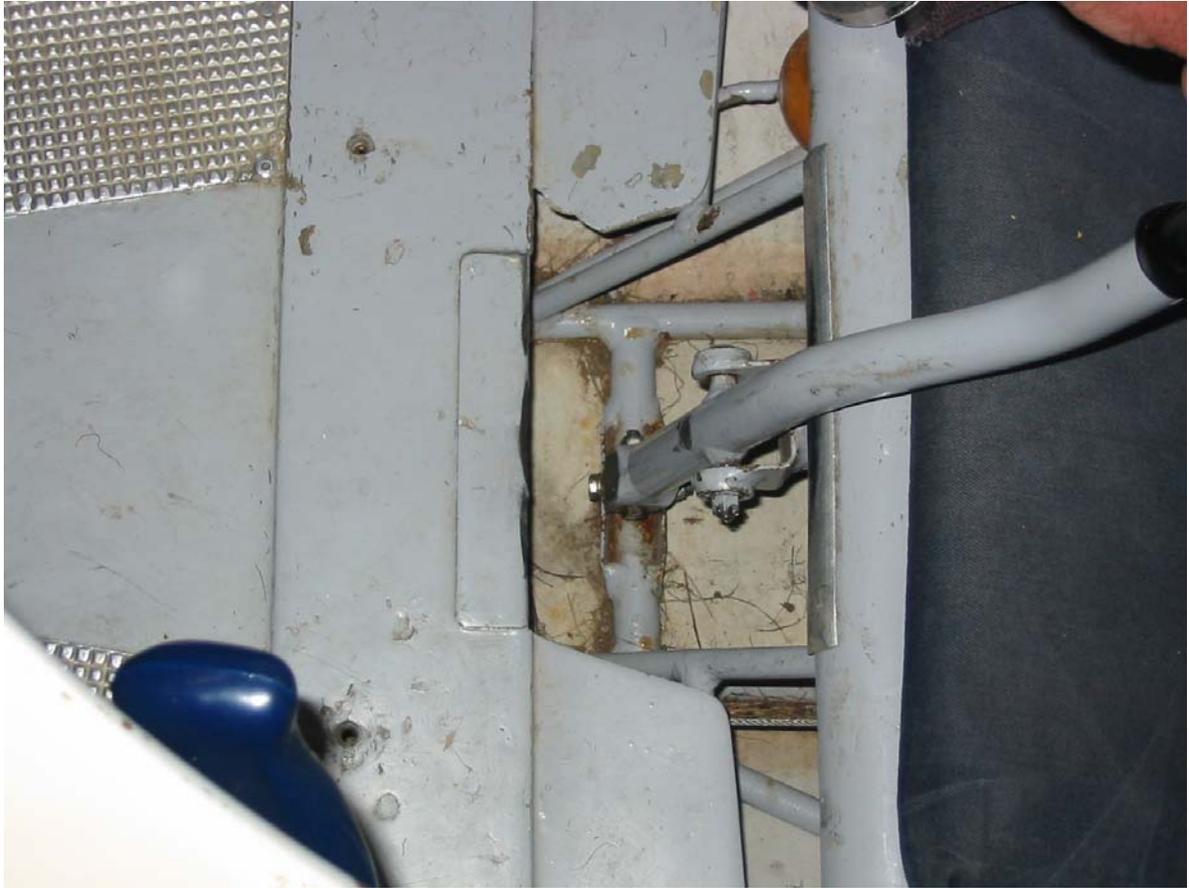
Figure 2

An examination of the glider revealed that, in the accident, the student's camera had been damaged. Initial indications suggested that the camera might have become lodged in the aperture for the front seat control column, between the column and its forward control stop; this is located at the aft end of the cockpit floor. This was possible because the space behind the floor around the control column, which allowed the control to be moved through its full range, was unguarded (see example in Figure 2). Further examination revealed that there was a small piece of black material in the edge of the floor in front of the control column, which looked similar to the material on the camera case (see Figure 3). Also the dents in the camera and witness marks on the camera case appeared to be consistent with the camera being jammed between the floor edge and control column at this point. Consequently, the material that was wedged in the edge of the floor and the camera case were sent for analysis.

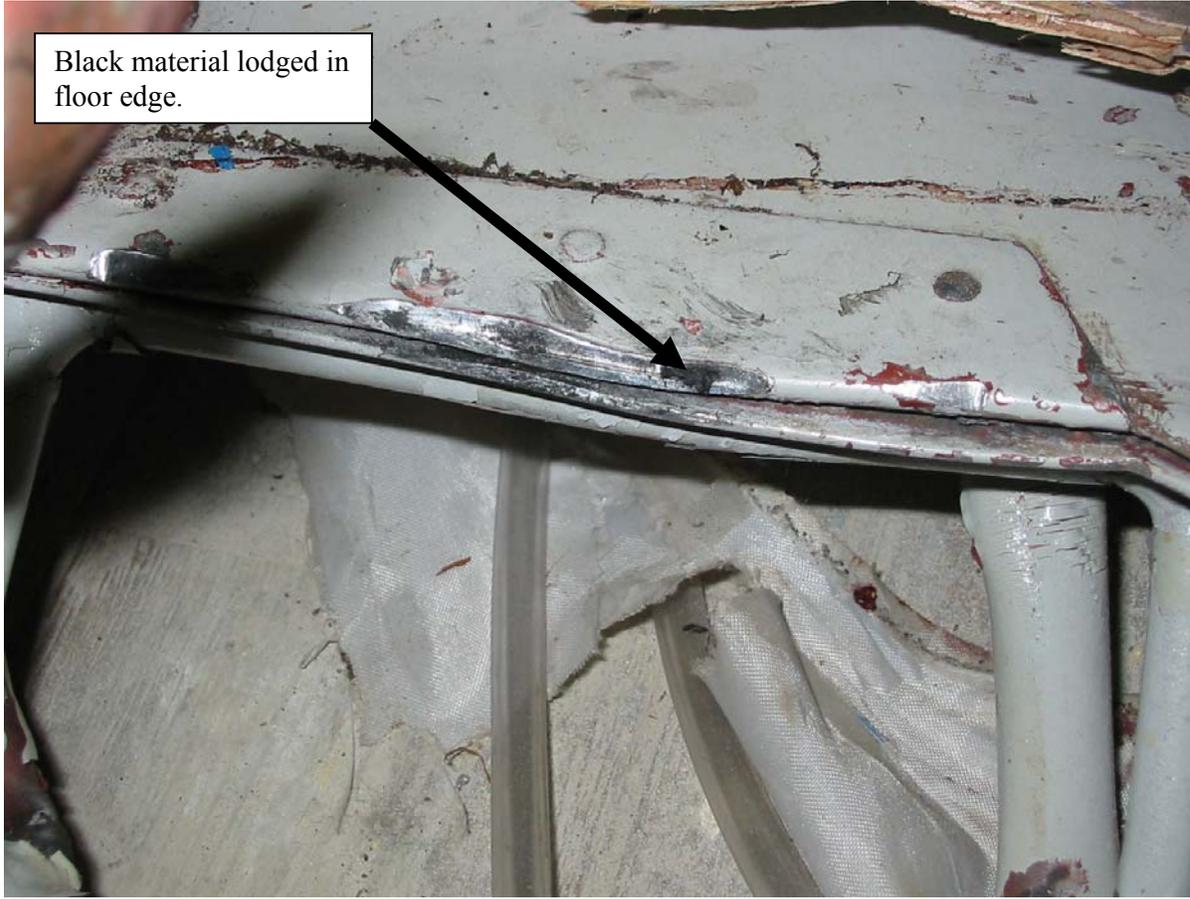
Figure 3

The results of the investigation indicate that the student's camera, which he had placed on the floor in front of his control column, moved rearwards and became lodged in the gap between the aft edge of the cockpit floor and the front seat control column as the glider accelerated and bounced over the runway surface during the take-off run. This gap had been widened when the instructor had moved the control column to its fully aft position, as usual for this type of glider, at the beginning of the takeoff. Thus, when the instructor attempted to move the control column forward, as the glider started to pitch up, he was prevented from doing so by the presence of the camera. The increase in the glider's nose-up pitch angle and movement of the controls to try and overcome the restriction may have resulted in the camera becoming even more firmly wedged.

It is recommended that the British Gliding Association reinforce the message that there must be no loose articles in aircraft when they are being flown.
