ACCIDENT

Aircraft Type and Registration:	Schempp-Hirth Nimbus-3 glider, G-EENN	
No & Type of Engines:	None	
Year of Manufacture:	1981 (Serial no: 9)	
Date & Time (UTC):	4 September 2012 at 1233 hrs	
Location:	Portmoak Airfield, Scotlandwell, Kinross	
Type of Flight:	Private	
Persons on Board:	Crew - 1	Passengers - None
Injuries:	Crew - 1 (Fatal)	Passengers - N/A
Nature of Damage:	Aircraft destroyed	
Commander's Licence:	FAI Gold C Certificate and 2 Diamonds	
Commander's Age:	49 years	
Commander's Flying Experience:	1,325 hours (of which at least 100 were on type) Last 90 days - 1 hour Last 28 days - 1 hour	
Information Source:	AAIB Field Investigation

Synopsis

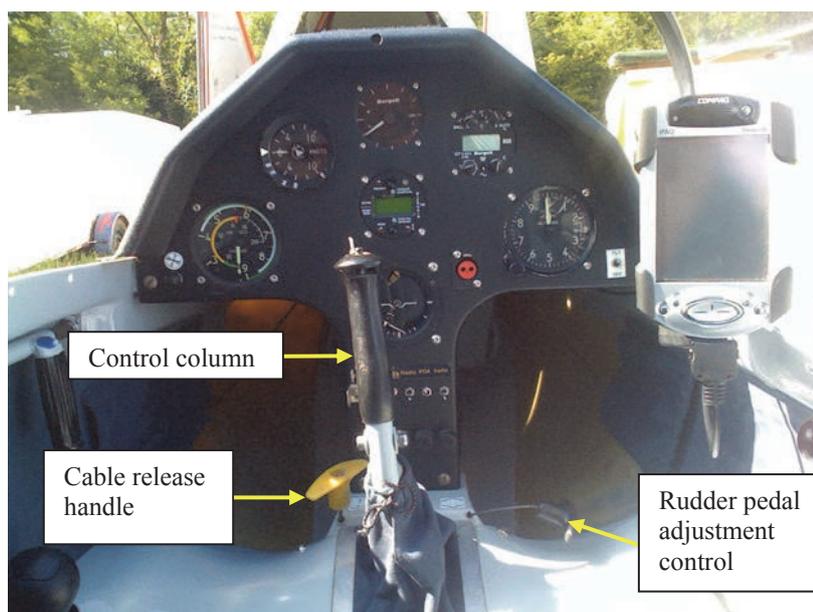
Figure 1

The Nimbus-3 is a single-seat high-performance glider constructed from carbon fibre and fibreglass with a maximum takeoff weight of 750 kg. It has a 25.5 m wing span and conventional flying controls operated by a control column and rudder pedals. It is also equipped with airbrakes, trailing edge flaps and a single-wheel, retractable, main landing gear. The wing tips are angled upwards and rubbing strips are fitted on the lower surface of each wing close to the wing tip. The glider can also carry water ballast in integral tanks fitted inside each wing. In G-EENN the pilot was secured by a four-point harness. For winch launches, the cable is attached to the cable release mechanism situated beneath the cockpit, just in front of the main wheel. On G-EENN the cable was released by the pilot pulling on a yellow coloured 'T' handle located just in front, and to the left, of the control column. A photograph of the cockpit of G-EENN, taken by a previous owner (Figure 1), shows the position of the cable release and rudder pedal adjustment controls.

Photograph of the cockpit in G-EENN taken several years prior to the accident

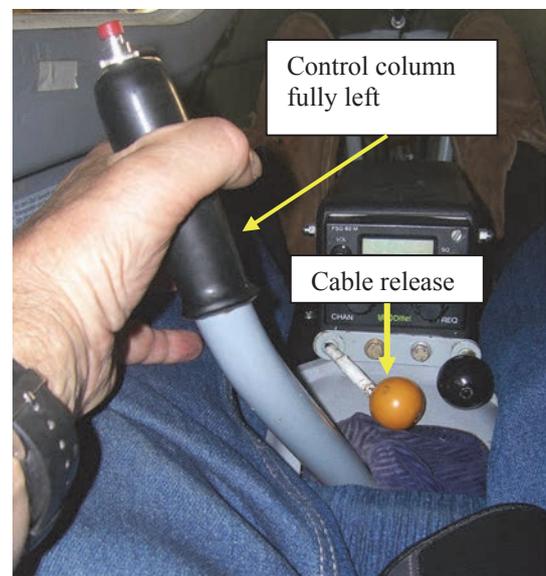
Figure 7 shows the location of the cable release on a Schleicher ASW 19 glider, which has a similar arrangement to the ASW 20L. The photograph was taken with the control column in the full left position.

Location of cable release on ASW 19 glider
