Aircraft Type and Registration:	SZD 50-3 Puchacz Glider, HCD	
No & Type of Engines:	N/A	
Year of Manufacture:	1992	
Date & Time (UTC):	18 January 2004 at 1320 hrs	
Location:	700 metres NW of Husbands Bosworth Village, Leicestershire	
Type of Flight:	Training	
Persons on Board:	Crew - 2	Passengers - None
Injuries:	Crew - 2 (Fatal)	Passengers - N/A
Nature of Damage:	Glider destroyed	
Commander's Licence:	British Gliding Association Assistant Instructor Rating	
Commander's Age:	65 years	
Commander's Flying Experience:	1,120 gliding hours (of which nine were on type) Last 90 days - 10 hours Last 28 days - 1.5 hours	
Information Source:	AAIB Field Investigation

Synopsis

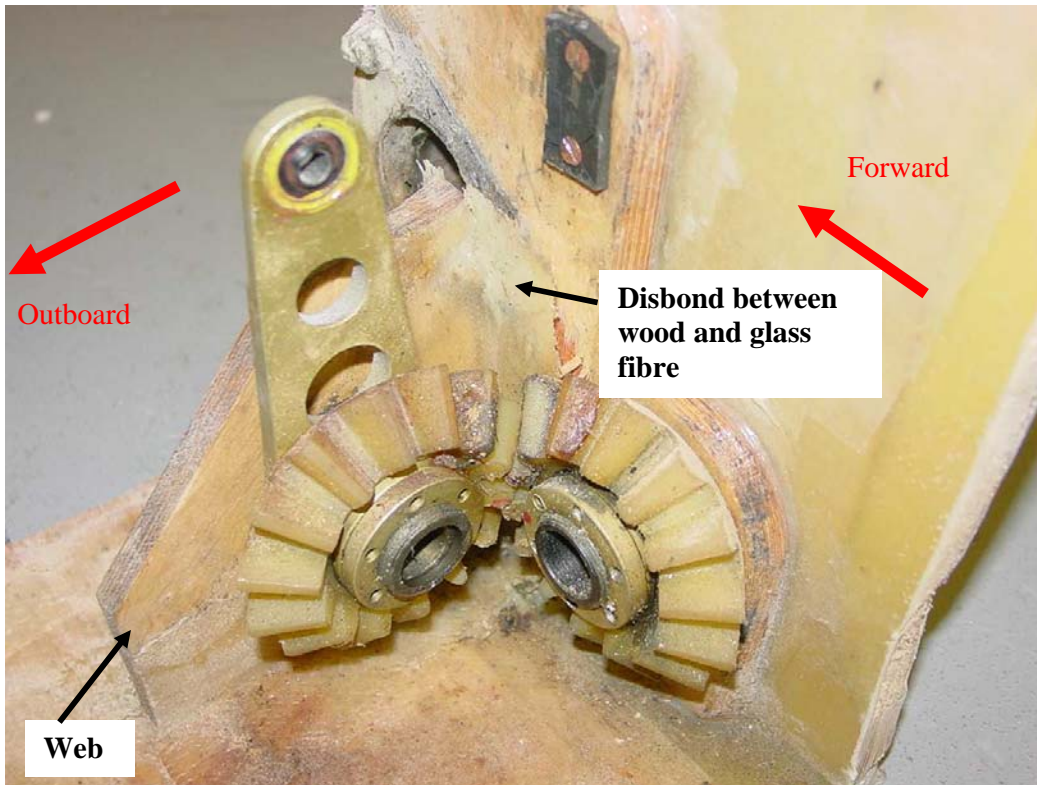
Figure 1. Details of the left hand airbrake bevel gear assembly, after being cut out of the aircraft

It was found that a plywood web supporting one of the bevel gears in the left airbrake system had become disbonded from the inner surface of the wing root rib, see Figure 1. This had allowed the web/gear wheel assembly to lean away from the mating gear, resulting in the gear wheel teeth no longer being in full engagement. In addition, the reaction forces between the teeth acted to push the web-mounted wheel further away when the airbrake mechanism was operated, with an associated risk of the teeth coming momentarily out of engagement and in consequence, a loss of synchronisation.

The bevel gear assembly and the surrounding structure were examined by the composites department of QinetiQ (formerly the Royal Aerospace Establishment) at Farnborough. The plywood web had been attached to the root rib by means of adhesive applied to glass fibre cloth that overwrapped both the web and rib. Examination of the disbonded area revealed two distinct areas: one was a clean, cohesive fracture within the surface plies of the wood, with the fracture surfaces being clean,

indicating that the fracture was new. The nature of the failure suggested a peeling action, indicating a span-wise load direction. The other area had been poorly bonded and had partially covered a steel flange that formed part of a fitting on the root rib. A gap was evident between the glass fibre cloth and the rib, with a long-term accumulation of dirt, indicating that this had most probably arisen during manufacture.

The failure of the bonded joint occurred in tension, rather than shear, which would have required loading to have been applied in the span-wise direction. At the moment the aircraft nose struck the ground, it is likely that considerable deflection of the wings occurred, in the form of either a downward bending, or a shock wave which travelled along the span. Since the airbrake control rods were mounted above the main spar, these would be loaded in tension when the wing was deflected downwards, which in turn would have acted to unlock the over-centre mechanism and thus allow the associated airbrake to deploy. If the deflection was excessive, it is likely that the tensile snatch load in the control rods could have caused the bonded joint to fail.

The reaction forces between the gear teeth loaded the gear support web in a manner that imposed a shear force in the bond between the web and wing root. Since the bond would have been inherently stronger in shear than in tension, it increases the probability that the failure occurred as a result of wing deflection at impact, as opposed to a progressive failure over a period of time. Nevertheless, it was not possible to be completely certain on this issue. The dissimilar arrangement of the left and right bevel gear support structure meant that the web that was the focus of this examination was used only on the left side. It was considered that as a result, the left side gear support was less robust than the right. However, both sides are difficult to inspect, the only access being via holes in the wing root web. A Safety Recommendation (2004-68) is made later in this report to the BGA concerning inspections of the airbrake bevel gear mechanism in the left wing.

Below: view of inner rib after removal of web

It is recommended that the British Gliding Association require regular inspections to be conducted on the left wing bevel gear support structure associated with the airbrake actuation system of the SZD Puchacz glider, paying particular attention to the bond between the gear support web and the inner face of the wing root rib.
