ACCIDENT

Aircraft Type and Registration:	1) Scheibe SF27 glider, HGM 2) Schleicher ASW 19 glider, GDP
No & Type of Engines:	1) None 2) None
Year of Manufacture:	1) 1965 2) 1979
Date & Time (UTC):	2 October 2006 at 1515 hrs
Location:	Sutton Bank, North Yorkshire
Type of Flight:	1) Private 2) Private
Persons on Board:	1) Crew - 1 Passengers - None 2) Crew - 1 Passengers - None
Injuries:	1) Crew - 1 (Minor) Passengers - N/A 2) Crew - 1 (Fatal) Passengers - N/A
Nature of Damage:	1) Aircraft destroyed 2) Aircraft destroyed
Commander's Licence:	1) British Gliding Association (BGA) Gliding Certificate 2) British Gliding Association (BGA) Gliding Certificate
Commander's Age:	1) 50 years 2) 48 years
Commander's Flying Experience:	1) 733 hours Last 90 days - 20 hours Last 28 days - 5 hours 2) 280 hours Last 90 days - 10 hours Last 28 days - 1 hour
Information Source:	AAIB Field Investigation with assistance from the British Gliding Association (BGA)

Synopsis

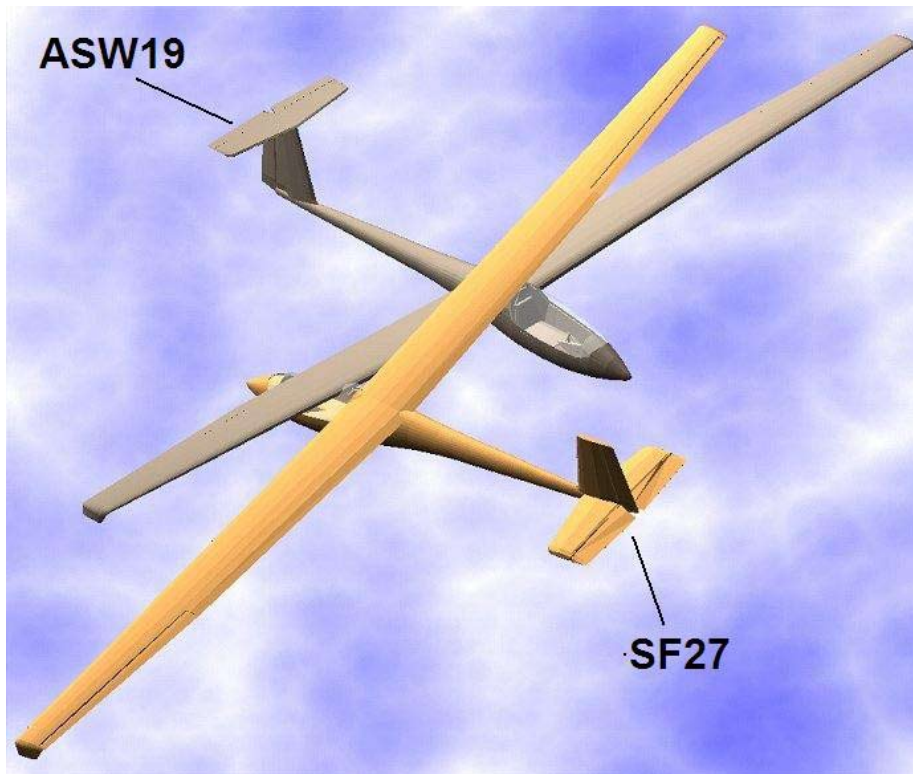
Figure 3

The paint transfer seen on the SF27 overwing fairing, and the fragment of the lower surface of the right wing from the ASW 19, confirmed that initial impact was between the right wing of the ASW 19, approximately 3 metres outboard of the wing root, and the cockpit canopy and right wing root of the SF27, see Figure 3. The forces involved in such a collision would have been sufficient to disrupt the wing-to-fuselage mountings of the SF27 and cause the separation of the outboard section of the ASW 19 wing. The loss of such a large portion of the wing, including the aileron, would have made the ASW 19 uncontrollable and caused it to roll right as it descended. The fact that fragments of both glider's canopies were found at the top of Sutton Bank, and that a 3 metre section of the right outboard wing of the SF27 was found 200 metres away from the main wreckage, confirmed that there were additional impacts between the two gliders but there was insufficient evidence to

determine the sequence of these additional impacts. At some point after the initial impact the outboard right wing of the SF27 failed, approximately 4.5 metres from the wing root, which would have made this glider incapable of flight.
