**AAIB Bulletin No:**

**Ref:** EW/C2002/06/05

**Aircraft Type and Registration:** Slingsby Sport Vega Glider T65D, BGA 2758

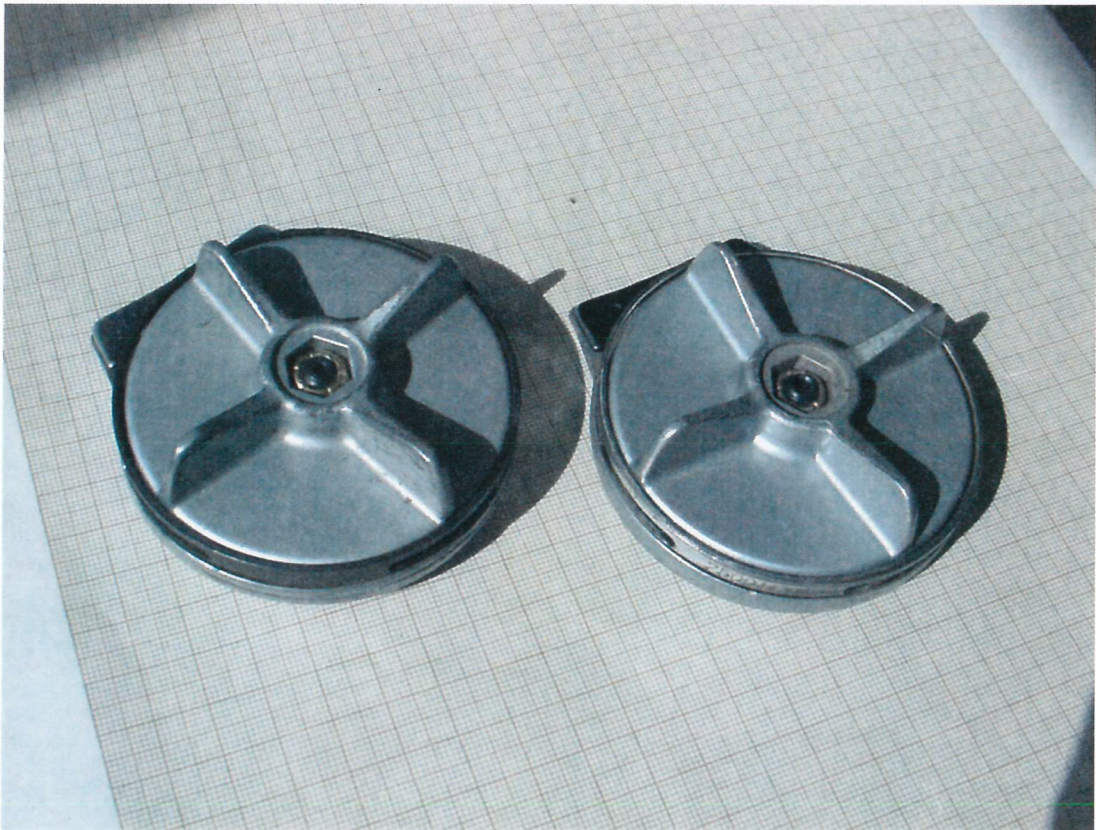
**Figure 1 - Failed buckle and example buckle**

The rotary buckle is an all-metal device consisting of a housing with five slotted sockets to accommodate end fittings for two shoulder restraints, two lap belts and one crotch strap. Release of the end fittings is accomplished by rotating the four-vaned handle (see Figure 1) in either direction. The release mechanism for the crotch strap or either of the lap belts can be inactivated so that, with rotation of the handle, the buckle will remain attached to one item of webbing. The two shoulder restraints can also be released separately by pushing forward on the tab located between the shoulder fittings.

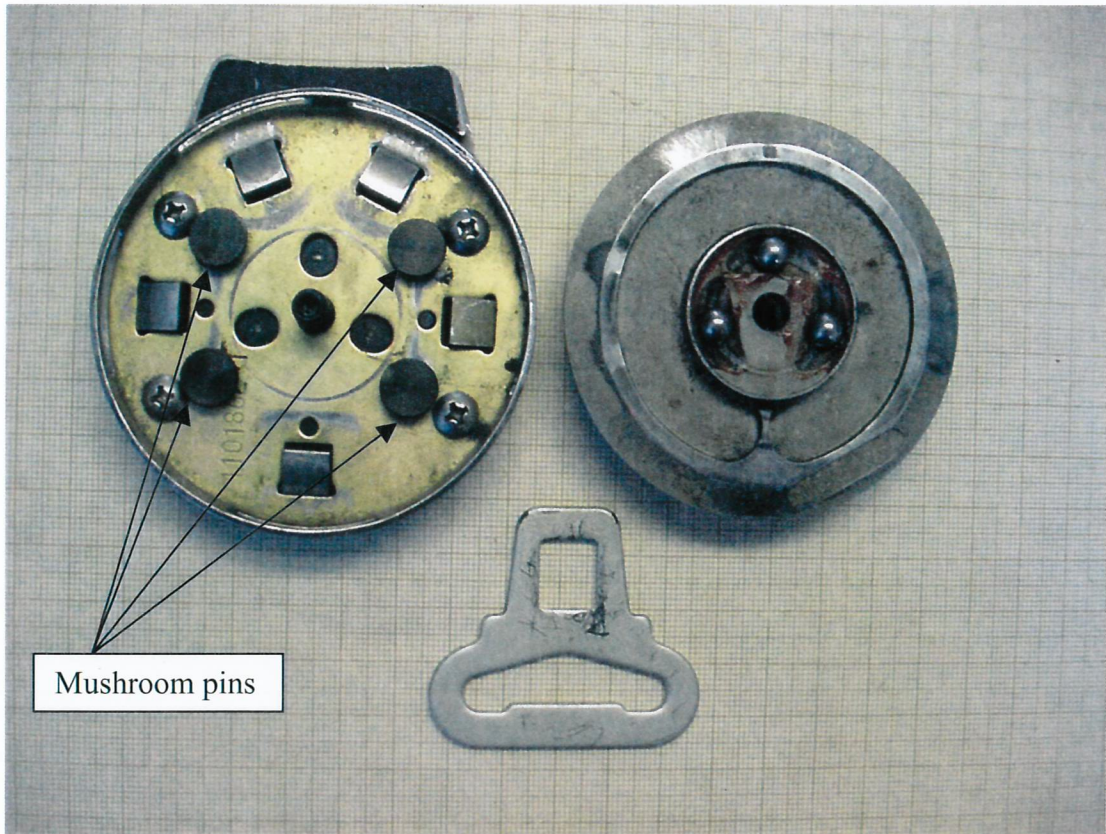
**Figure 2 - Example buckle with one harness fitting**

compared with example buckle (Figure 2) from the same manufacturer. On the example buckle the stems of the mushrooms were drilled before riveting and exhibited a greater spreading and hence a greater resistance to pull-out.

It was noted that the shoulder restraint fittings only have one locating mushroom pin (Figure 2) but are held in place because of the restriction on their movement by the smaller spacing between the restraining dog and the head of the mushroom pin. Under load, the geometry of the harness would make the shoulder fittings more likely to maintain their 'flat' attitude to the buckle, whereas the lap fittings would be liable to tilt away from the body plate because of the direction of the applied force. It is this tilting that would tend to pry the mushroom pins from the body plate and, together with the increased freedom of movement, would allow the fitting to ride over the restraining dog if the mushroom pin became detached.

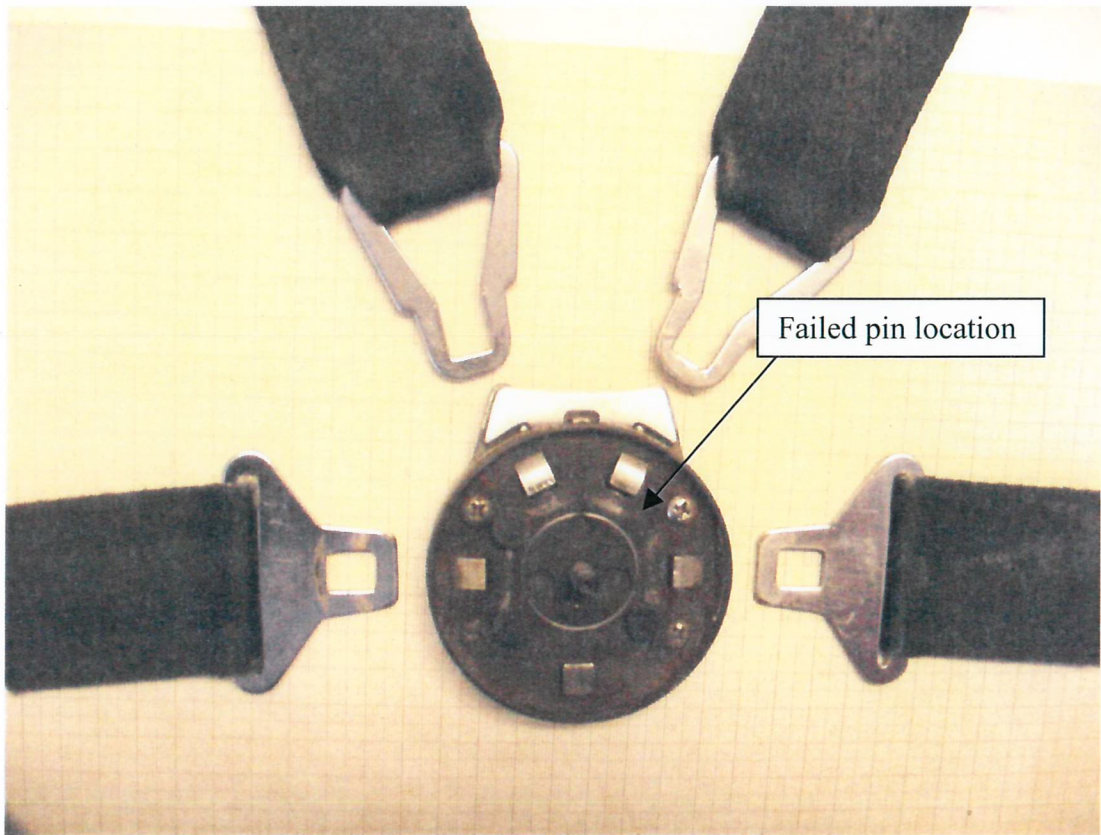
**Figure 3 - Failed buckle with harness fittings**

The rotary buckle is a simple fabricated device in which each belt plug-in fitting is restrained by a restraining dog (retracted by rotation of the four-vane handle), and a combination of the 'mushroom' pins shown in Figure 2 (an example with the pins in place). The buckle had failed (Figure 3 - failed buckle and end fittings) by the left-hand lap fitting pulling out of the buckle, which created witness marks on the fitting and on the remaining mushroom pin with which it was in contact (Figure 4). In order for this to occur, the detached mushroom pin could not have been in place at the time of failure and the physical evidence indicated that it had been loose for some time. The arcs of scoring (Figure 4) show the rotational movement of the pin when the buckle was operated.

Although the lap fitting from the failed buckle had a different pattern to the example fitting, it could not be determined whether this induced the pin failure. The metallurgist considered that of greater significance was the way in which the mushroom pins had been riveted in the failed buckle, when

The manufacturer's limited examination of the rotary buckle and other hardware in the USA confirmed that the rotary buckle was of their manufacture but that the other hardware was not. The examination also noted that the buckle was manufactured before December 1980 and thus had a lower rated strength than later buckles. There were additional negative comments on the apparent lack of servicing of the buckle, which had become worn and exceeded the wear limits of the Component Maintenance Manual, and the method of attaching the webbing to the fuselage structure, with a bolt piercing a double lay of the webbing.

The British Gliding Association should review the document 'Maintenance of seat harnesses and belts' so as to reflect best industry practice and to provide clearer guidance for airworthiness inspection.
