**GLIDER ACCIDENT REPORT BGA NO: 36/04**

Aircraft Manufacturer:	Schleicher
Model:	Ka 7
BGA Number:	3957
Fin Identifier:	HHL
Year of manufacture:	1959
Owner:	Lincolnshire Gliding Club
Place of Accident:	Strubby Airfield, Alford, Lincolnshire.
Date of Accident:	26 May 2004
Time of Accident:	12:10 hrs (local)

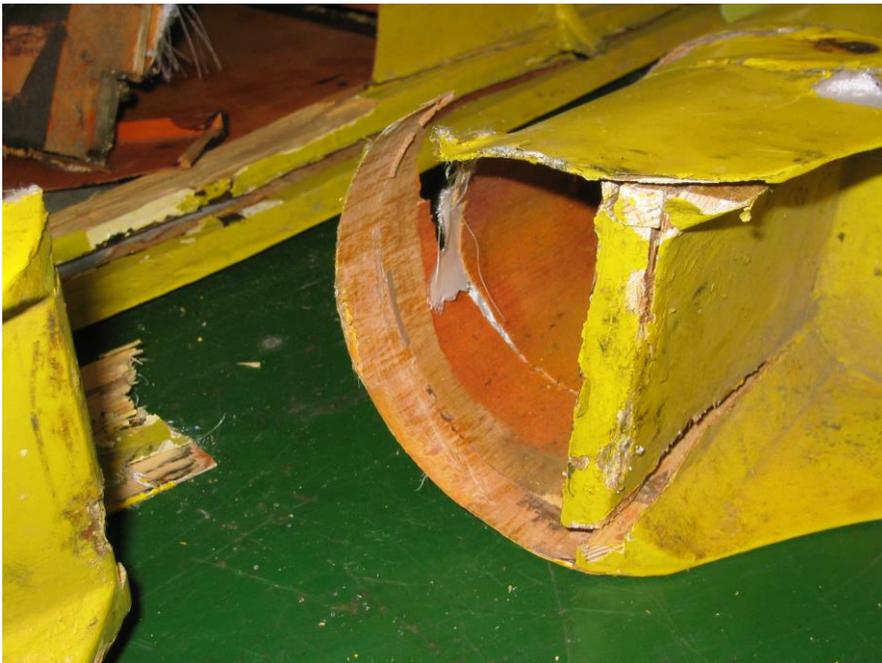
On the left hand elevator it was noted that where the plywood skin had come away from the No 1 rib; the surface of the exposed glue joint had little in the way of wood fibres adhering to it, indicating a poorly effected joint. Moreover, the surface of the glue was dull, indicating that the failure was relatively old (see Figure 2), possibly dating from the time of manufacture. A joint in such a condition was considered, in the opinion of the expert from TRADA, to have little or no capability to transmit torsional loads through the glue, as intended in its design.

**Figure 1** Left elevator D box at Rib No. 1 position illustrating poor glue bond

In addition, the inspection of the elevator rib No 1 glued joint is now required to be carried out annually, instead of every three years, in accordance with the extant requirements of AD72-7/3 and the applicable Schleicher Technical Note 18.

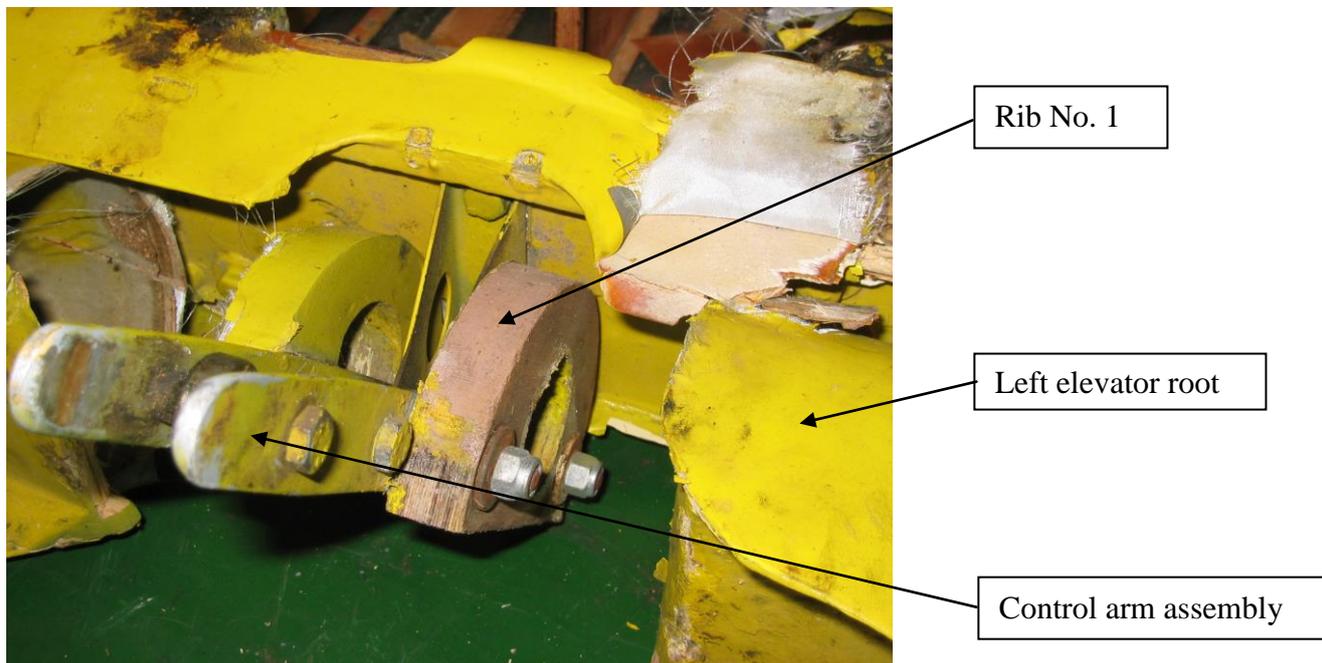
**Figure 2** Left elevator Rib No 1 showing lack of wood fibre adhesion to the glue (pink surface). Note the failure of the wood skin in preference to the glue on the right elevator.
