Glider Type and Registration (Tail No):	Discus CS	Lak 17
BGA No:	G-IDER (W4)	G-CKOI (170)
Engine:	None	1 (turbo)
Year of Manufacture:	1992	2006
Time (local) and Date:	16:02 hrs on 26 July 2014	
Location:	Lt. Paxton, Nr. St. Neots, Cambs.	
Type of flight (actual/intended):	Competition task (both gliders)	
Type of launch:	Aerotow	Aerotow
Persons on Board:	1	1
Nature of Damage:	Glider destroyed	Serious
Injuries:	Minor	Minor
P1's Qualifications:	Silver C	3 diamonds
P2's Qualifications:	N/A	N/A
Commander's Age:	70 years	60 years
Commanders' Flying Experience :		
Total all types:	800 hrs	5000 hrs
Total on Type:	200 hrs	1000 hrs
Last 6 months:	15 hrs	100 hrs
Information Source(s):	BGA Accident Report Forms, Club Investigation, witness statements and follow-up enquiries

Synopsis

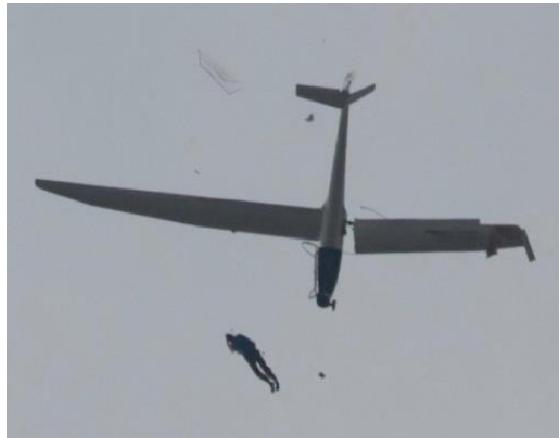
The pilot had seen another glider flying in the same area as his on several occasions while on the competition task. He thought he saw a glider prior to the accident circling in what seemed to be a poor thermal about half a mile away. He didn't recollect seeing any more of this glider until immediately before the impact, when it appeared from his left side and above, impacting with W4's raised left wing. As it did so, there was a very loud noise and the glider went into a tumbling spin, photo (a). The pilot realised that he had no option but to get out, so operated the normal canopy-opening knob and thought that the canopy flew off¹. He then pulled the seat harness release lever and with no effort he fell from the glider into a tumbling free fall, photo (b)

¹ Photo (b) shows that the glider canopy had opened, but that the frame remained attached to the glider. The apparently

complete transparency can be seen to the left of the glider's tail.

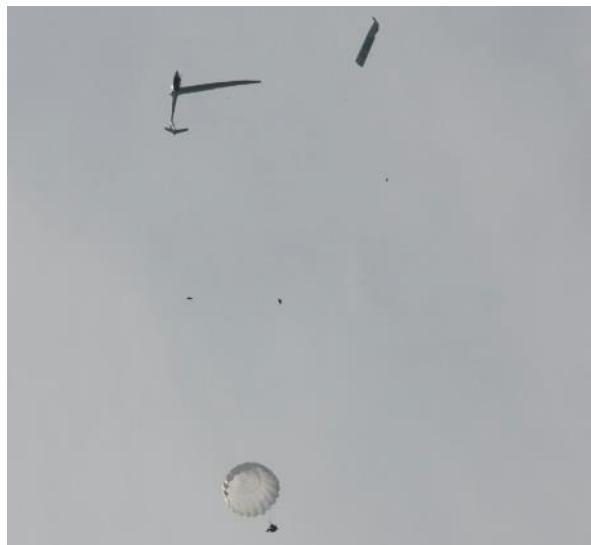
(c)

He pulled the parachute 'rip-cord' and, as the canopy deployed with a sharp tug, it pulled the breast strap over his head, photo (c). He was then surprised that he still held the unattached parachute release handle in his right hand so dropped it to pull the breast strap back across his chest. He then took hold of the parachute cords and attempted to manoeuvre the parachute, as there were power lines, a river and trees below him. However, the parachute didn't respond and he landed heavily into standing crop in a field that was being harvested. He saw a combine harvester bearing down upon him and so crawled out of the uncut crop into a cut area, pulling the parachute after him. A farm worker came to his aid at that point.

In consideration of the initial difficulty that the pilot of W4 had with his parachute, the following Safety Recommendation is made to the BGA:

Safety Recommendation 2015-xx

It is recommended that the BGA should remind all glider pilots of the high importance of properly adjusting their parachute harness to ensure as far as possible that it will deploy correctly and avoid the possibility of the breast strap ‘riding up’ upon deployment.

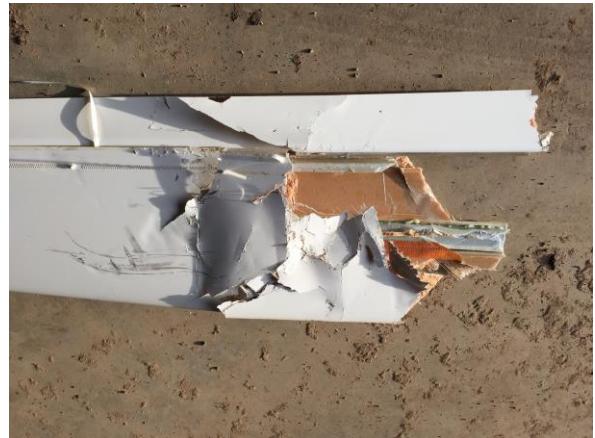
A hard impact had occurred between W4’s left outer wing (d) and 170’s cockpit (e). This removed the outermost part of the wing, and precipitated a structural failure at its inboard end, and forced the instrument binnacle downwards causing structural damage to the cockpit section. Secondary damage resulted

to the right outer leading edge of 170’s wing and the root section of W4’s left tailplane, probably from impacts with debris from W4’s broken wing. This led to a structural failure of the tailplane but this remained loosely attached until the glider struck the ground.

(d) Failure region of W4’s outer left wing

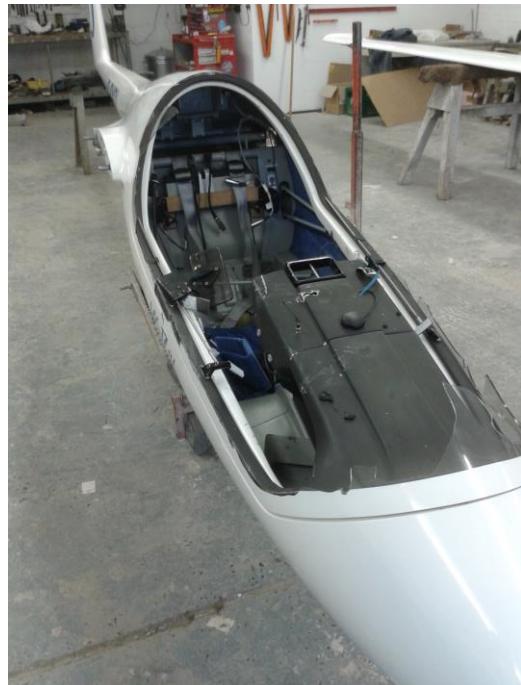
(e) Damage to 170’s right cockpit edge and instrument binnacle

his glider had been put into a steep dive, in his attempt to avoid the collision. All damage seen was judged as a result of the collision and, in W4's case, impact with the ground. Neither pilot reported any problems with their flying controls prior to the collision, and this is supported by examination of the wreckages by various parties during recovery/repair.

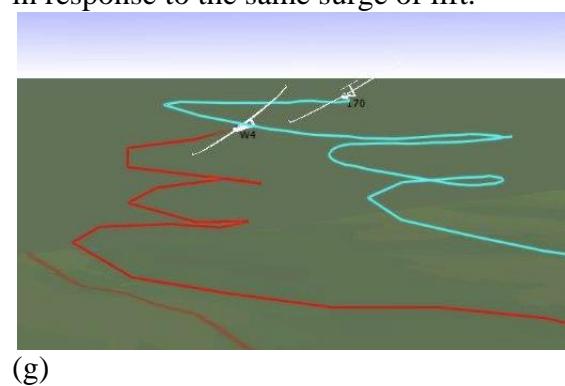
Each glider was equipped with a data logger, which provided good evidence of their flights. Figures (g) and (h) show screen shots from SeeYou of the flight paths of the gliders (W4 red, 170 blue) shortly before the collision, and figure (i) a plan view of their estimated relative positions for the 12 seconds before the collision. As may be seen, the gliders were circling in the same direction (to the right) but initially not about the same vertical axis. As glider 170 approached the same level as W4, it moved closer to W4's orbit. At 6 seconds before the collision, the gliders were about 480ft apart. Glider 170 was moving from right to left in the field of view of W4 so that at 4 seconds it was 20° to the left and at 2 seconds 50° left. At 2 seconds the gliders were approximately 250ft apart. The position of W4 relative to 170 hardly changed between 12 seconds and 6 seconds. At 4 seconds W4 would have been just behind the right wing tip of 170. At 2 seconds W4 was 70° R viewed from the cockpit of 170.

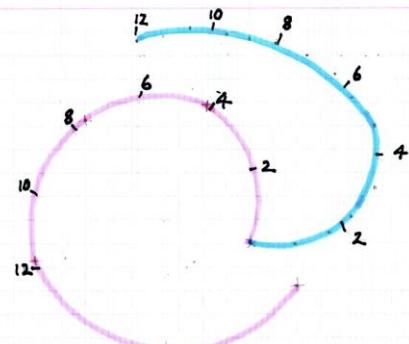
(i)

At 4 seconds from impact both pilots may have tightened their turns slightly (i), possibly in response to the same surge of lift.

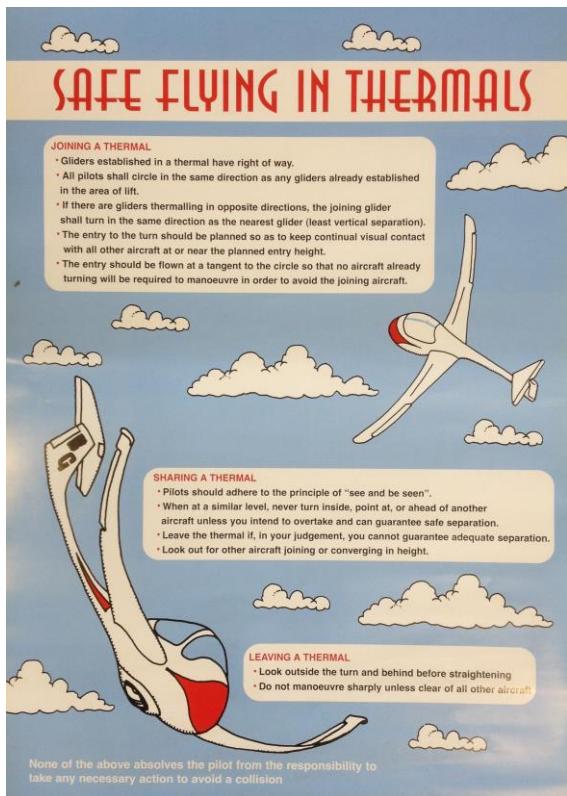
A poster (j) reflecting this was developed and issued some years ago to clubs, but like most ‘safety’ related material, maintenance of its effectiveness requires that such material is ‘refreshed’ on a regular basis.
