Technical News Sheet

Issue 3-2015

Date: 10/10/2015

Airworthiness Information.

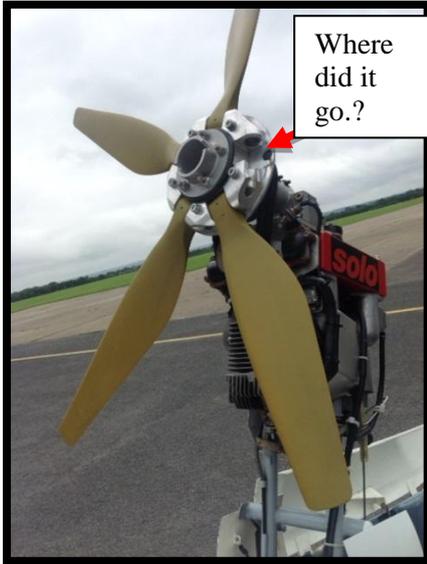
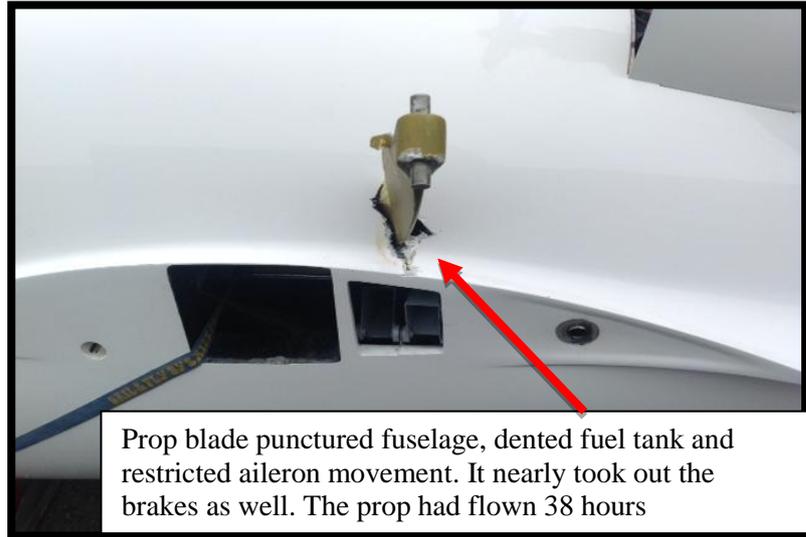
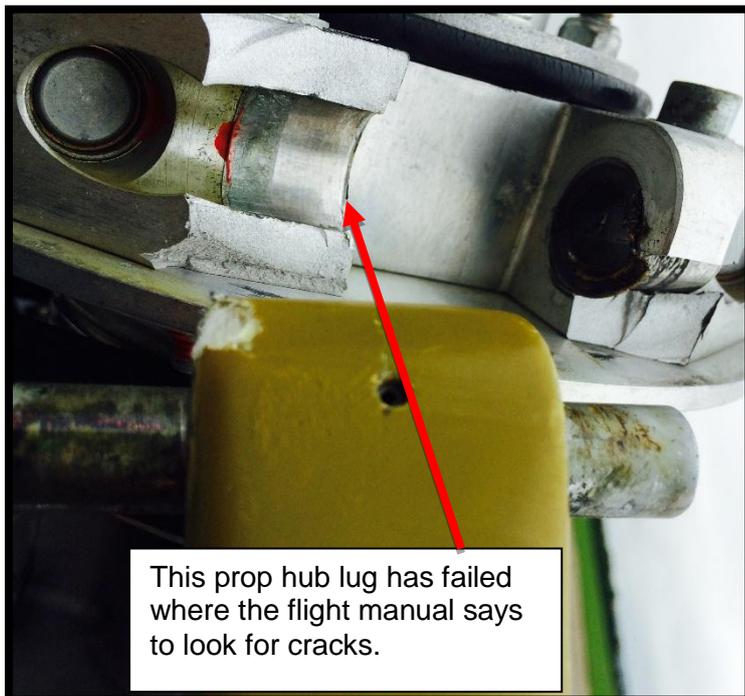
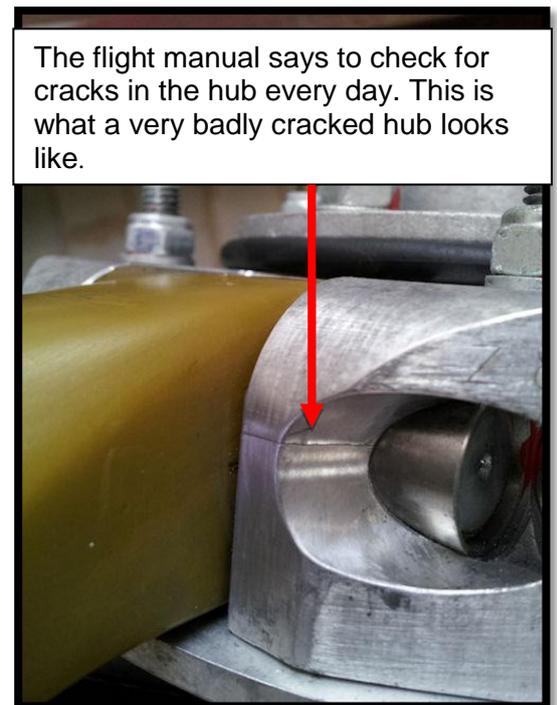
7 Schempp-Hirth Duo Discus T, Nimbus 4 DT (and possibly others)

Propeller hub failure in flight. AAIB investigating.

This Duo Discus turbo was not subject to an AD that effected earlier versions with known prop hub cracks.

Talking to a number of inspectors, they say this is not an unknown problem. This is a good example of why reporting even minor cracks on critical parts enables the BGA to carry out trend analysis and advise CAA/EASA accordingly.

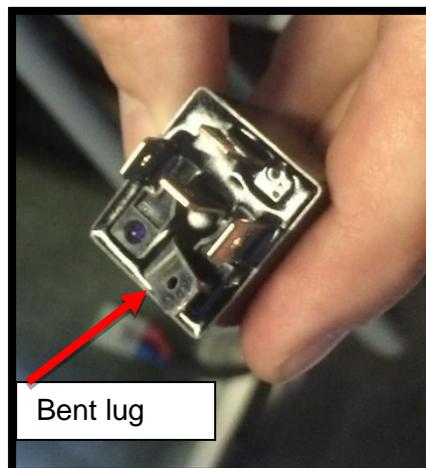
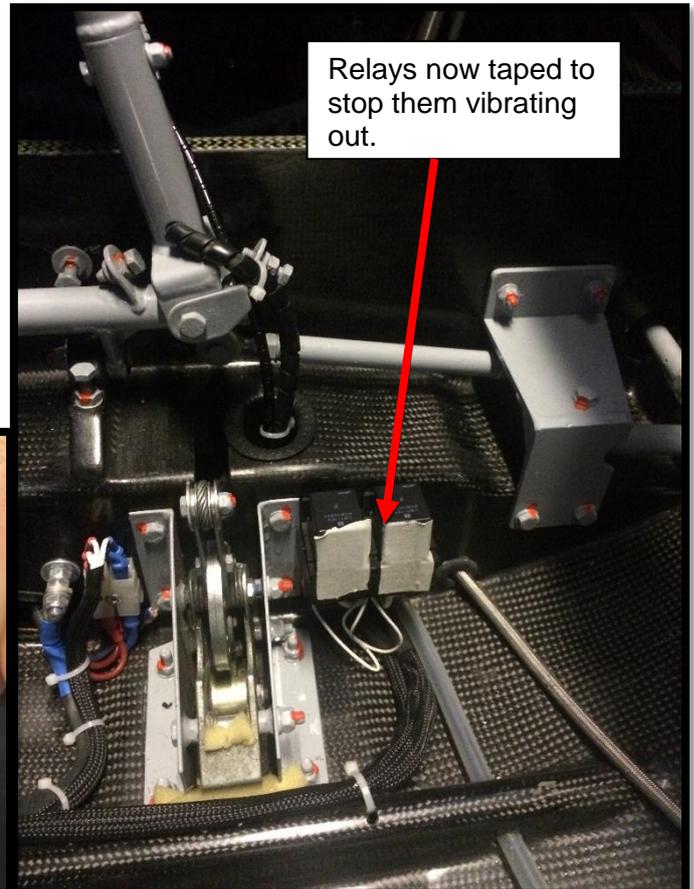
8 Duo Discus XLT (and possibly others)

During a DI the pilot could not get the turbo to raise. Upon further fault finding, the problem was narrowed down to one of the two relays that live under the P2 seat. We removed the P2 seat and found one of the relays had come out of its connection block, was floating free in the fuselage and had one bent connector.

Our concern is that the connector had been bent by either the winch hook mechanism or the flight control mechanism.

The lessons is that on annual maintenance check the relays are very secure.

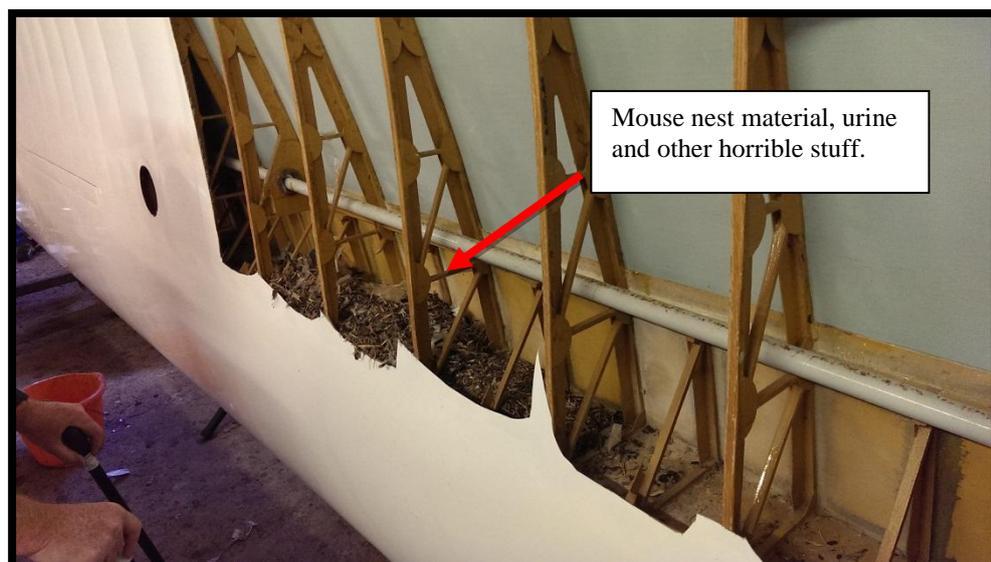
9 All Gliders. Reported by Lucy Wootton

A cosmetically good K6 wing was found to have a mouse nest. The required repair was large.

This is a reminder that mice can get in the smallest holes and build their homes in the most remote places.

Always be vigilant for odd noises (moving twigs) when turning the wings over.

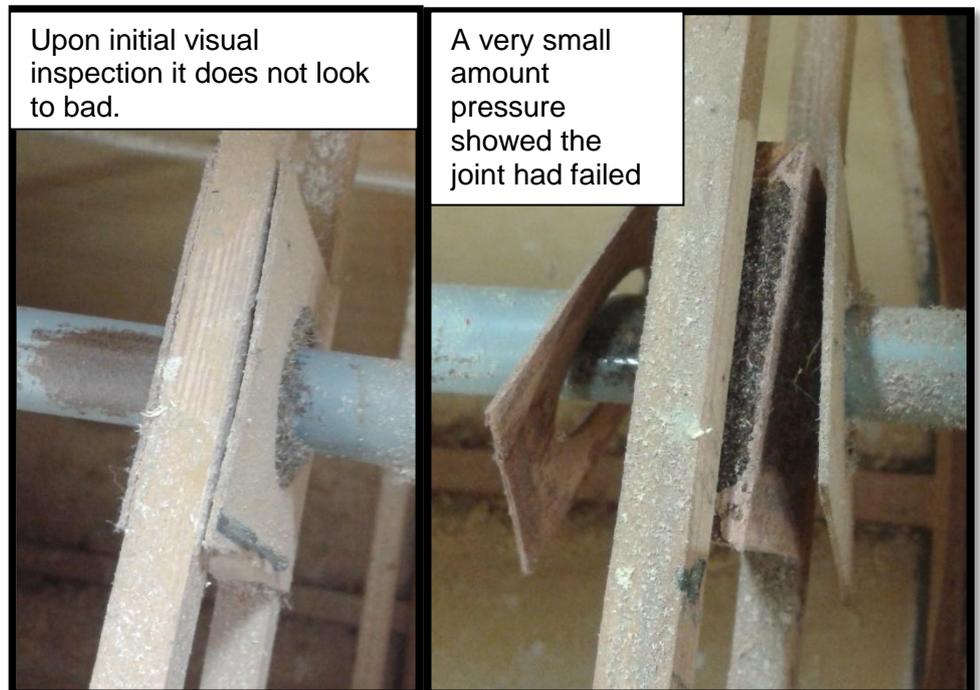
10 K6 (and also all Scheicher wooden gliders) (reported by Dave Bullock) Advisory

Glue failure of the elevator pushrod guides.

The rest of the glider was not too bad.

This failure could easily have caused flutter or worse.

When performing glue inspections do not assume that, when the rest of the airframe is good, that all the small (but critical joints) are also sound.

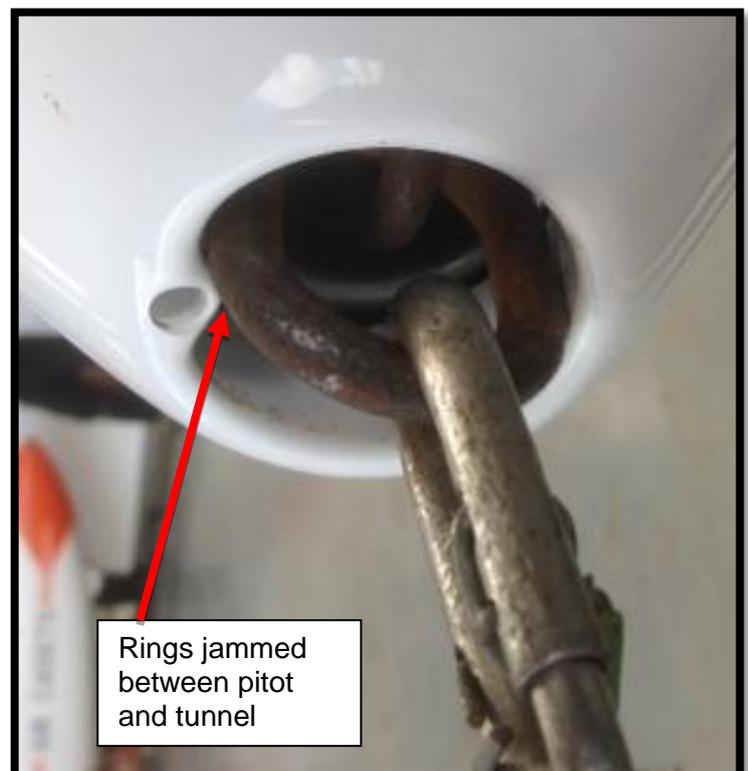
**11 Schempp-Hirth Discus (and others) After Refinish/Repair Advisory**

After any repairs or refinishing work to the nose of any glider with a nose hook that requires the rings to go in a tunnel.

Part of checking the job is done correctly is to make sure that rings cannot possibly get jammed in the tunnel

Do not leave this job to the pilot on the first post-refinish/repair flight.

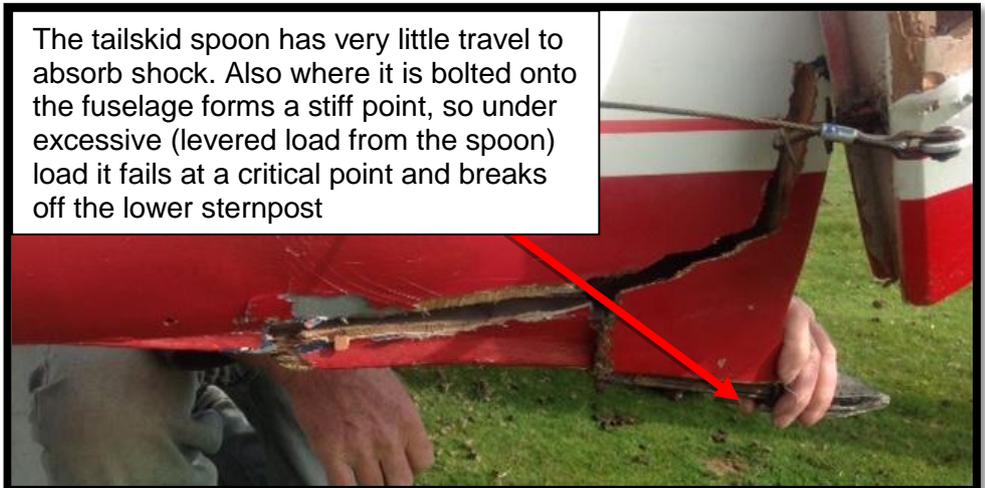
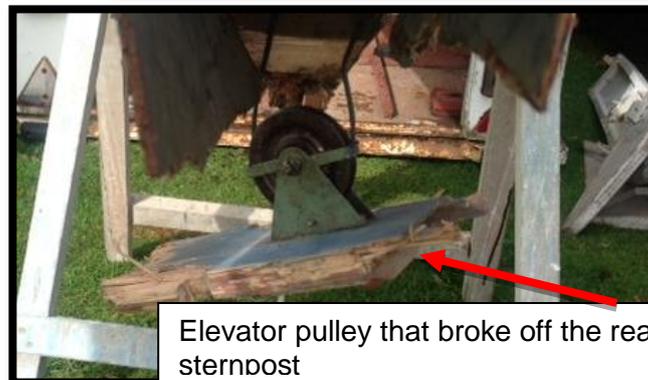
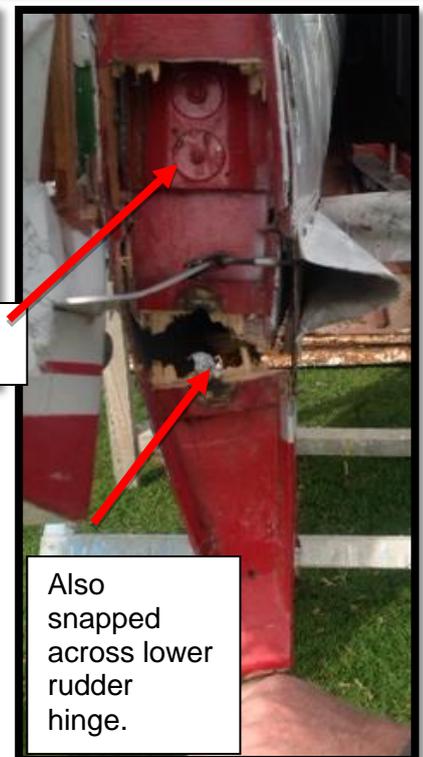
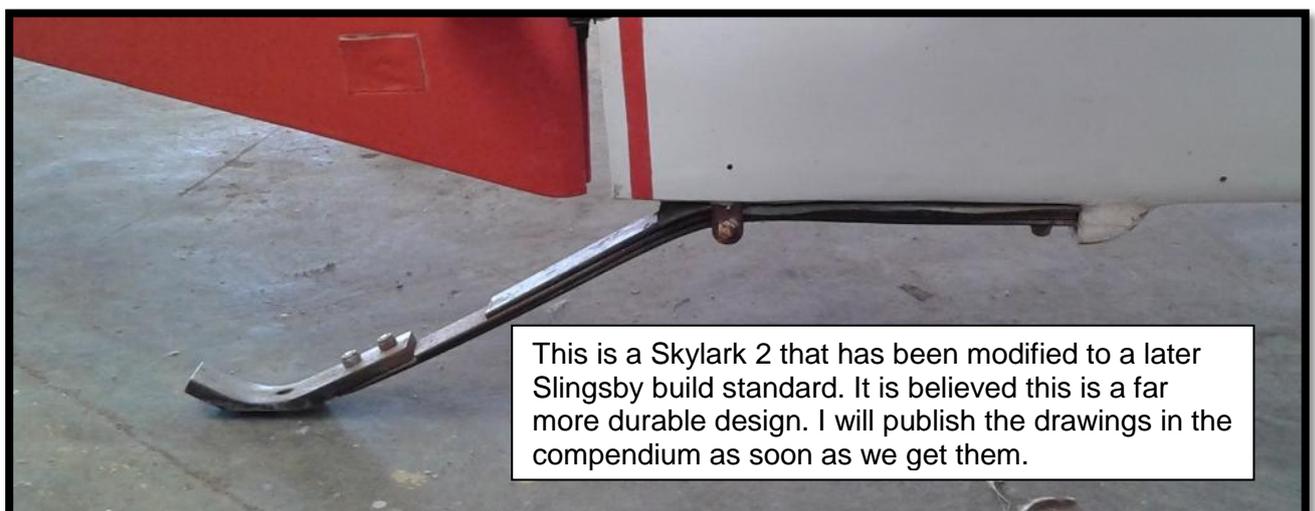
12 Slingsby Skylark 2 and 3 Series

This glider suffered a tail strike on a slightly snatched winch launch; the tailskid and lower sternpost on this Skylark 3 failed.

This resulted in the pilot losing all elevator and rudder control during the rest of the launch and subsequent crash.

There is no indication of any pre-accident damage or glue

failure on this glider when inspected after the accident. It is fair to say the original design of tailskid and short leaf spring provides almost no cushioning at all, if the tail strikes the ground.

On later versions of Skylarks the design was changed, presumably to make the tailskid more able to withstand a tail strike.

The newer design has a much longer leaf spring and a fairing in front of the tailskid retention bolts to stop the bolts catching on rocks etc.

If you have the old design, then you can modify it to the newer design.

Operationally, the vintage gliding people at Lasham always have somebody hold the tail on the ground prior until all-out to prevent a tail strike.

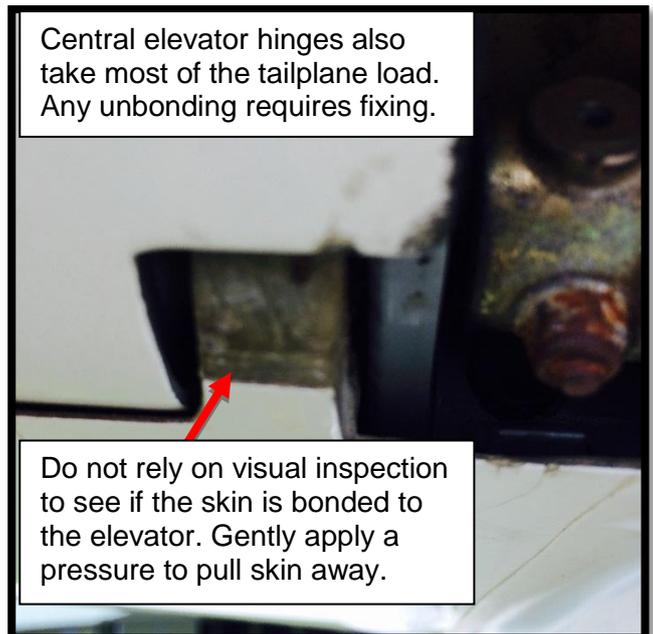
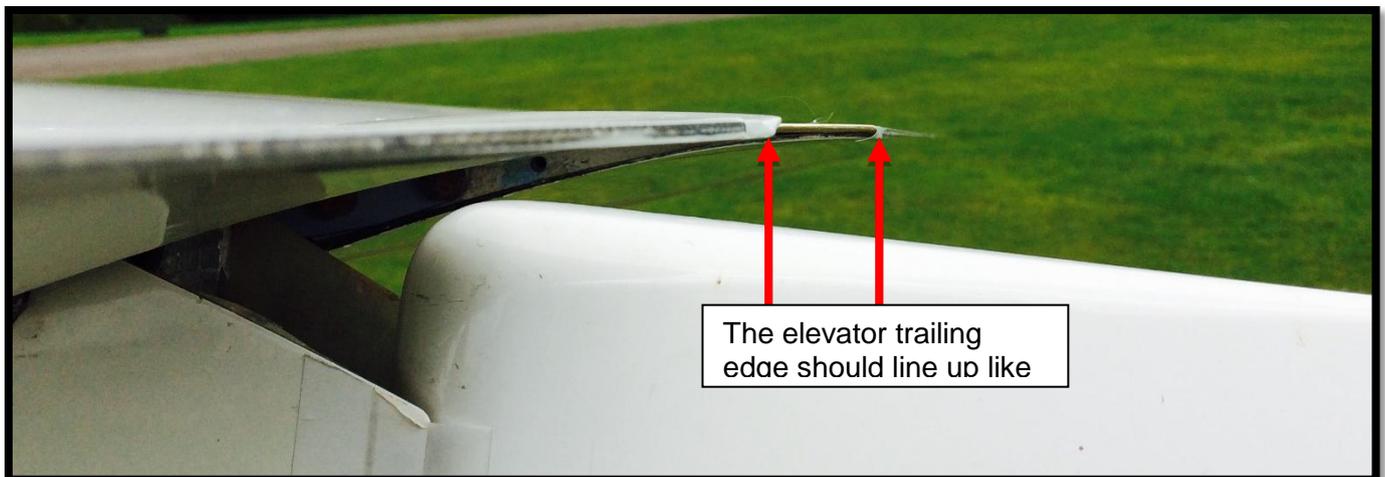
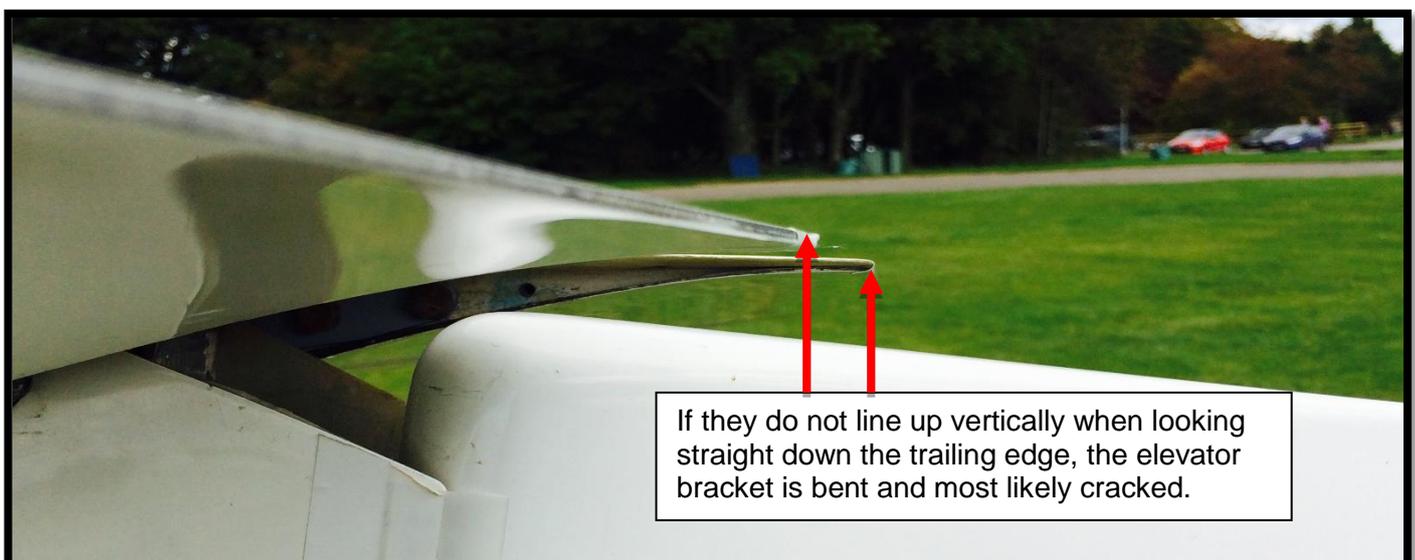
13 Finding Damage on Schempp-Hirth, Glasflugel, and Slingsby Tailpanes at Annual or after Ground Loop or Heavy Landing. Advisory

Owners and inspectors are not always finding damage on composite gliders in a timely manner, either on daily inspection, annual inspection or during heavy landing or ground loop inspections. The maintenance manuals can be unclear about what to look for.

A lot of Schempp-Hirth, Glasflugel and Slingsby (Kestrel) gliders share a common tailplane/elevator design. The example in the picture is a Duo Discus.

At every annual and after any sort of unusual event, you should ensure that the elevator's trailing edges line up with each other, and that the tailplane skins are still bonded to the centre hinges.

If the elevators do not line up, it is most likely the metal elevator U fitting that bolts the elevators together that is bent. It needs to be replaced (do not consider bending them straight!). It would be a good idea to teach owners to check this on every DI.
