ACCIDENT

Aircraft Type and Registration:	Silent 2 Electro, G-CIYA	
No & Type of Engines:	1 x FES-SIL-M100 22 kW brushless electric motor	
Year of Manufacture:	2015 (serial no: 2075)	
Date & Time (UTC):	19 October 2015 at 1457 hrs	
Location:	Husbands Bosworth Airfield, Leicestershire	
Type of Flight:	Private	
Persons on Board:	Crew - 1	Passengers - None
Injuries:	Crew - 1 (Serious)	Passengers - N/A
Nature of Damage:	Aircraft destroyed	
Commander's Licence:	National Private Pilot's Licence	
Commander's Age:	66 years	
Commander's Flying Experience:	154 hours (of which none were on type) Last 90 days - 11 hours Last 28 days - 1 hour	
Information Source:	AAIB Field Investigation

Synopsis

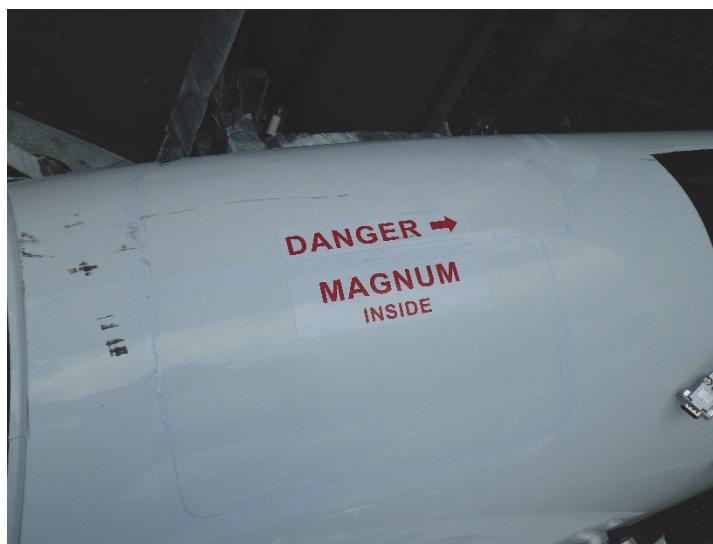
Figure 1
BPRS warning sign

G-CIYA was equipped with the Magnum 300 SSP Ballistic Parachute Recovery System (BPRS). The rocket and parachute were located in a compartment behind the pilot and above the wing spars. The operating handle was located on the right side of the cockpit and had a safety pin to prevent inadvertent operation. A warning placard stating '*Ballistic Parachute Deployment Handle Emergency Use Only*' was attached to the inside of the cockpit adjacent to the operating handle. A second red warning sign stating '*DANGER MAGNUM INSIDE*' was affixed to the BPRS compartment access panel (see Figure 1).

This airworthiness requirement is satisfied by adopting the recommended specification in ASTM F2316 -12⁴. However, along with other SSDR aircraft, G-CIYA was exempt from the requirements of BCAR and the only warning placard on the outside of the aircraft referred to 'Magnum'. It, therefore, may not have been apparent to first responders that a ballistic rocket was fitted to the aircraft. A warning placard, shown at Figure 3, was found in the pilot's documentation, which did appear to conform to the specification in ASTM F2316-12. However, the web site, which was in German, was for a pilot's equipment shop and provided no readily accessible information on how to disarm the BPRS. The telephone numbers were not always answered and the person answering the calls could not always speak English.

It is recommended that the Civil Aviation Authority require that Ballistic Parachute Recovery Systems fitted to Single Seat Deregulated Aircraft comply with Article 38 of the Air Navigation Order and that the installation and placarding meet the same requirements as for aircraft operating on a Permit to Fly.

The UK agent of the Silent 2 Electro has advised the AAIB that the aircraft manufacturer has taken action to attach the correct BPRS placards to their aircraft and trailers prior to delivery.

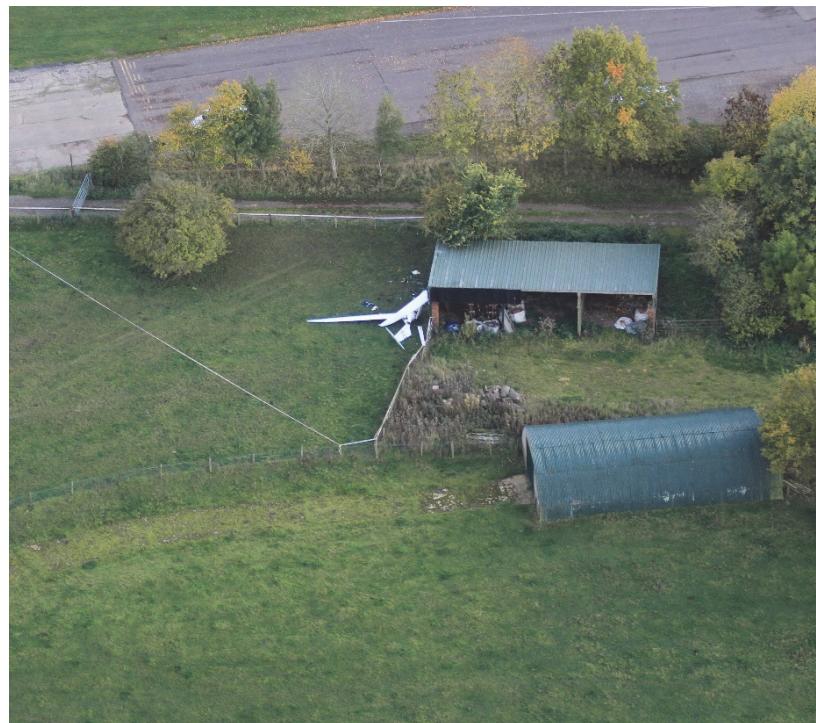
Figure 2
Accident site

The aircraft impacted the roof of a farm building located 20 m north of the northern taxiway at Husbands Bosworth Airfield, (see Figure 2). Ground marks and damage to the building indicate that the aircraft was in a steep nose-down attitude when the outer 4 m section of the right wing hit the roof of the building before the left wing and fuselage impacted the ground.

From the damage to the aircraft, and ground marks, it was established that the aircraft was in a very steep nose-down attitude when it crashed. The initial impact occurred between the outer $\frac{1}{3}$ of the right wing and the roof of the farm building. The left wing, followed by the cockpit section, then hit the ground. This sequence reduced the force on the cockpit section, increasing the chance of the pilot surviving the accident.
