Issue 1-2016

Date: 09/08/2016

Airworthiness Information.

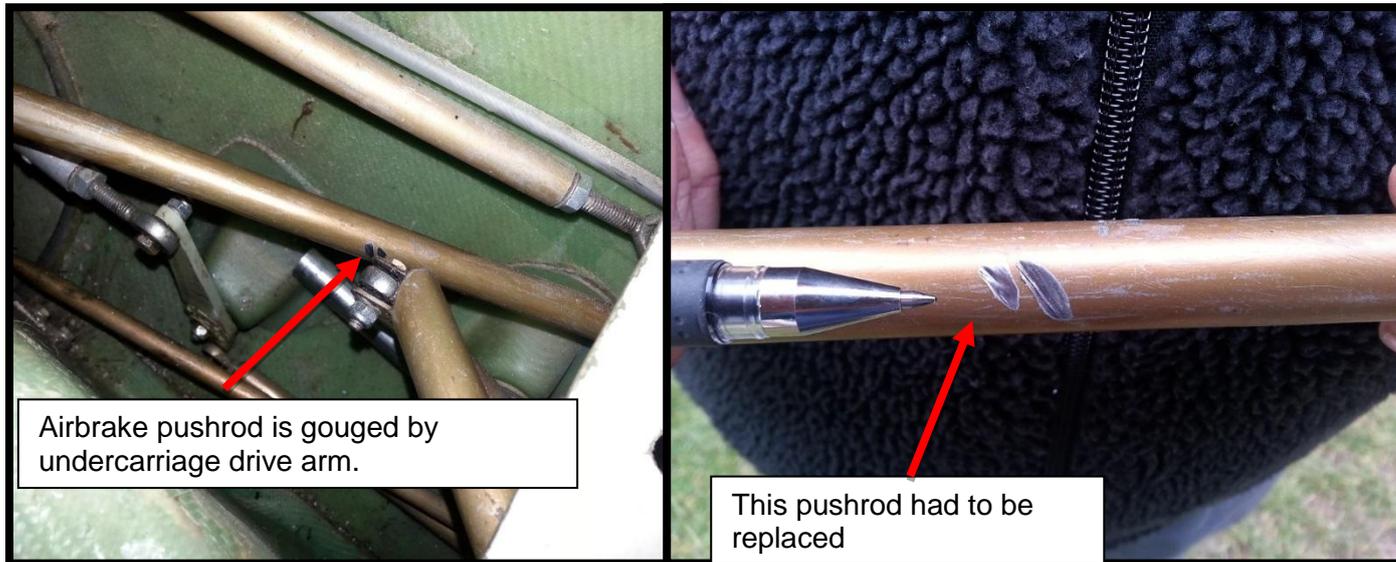
10 DG200/202 (and possibly others)

DG 200/202 Undercarriage control rod hits airbrake control rod. Located on port side of wheel box. Previously reported ref TNS 6-2011. Reported by Andrew Brind

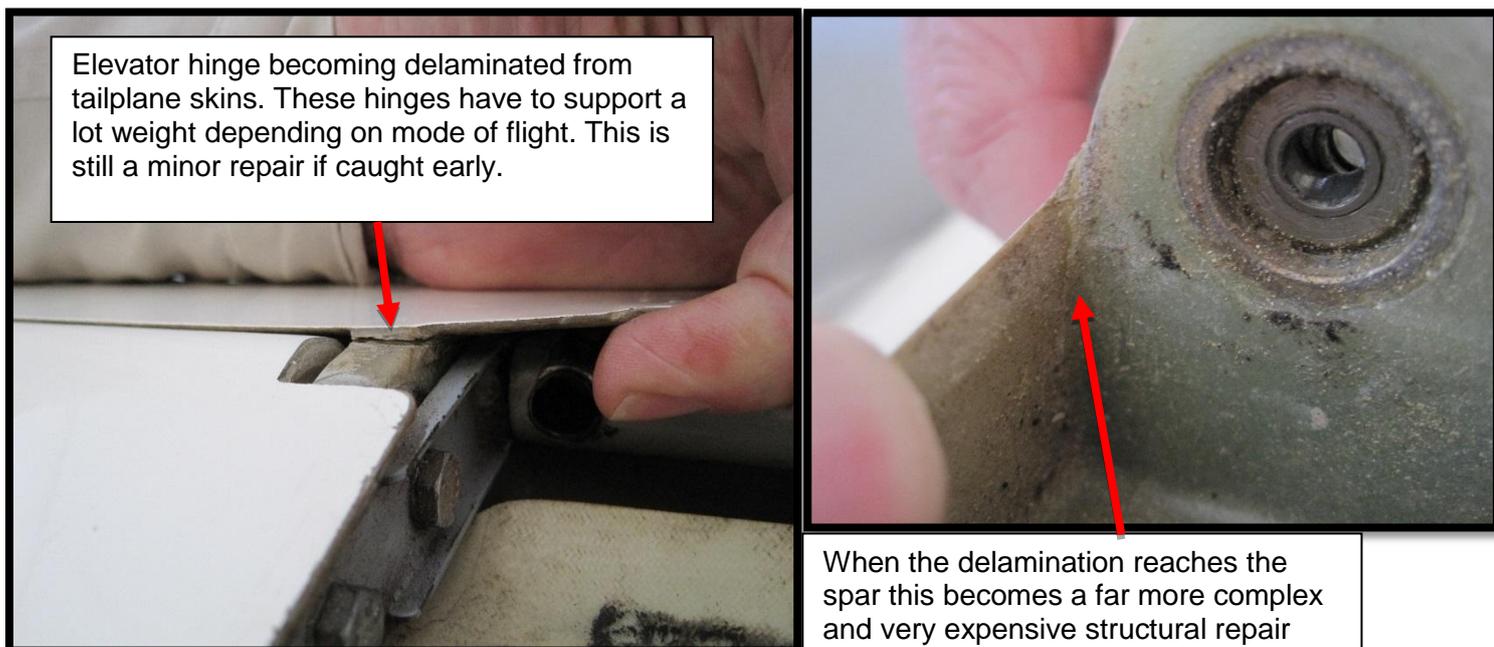
11 All Schempp-Hirth, Glasflugel and Slingsby Kestrel with Fixed Tailplanes

This damage is being consistently missed by owners and inspectors. It only shows when the tailplane skin is gently flexed away from the hinge. This can become a structural problem if not spotted and fixed early.

This sort of damage can be found during a DI rather than annual maintenance. The damage can be caused by bad ground handling (no dolly when towing out or turning); lifting the tail at the inboard end of the tailplane; heavy landings; poor trailer fittings; ground loops; and flexing the elevator against the tailplane skins when the tailplane is not attached to the glider.

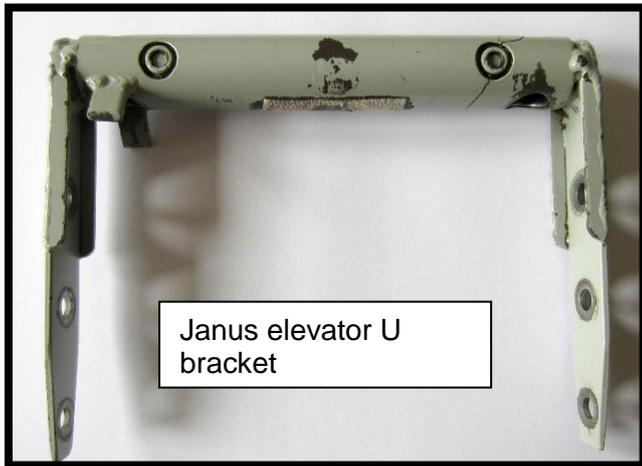
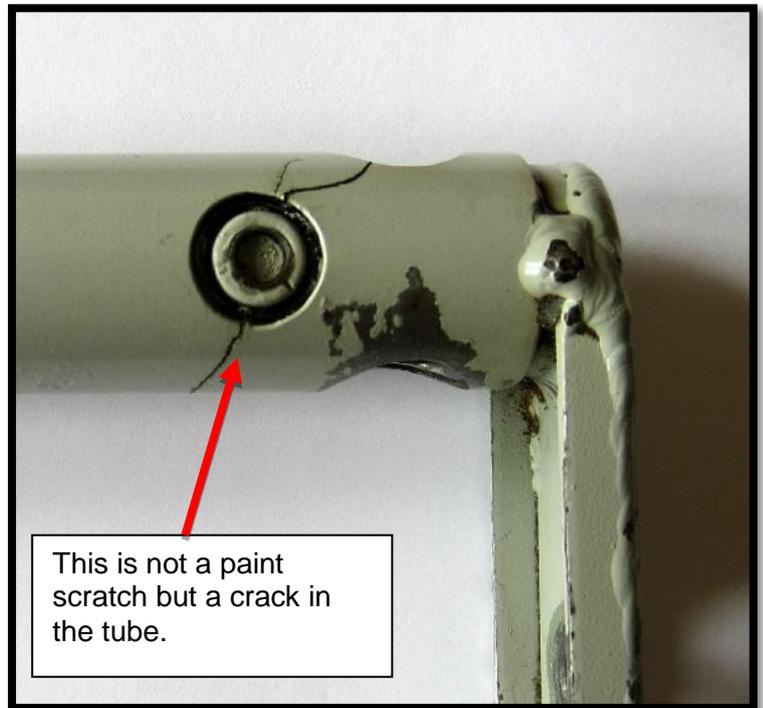
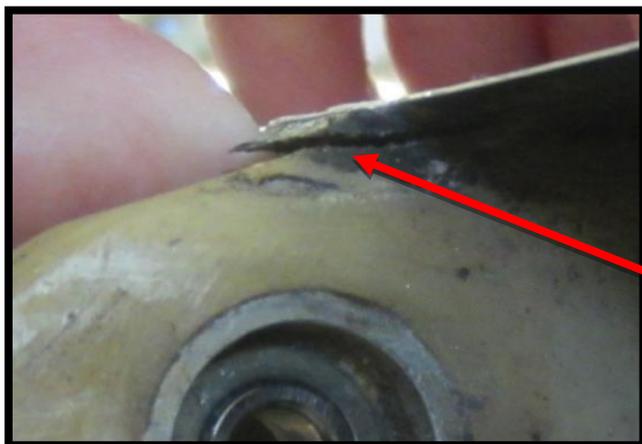
12 All Schempp-Hirth, Glasflugel and Slingsby Kestrel with Fixed Tailplanes

Cracked U bracket on Janus elevator. We have seen this damage a few times on this type of design - usually after a heavy landing or ground loop with associated damage to the hinges. In this case there was only minor hinge damage to indicate a cracked U bracket.

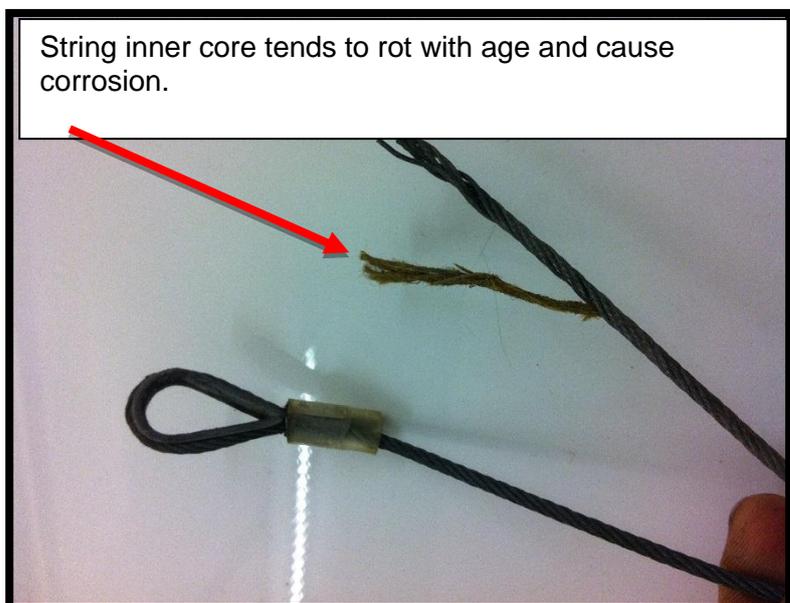
13 Glasflugel Libelle

These hemp Cables were found in a Libelle 201 - not a glider we normally associate with hemp cables.

The only fix is to replace them.

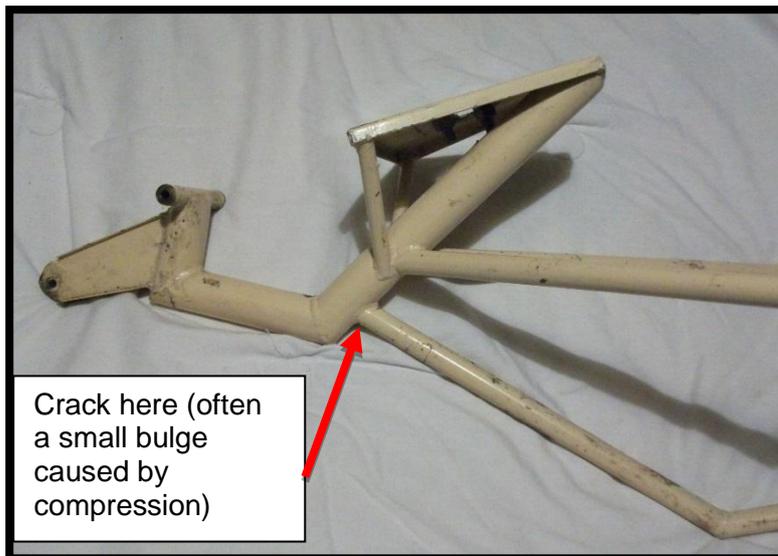
14 ASW19/20 Pegase (and possibly others with hinged instrument panels)

This is a fairly common problem with older gliders and should be checked at every annual. Fixing it in situ is virtually impossible.

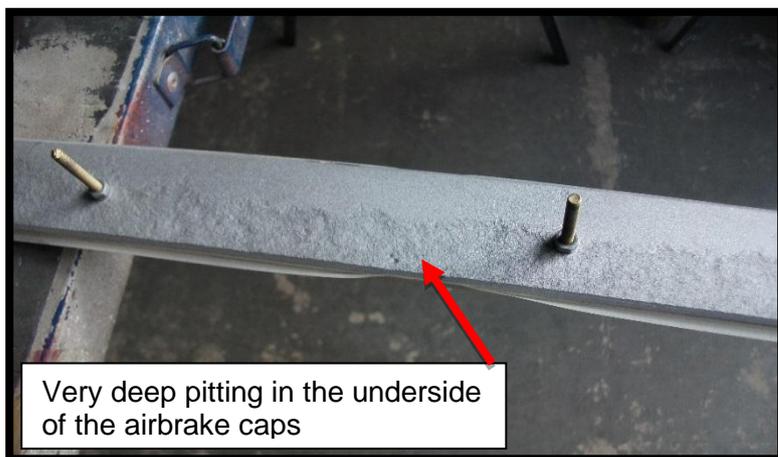
15 Astir/Twin Astir Brake Caps - Severe Corrosion

Corrosion in the top of the aluminium brake cap is easily spotted when the blisters appear and the gelcoat starts to separate from the cap.

However, it is easy to miss corrosion on the underside of the cap.

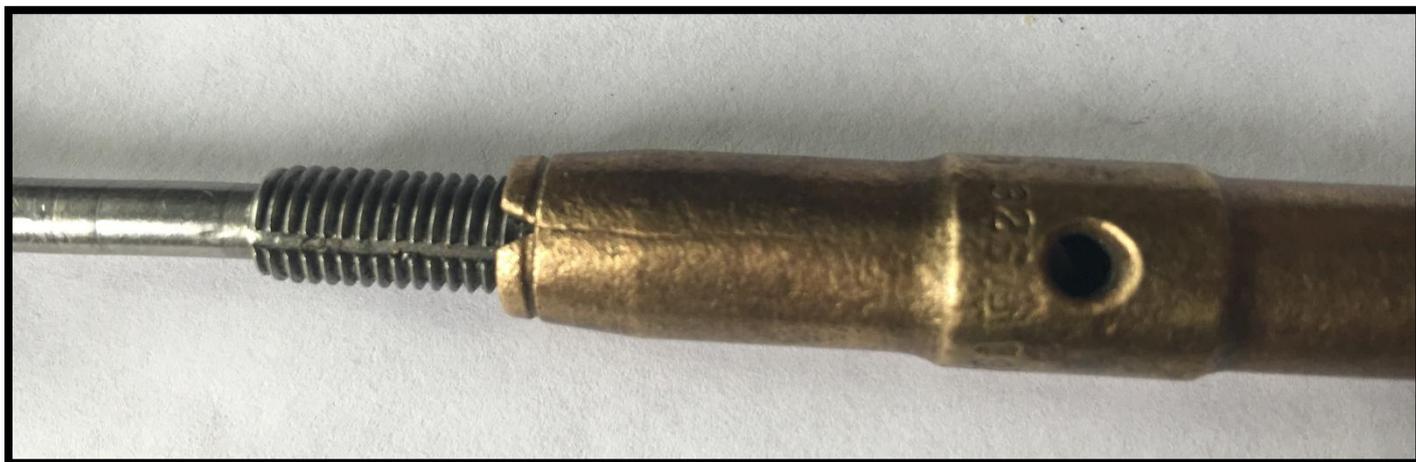
16 All Turnbuckles

Always inspect these carefully when doing annuals and routine maintenance. In this case, the turnbuckle has been stressed at some point and the barrel/fork ends have twisted and bent with thread damage to the barrel.

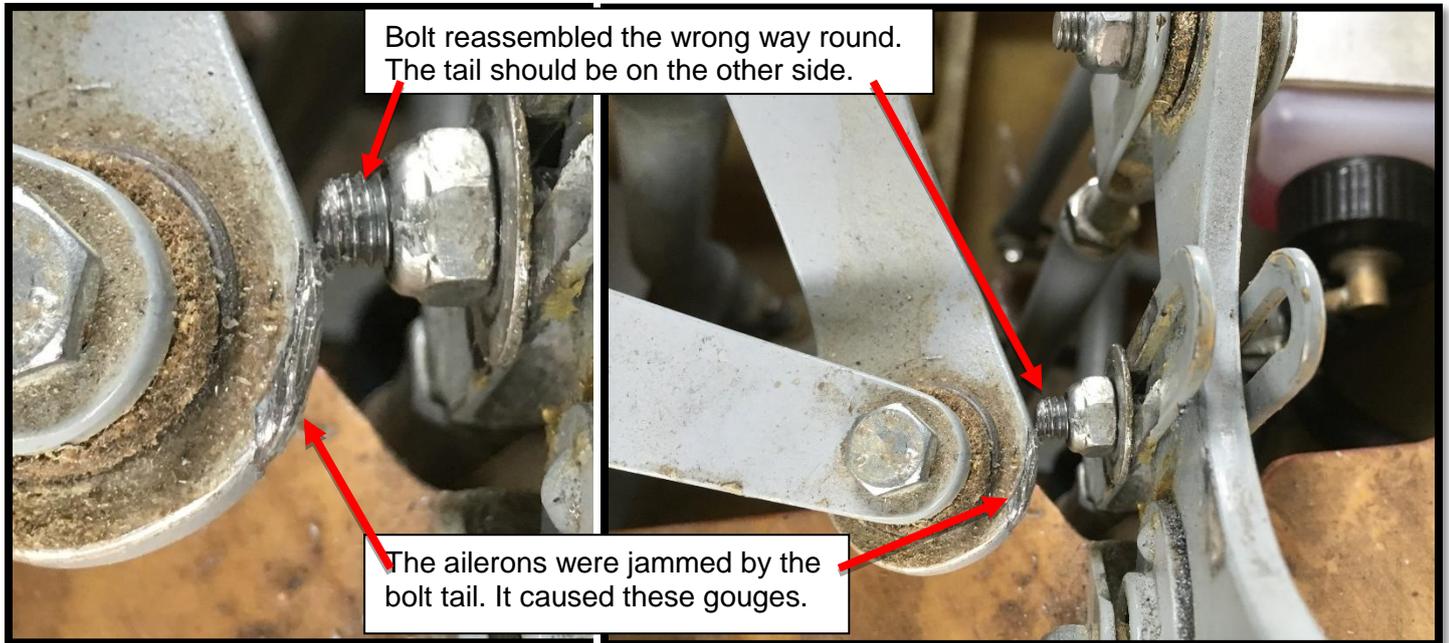
17 ASW20 Inflight Aileron Restriction.**Advisory**

This aileron restriction could only happen in positive flap with the brakes open, so was not found in pre-flight checks. The bolt was turned around while replacing the brake lines after they had been damaged with the wrong hydraulic fluid. An innocent mistake, but could have been deadly on the approach.

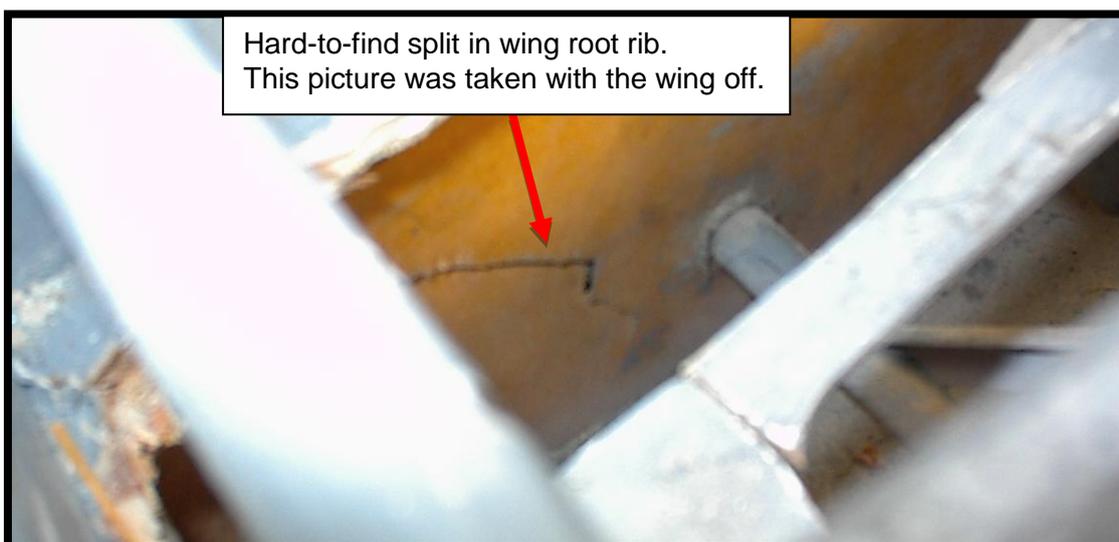
18 RF5 (and possibly RF4 and others with similar design)**Advisory**

Sometime after an undercarriage problem, this damage was found on the aircraft's wing root ribs. When an RF5 does a gear-up landing for whatever reason, there are small skids that protect the fuselage by transferring the impact loads into the wing. However even a slightly heavy load on these skids can break the wing ribs and damage the attachment bolts.

Access to inspect the ribs and bolts with the wing on is very poor, although small modern cameras do help. The best way to inspect this airframe after a gear-up landing is to remove the wing. Having spoken to a few inspectors who look after RF5 airframes, we understand that it is not normal practice to remove the wing at every annual, as this is quite an undertaking. It would be good practice to remove the wing periodically at annuals to ensure there is no damage and that the wing attachments are in good condition.

The message is clear: after any sort of gear-up issue, the only thorough way to inspect the structure and attachments thoroughly is to fully remove the wing. If doing an annual on an RF5 be sure to carefully inspect for any signs of damage.
