Issue 2-2016

Date: 7 December 2016

Airworthiness Information

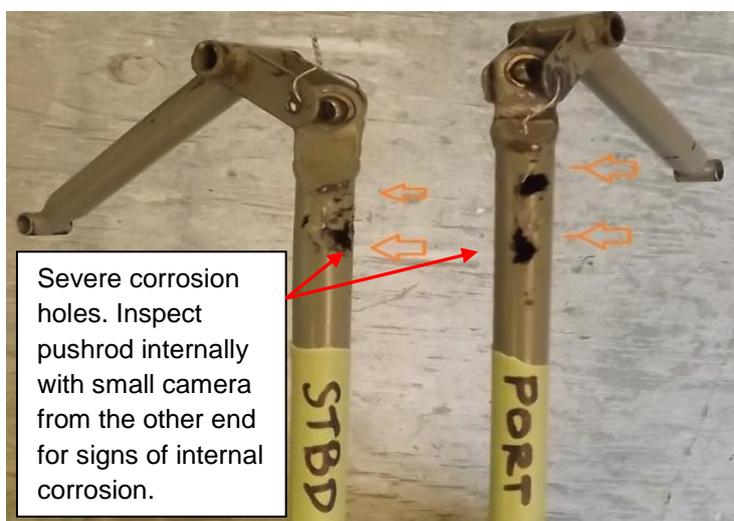
6. Libelle (and possibly other types)

The picture shows holes in the pushrods caused by severe internal corrosion in the airbrake paddle pushrods in the airbrake box. The corrosion holes are on the lower surface of the pushrod against the lower surface of the brake box, so are very hard to spot. The other end of the pushrod has an 8mm threaded rod that can be removed to allow internal inspection of the pushrod with a 7mm camera. The water could have got into the check hole of the 8mm rod end, when the brake box was filled with water (left out in the rain?). Report any findings to the CTO.

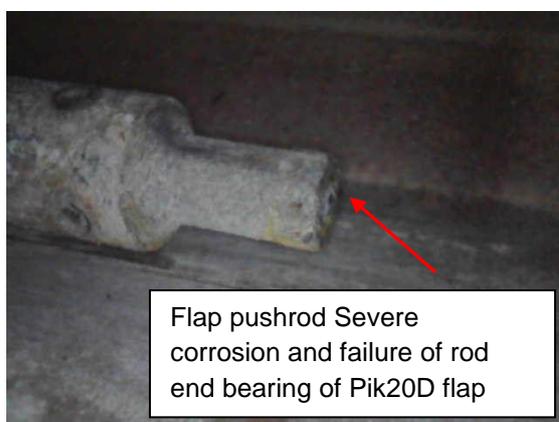
7. Pik20 Wing Pushrods and Bearings (all variants)

This was found when the flaps were reported as being a bit stiff.

At the next annual, we advise you to look inside the wing and fuselage with a camera. Report any problems to the CTO. The trailer was fairly damp and unventilated. When we checked a Pik 20E from a ventilated trailer at the same site it did not have this problem.

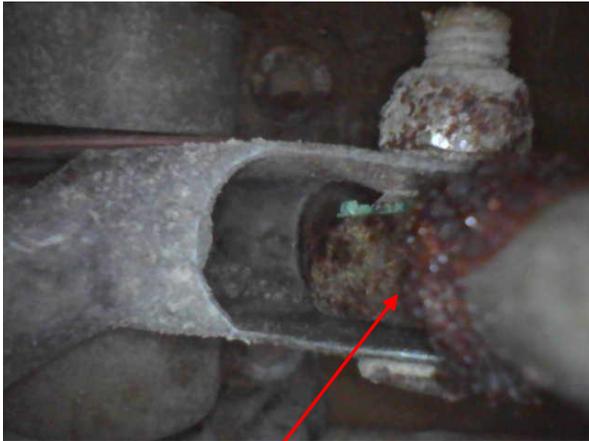
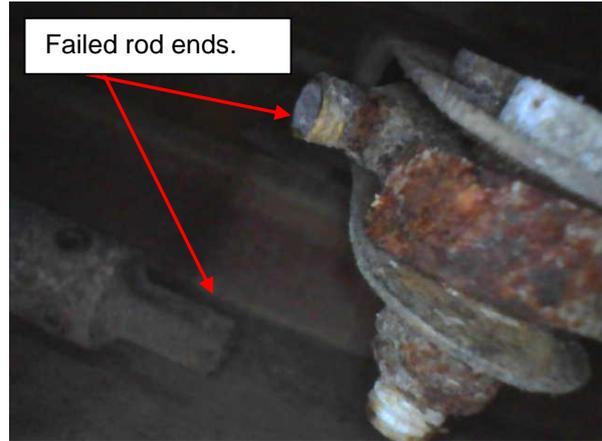
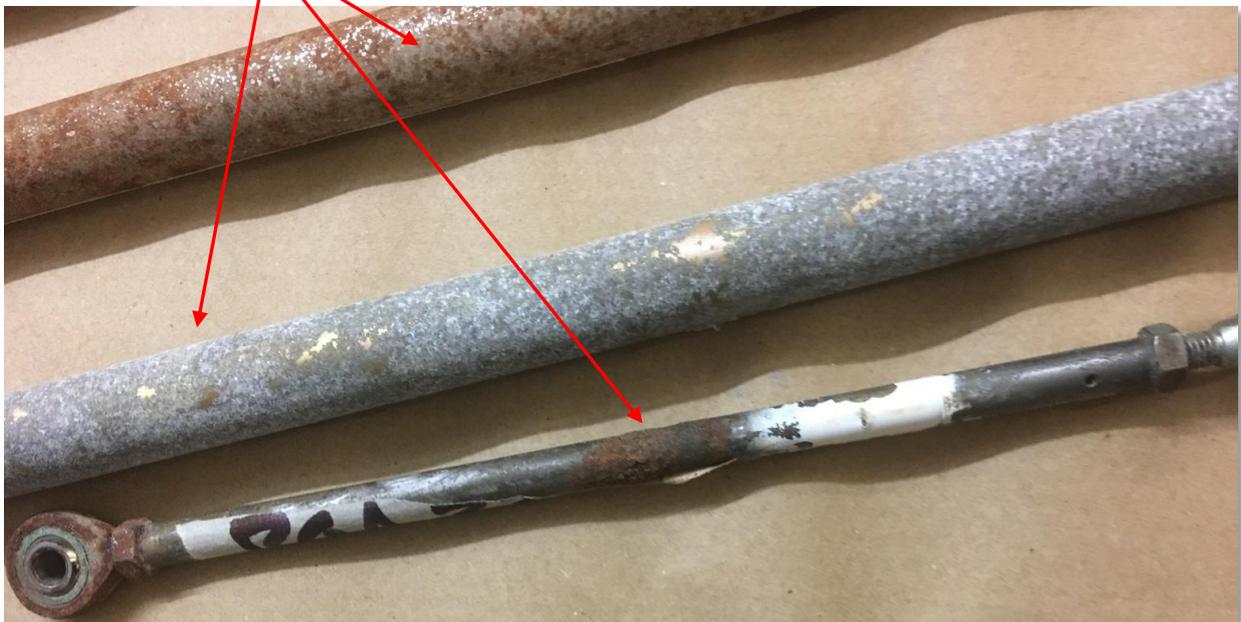
These levels of corrosion are totally unacceptable. Note that it requires up to 8 holes per wing to remove all pushrods

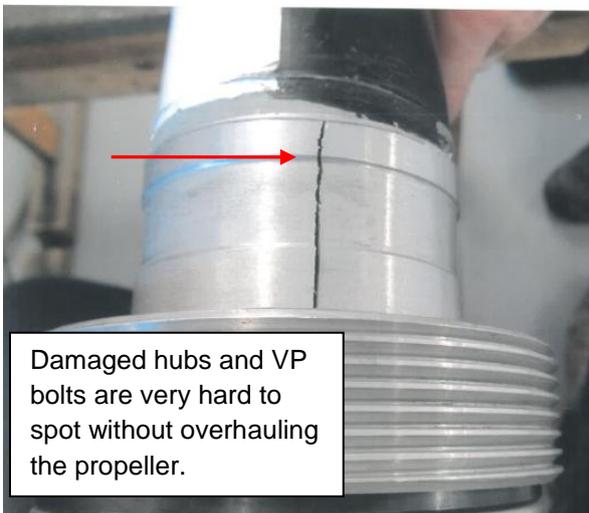
8. Grob 109 (and other types with wooden propellers in metal hubs) Advisory

Cracked prop hub, caused by expanding wooden/composite blade. This prop was less than 5 years old when damage found due to small expansion cracks in prop blade.

If you ever consider extending the 6 year prop life by declaring a deviation (EASA terminology for "on condition" when using a SDMP, see item 14) be aware that, if the aircraft is stored outside under covers or in humid environments, this hidden damage is far more likely.

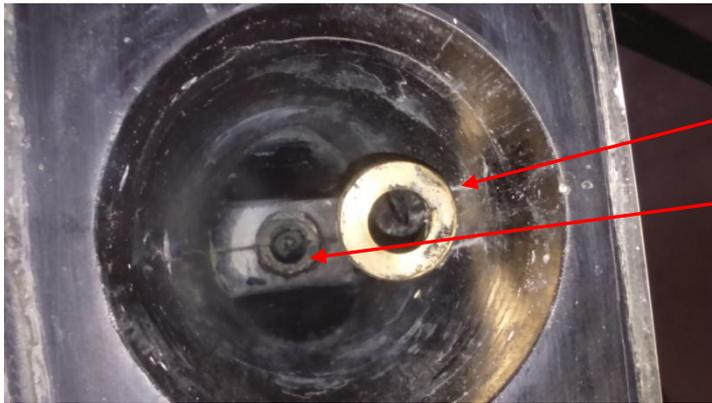
Loose wing tip spigot bush in wing (in this picture it is totally detached) This results in the tip being a very loose fit. (check play every rig?)

The bush should be a tight fit in here.

Note that excessive play can be caused by a worn bush rather than a detached bush. In all instances contact the agent for a repair scheme.

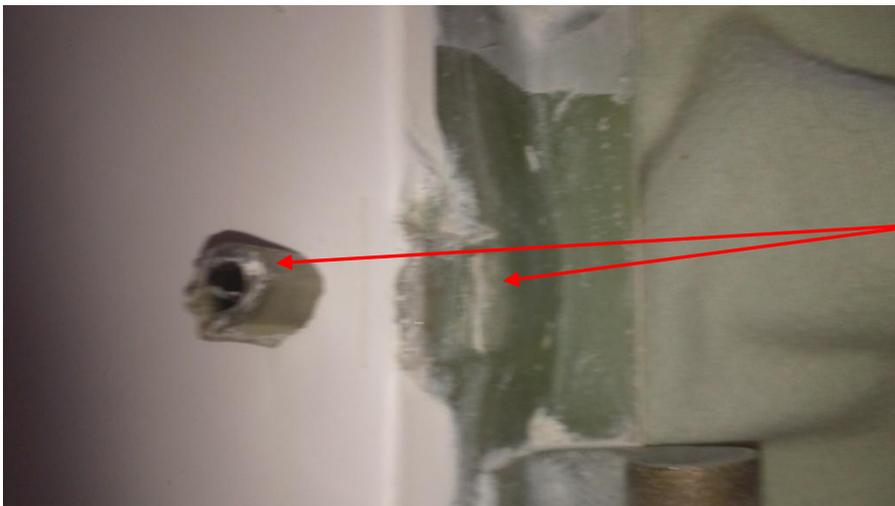
Broken aileron hinge - only found when Mylar removed.

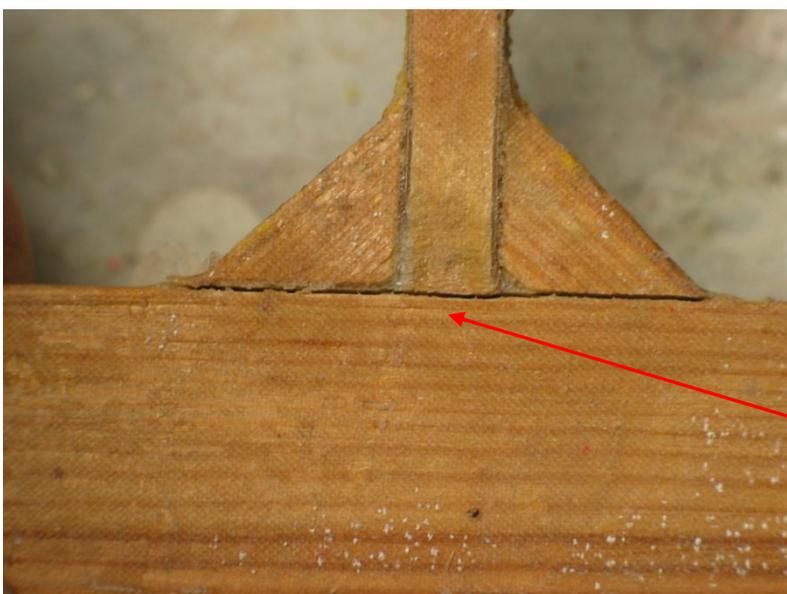
10. SZD30 Pirat Elevator Trailing Edge Glue Joint Broken/Failed

This is not a type renowned for glue joint issues.

End grain gluing of wood does not give great adhesion qualities, making end grain joints more susceptible to flexing damage.

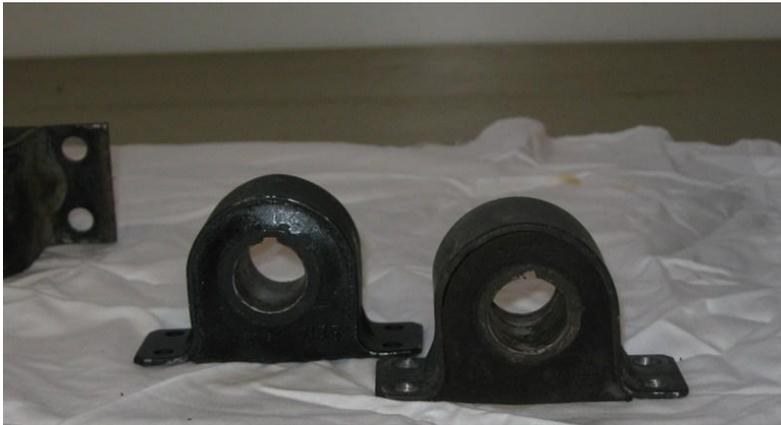
11. LS/DG and Nimbus Undercarriage Collapses (and possibly others) **Advisory**

These are rubber LS4 undercarriage mounts. They have a limited life. No perishing or bulging allowed. When buying new mounts, inspect carefully before fitting them, as they have often sat on a shelf for many years and are unacceptably perished.

The cause is often lack of maintenance. Legacy (and some new) LS and DG gliders have undercarriage mounting rubbers, rubber suspension discs (in the metal legs), and gas struts fitted. All these items perish and have a finite life. In the late 1980s, when I worked at the LS factory, when we did an annual on an LS1, 3 or 4, all the undercarriage mounting rubbers and gas struts would be changed every 6 years. The maintenance manual did not call for this, but it was factory policy to avoid unnecessary problems.

The maintenance manual often states to check these things but does not actually tell you how check the condition. Trying to put the wheel down when there is insufficient clearance to the ground can do a lot of damage to perished mounting rubbers, often leading to a collapse.

At every annual, check the rubber for any signs of bulging or perishing (always change the lot if any are perished), check that the gas strut still has the correct force, and that the suspension forks are not seized solid. Also check that the undercarriage over-centre locks are all correctly adjusted.

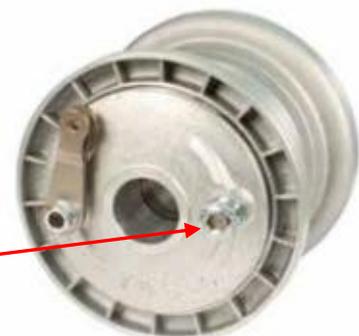
13. Wheel Brake Torque Links (Hydraulic or Drum Brakes) **Advisory**

Any play at all in the torque link (which transfers all the wheel brake loads from the wheel hub to the undercarriage) leads to rapid failure of the stud. This subsequent failure allows the entire hub to rotate; this collapses the undercarriage and pulls the wheel brake cable out of the stick which, in turn, pulls the stick fully forward!

Should be no play here

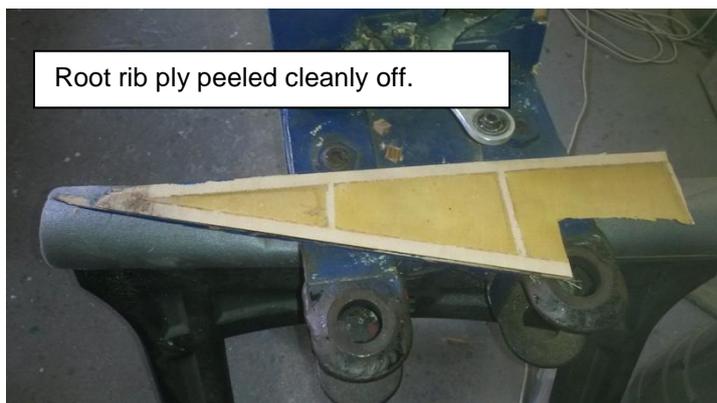
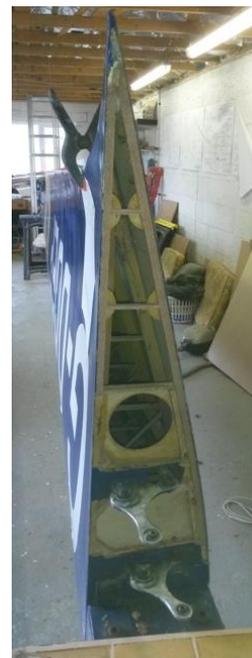
15. K6 Wing Root Glue Failure

This root rib plywood unpeeled easily once an unbonded edge was found. However, prior to this, the wing was passing its glue inspection. This emphasised the need to put some stress on glue joints and not rely totally on visual inspections. There will be a separate update about glue failure in the coming weeks. Terry Mitchell has made a YouTube video of him discovering glue failure in a K8 which can be found at https://youtu.be/JPCj_yY58WU.
