Accident 2015162

Skylark 3b accident at long Mynd

12 Slingsby Skylark 2 and 3 series Advisory

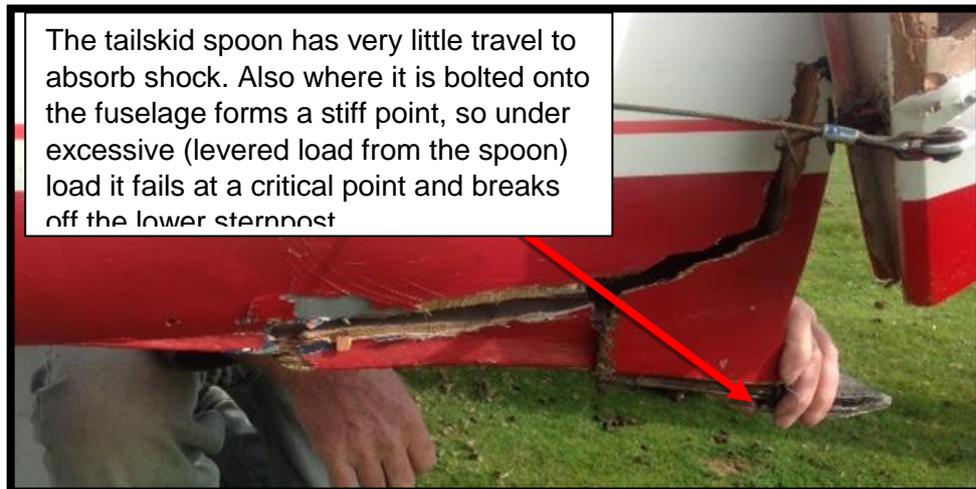
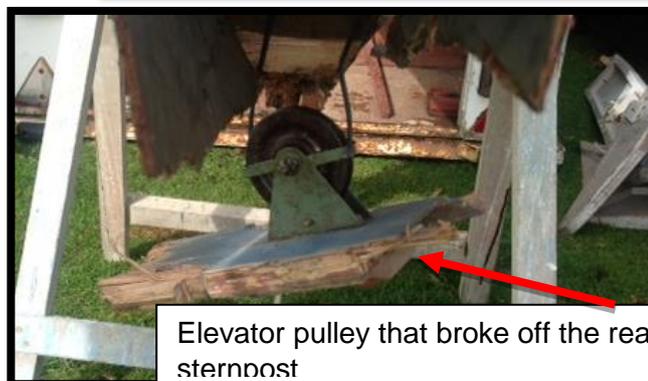
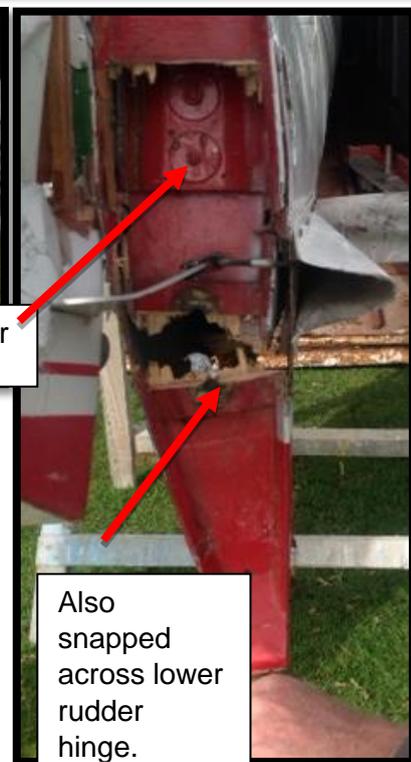
This glider suffered a tail strike on a slightly snatched winch launch, the tailskid and lower sternpost on this Skylark 3 failed.

This resulted in the pilot losing all elevator and rudder control during the rest of the launch and subsequent crash.

There is no indication of any pre accident damage or glue failure on this glider when inspected after the accident. It is fair to say the original design of tailskid and short leaf spring provide almost no cushioning at all, if the tail strikes the ground.

If you have the old design, then you can modify it to the newer design.

Operationally, the Vintage gliding people at Lasham always have somebody hold the tail on the ground prior to all out to prevent a tail strike.

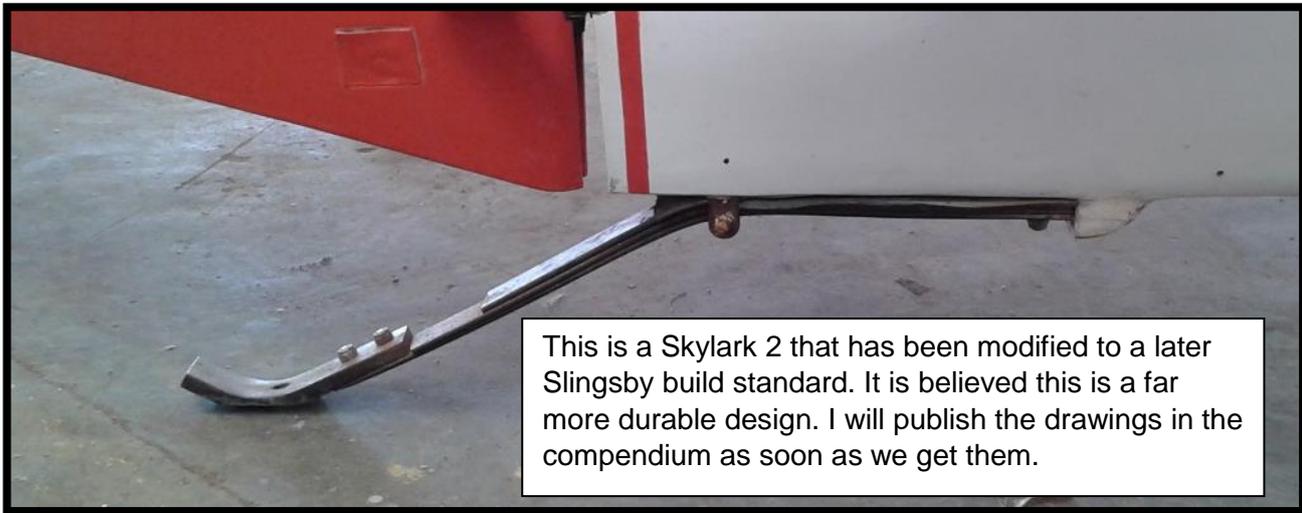
The newer design has a much longer leaf spring and a fairing in front of the tailskid retention bolts to stop the bolts catching on rocks etc.

This is a Skylark 2 that has been modified to a later Slingsby build standard. It is believed this is a far more durable design. I will publish the drawings in the compendium as soon as we get them.
