Glider Type and Registration (Tail No):	Hoffman H36 Dimona G-BLCV
Engine:	1 x Limbach L2000 – EBIC piston engine
Year of Manufacture:	1984
Time (local) and Date:	15:00 hrs 5 April 2016
Location:	2NM North of Raglan, Monmouthshire
Type of flight (actual/intended):	Training (field selection exercise for Bronze Cross-Country endorsement)
Persons on Board:	2
Injuries:	Instructor: Broken collar bone Student: Hairline fracture in one vertebrae
Nature of Damage:	Severe damage, beyond economic repair
Commander's Qualifications:	Full Cat and MGIR
Commander's Age:	64 years
Commander's Flying Experience:	Total all types: Gliders – 1,793 hours Power - 503 hours Total on Type: 265 hours Last 6 months: Gliders – 6 hours Power - 10 hours
Information Source(s):	Information supplied by the pilot/student, examination of the wreckage and follow-up enquires

Synopsis

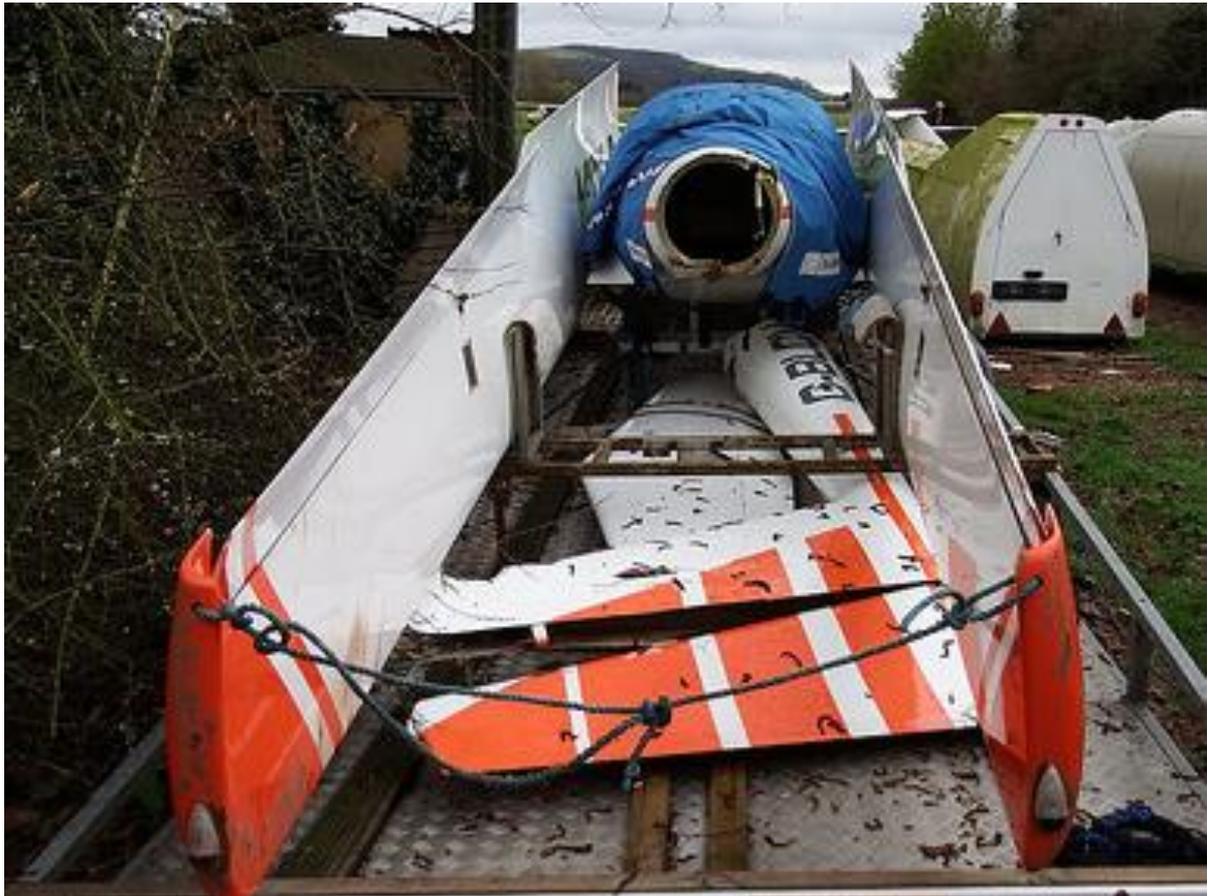
The aircraft was substantially damaged in the accident and is beyond economic repair. One propeller blade had broken off and was in three sections, the right wing was damaged, the fuselage was severed behind the cockpit and both landing gear legs had broken off, Photo 1. It was recovered by a maintenance/repair organisation who reported that, as the fuel drain valve had been wiped off in the accident, there was no fuel in the tank but that there was good evidence that a reasonable quantity of fuel had drained out onto the ground. The pilot reported that the fuel gauge was indicating approximately $\frac{1}{4}$ full prior to commencing the approach. There had been no fire. Also, when recovered, it was reported that the master switch and the magneto switch were both found in the OFF position.

Photo 1. Overview of the damage to G-BLCV after recovery

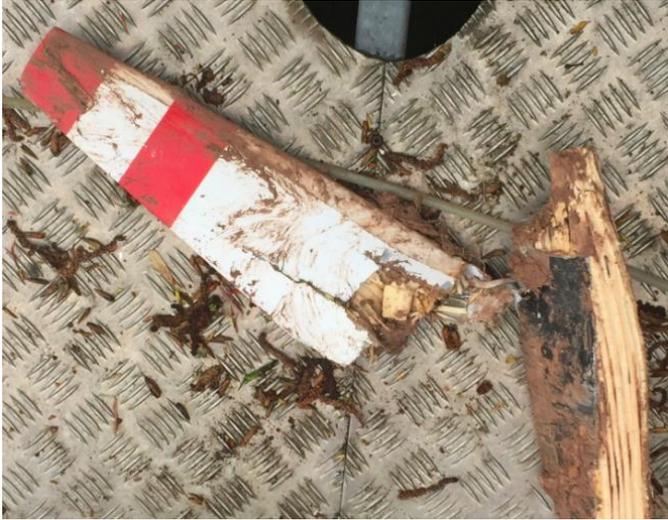
Examination of the two bladed in-flight adjustable (fine, coarse and feather positions) Hoffman propeller indicated that one blade had not contacted the ground, and was completely undamaged. The other blade had broken off, was covered in dried mud and was in three sections, Photo 2. There was no evidence of any circumferential scoring or leading edge damage on this blade tip, all of which indicated a lack of any significant propeller/engine rotation at the time of ground contact, see Photo 3.

Photo 2. Broken, not shattered, propeller blade

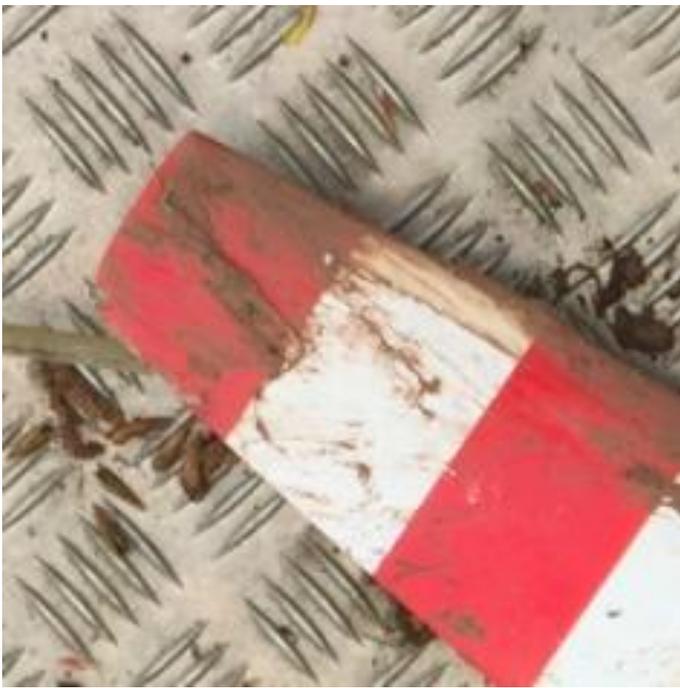
Photo 3. Propeller tip area. Note the absence circumferential scoring/LE damage.

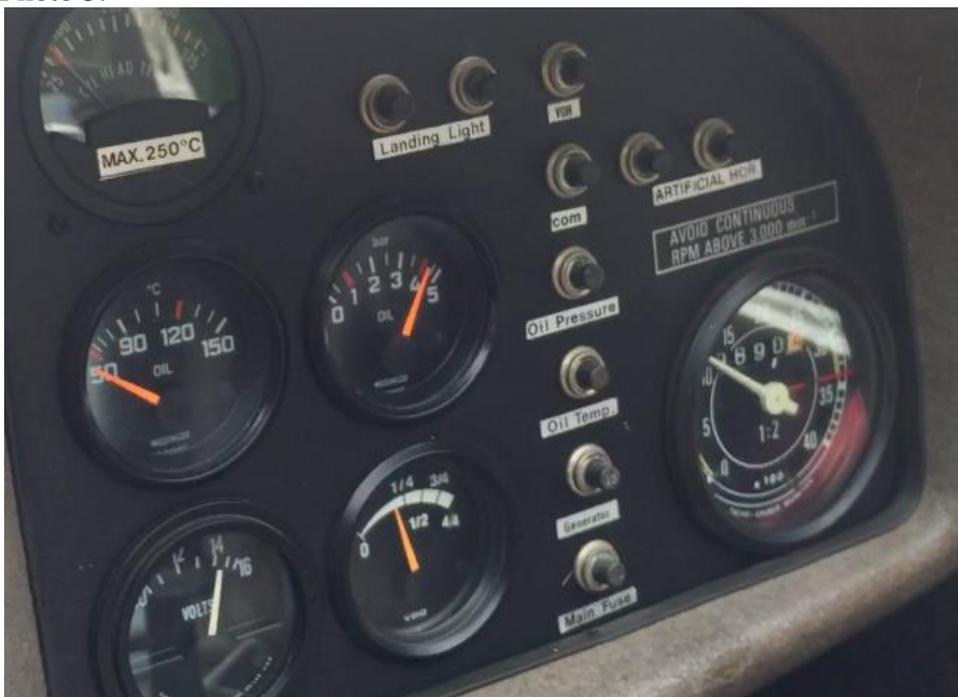
With the ignition toggle switch set to ON, the engine started without delay and settled at 1100 rpm with the throttle closed, following which it responded normally the throttle movement, see Photo 5.

Photo 5. Engine idling at 1100 rpm with the throttle closed.

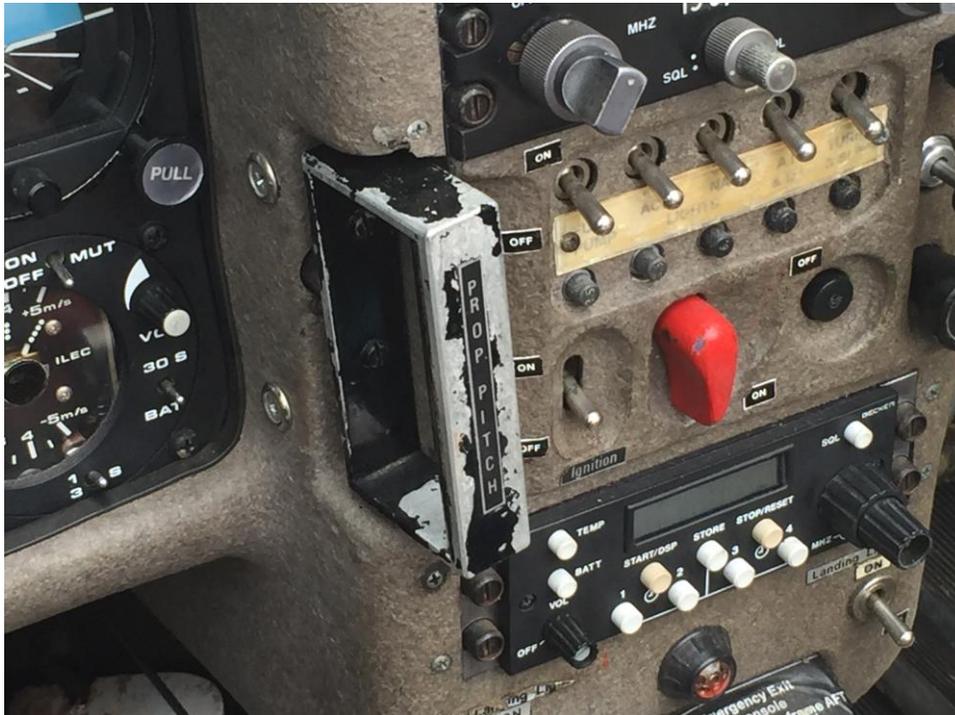
All instrument indications appeared normal. Several starts were made and, throughout, no defects could be identified with the engine operation. It was noted that although the ignition toggle switch was recessed slightly into the panel, it was devoid of any guard to minimise inadvertent operation, see Fig 6.

Fig 6. Propeller pitch change handle and adjacent ignition switch

At a height of 1800 ft, the pilot reported that the propeller was set to fine pitch prior to the descent. With reference to Fig 6, this is accomplished by reducing the engine speed to below 1500 rpm and pulling then releasing the Prop Pitch handle. This handle is immediately adjacent to the single toggle magneto switch. Although slightly recessed into the panel, it is noted that the switch is 'unguarded' and, potentially, could be vulnerable to inadvertent operation. However, the pilot states that she clearly remembers moving the ignition and master switches switch to OFF immediately after vacating the aircraft, indicating that the magneto switch had been set to ON at the time of the accident. The OFF position is down.

Consideration should be given by the BGA technical committee, on a case by case basis, whether motor gliders fitted with toggle type magneto switch(es) should be modified with an appropriate switch guard to minimise the possibility of inadvertent operation.
