Airworthiness Information

Gordon MacDonald
Chief Technical Officer

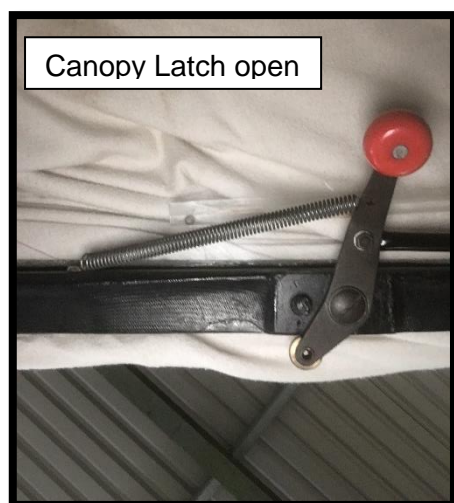
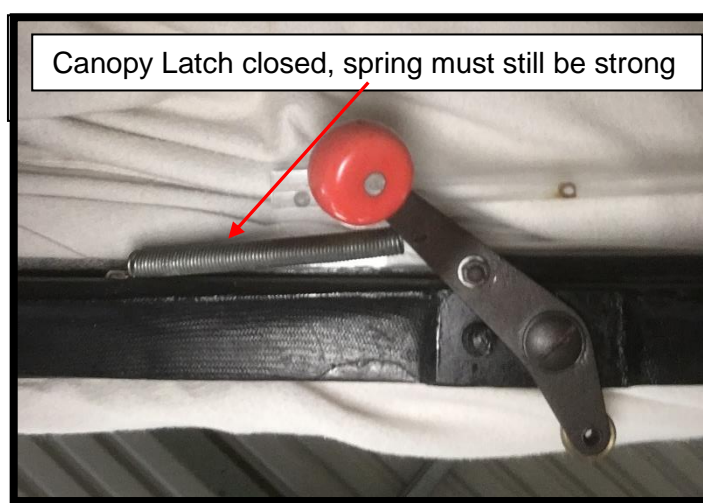
13. SZD 50-3 canopy latch (might be useful for Perkoz as well) Advisory

Many Puchacz have been fitted with a BGA Mod BGA 2003/11 found in TNS 06/03 (link below). This helps keep the canopy locked in flight. However, we have found the spring has been stretched and no longer doing its job of keeping the bias on lever in the closed position.

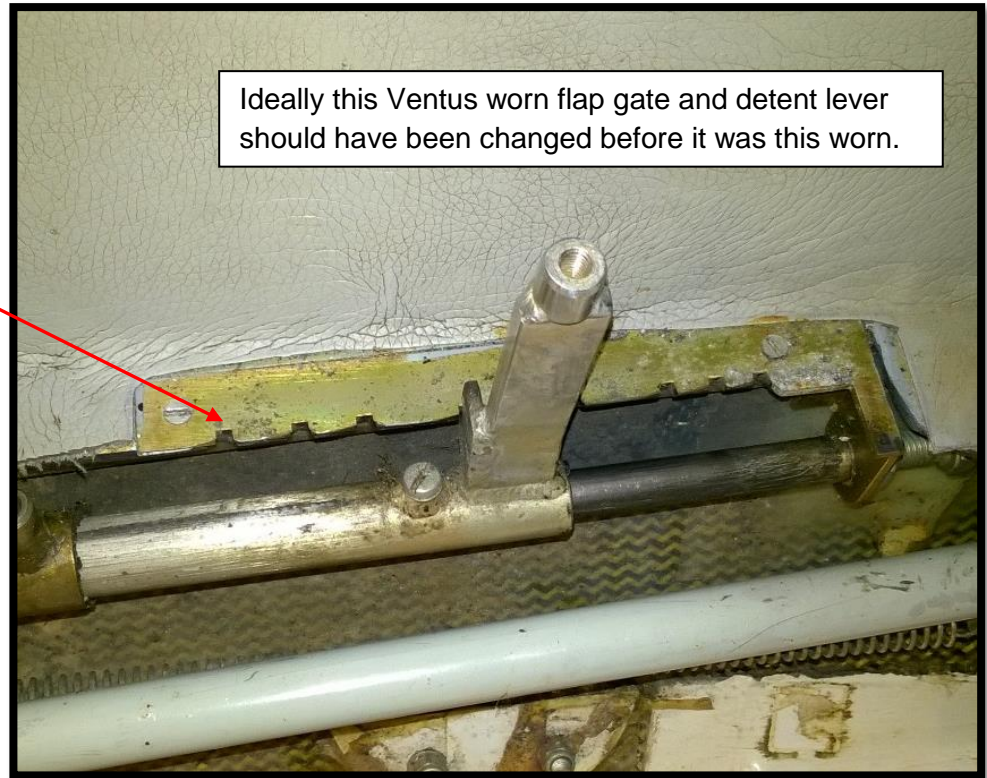
15 All flapped gliders

We have found a trend of very worn flap gates, detent pins and bias springs being too worn or broken. In landing flap, the loads on the detents and pins is very high. If the corners are rounded or bias spring weak, in heavy turbulence the flaps can jump to full negative flap, which below 100 ft is not recoverable. Come annual/ARC time ensure it is not too worn or weak.

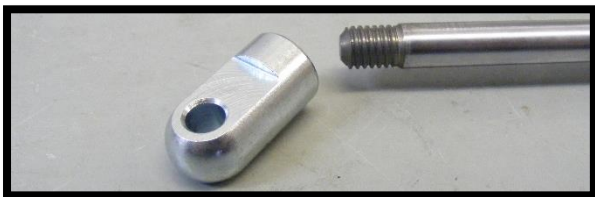
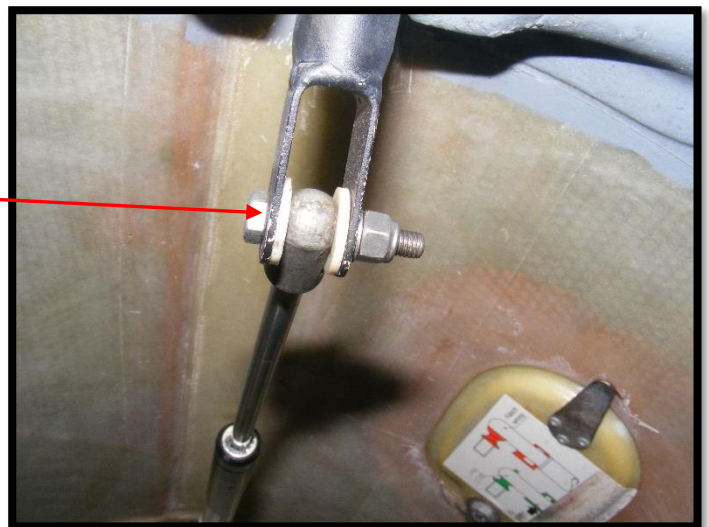
16. Canopy Gas struts problems

We had a report of the end of the gas strut unscrewing from the piston. It appears the piston could rotate, so over a period of years it unscrewed from the end fitting. If found to be rotating, consider using Loctite to lock it.

We have found the fork end fittings with elongated bolt holes. If not fixed it will eventually lead to the canopy collapsing.

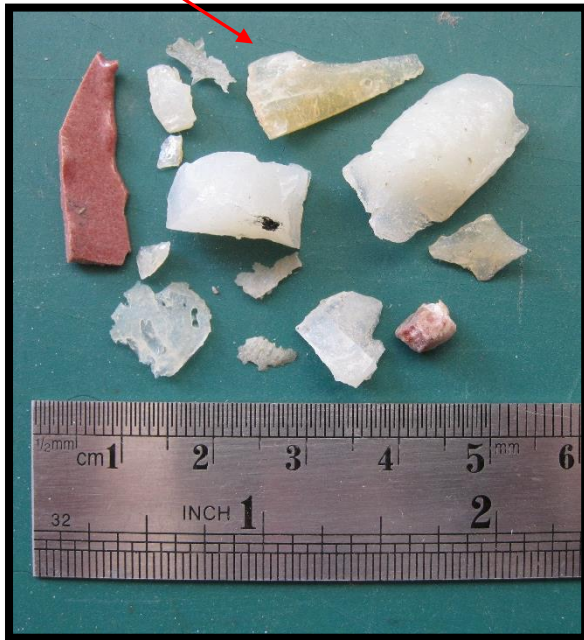
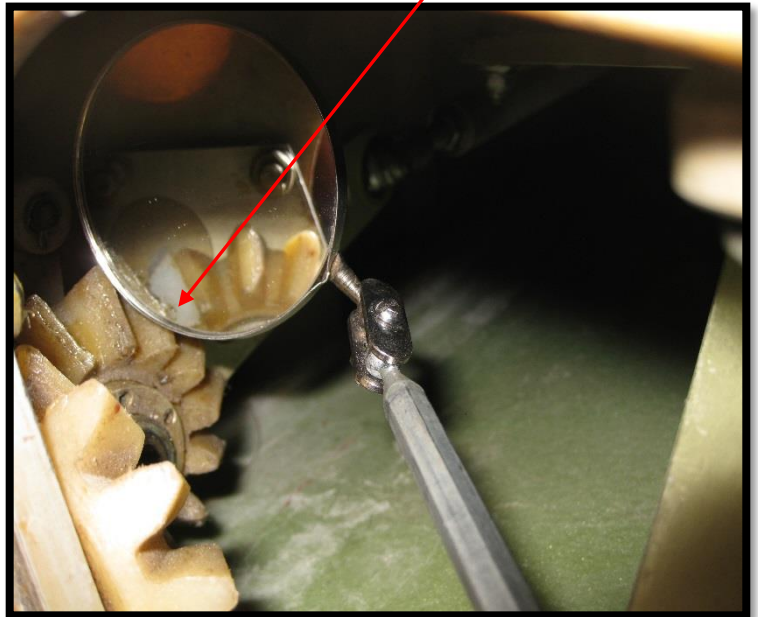
17. SZD 51 Junior (but could apply to any GRP aircraft)

A piece of resin from an old repair has jammed the airbrake cog (as shown in the inspection mirror). If you ever hear an unexplained rattle in a wing. Find out what is causing it. A lot of excess resin was subsequently removed.

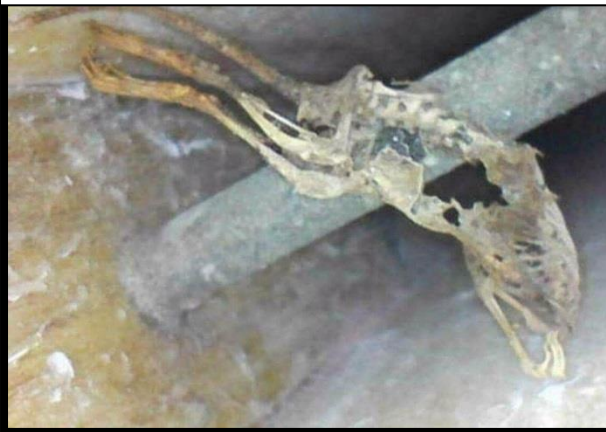
Dead mouse in top of Std cirrus Fin. Could be seen through the slot in the top of fin. Missed on many previous annuals but spotted by Lucy Wootton

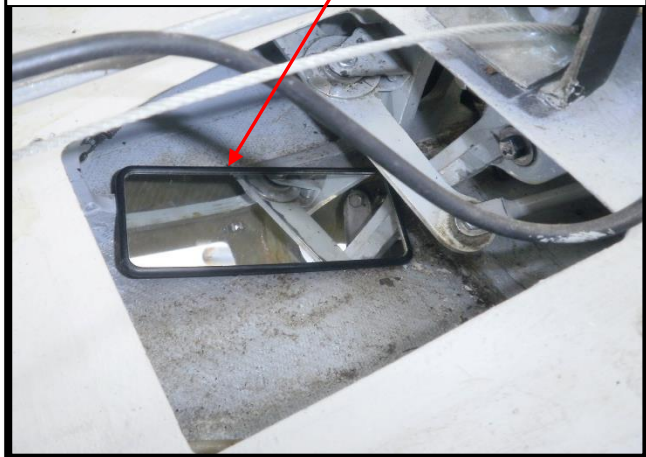
ASW15 found by owner. Mirror in amongst controls. Suspicion was it had been there for a year or 2.

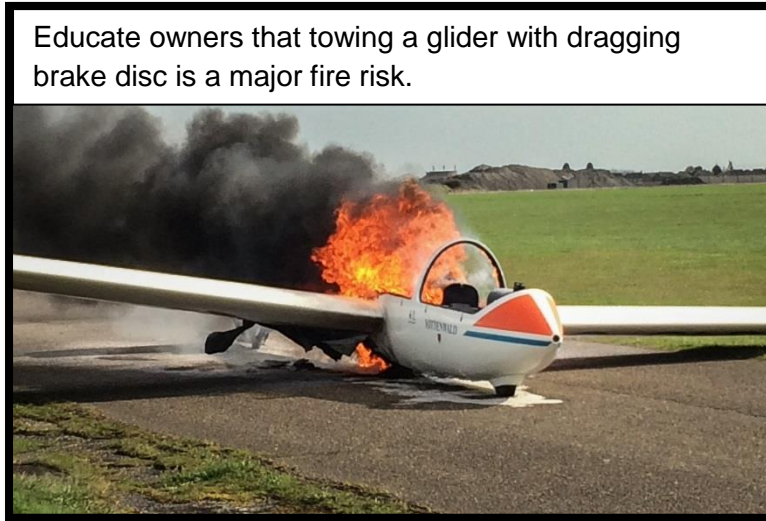
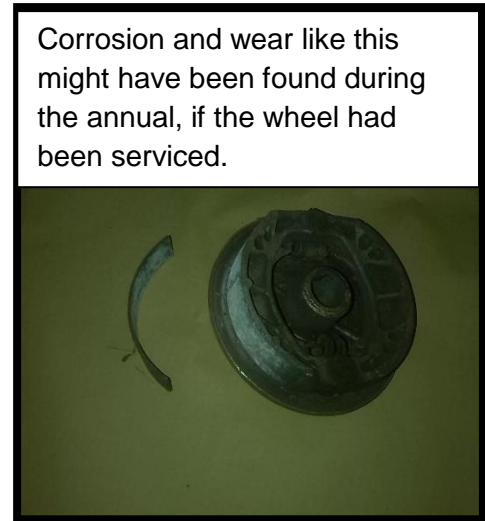
19. Wheel brake maintenance and educating owners about defects

Drum brakes. You can only check for wear, corrosion and lubrication by removing the wheel.

Disc brakes. Educate owners that even a slight dragging disc brake is a major fire risk and not just a deferred defect. Unfortunately we have seen a few of these fires in the UK on BGA gliders including another one this year.

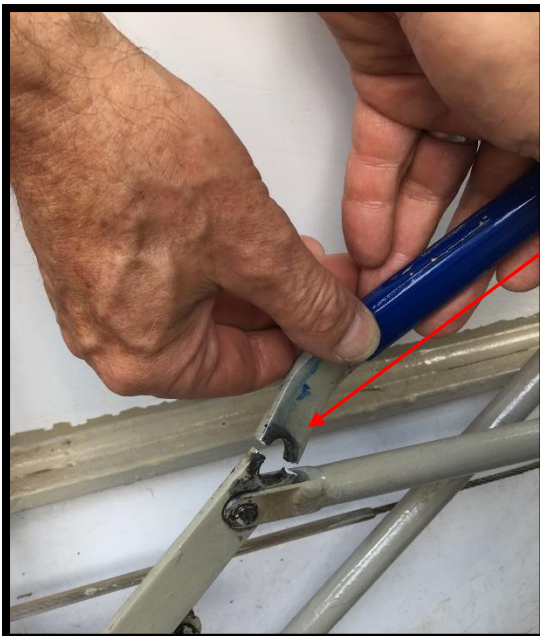
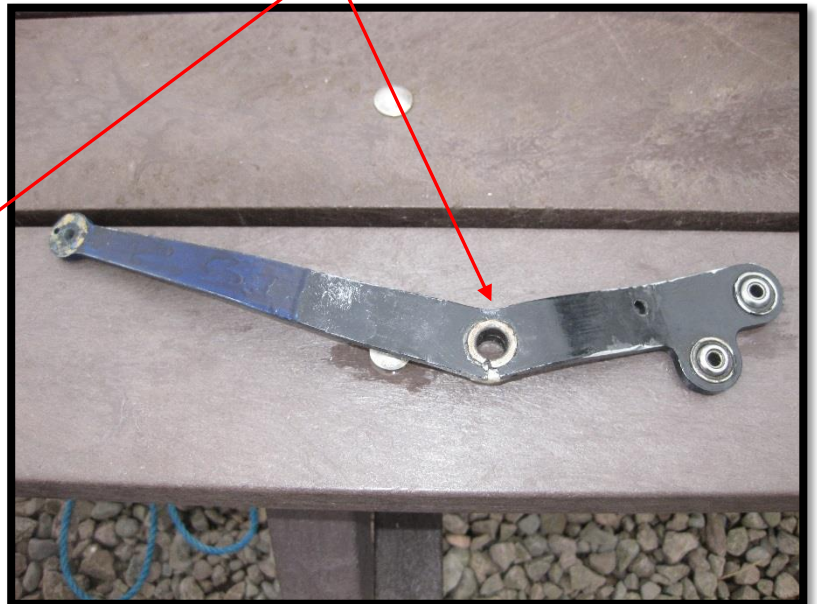
20. Airbrake levers, most gliders and motorgliders

Most airbrake levers do not tolerate side loads, corrosion and repeated heavy hydraulic wheel brake use. After tens of thousands of flights, we have seen very occasional failures. On high cycle brake levers, every annual, very close inspection is required at the obvious points of highest stress. The smallest of cracks, bearing or bush problems require replacement or repair.

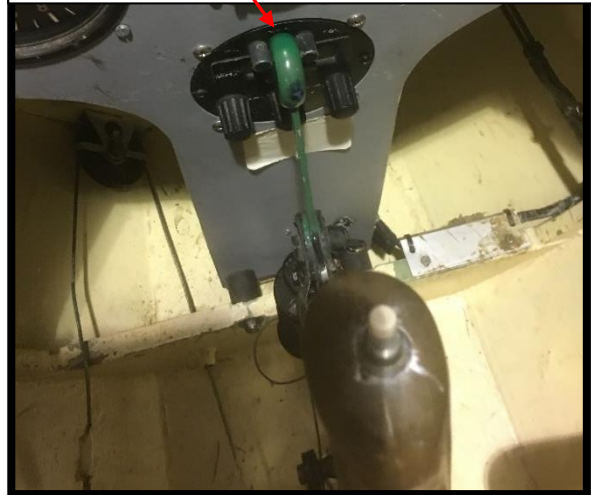
Trim lever can hit radio causing restrictions.

When fitting new radios be sure to exercise Trimmers in extreme positions to ensure adequate clearance. At ARC/Annual time be especially careful to check pilot owner fitted radios (allowed if they use converter plugs) for this.

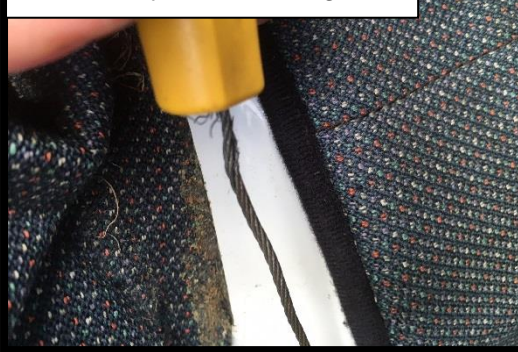
We have found too many frayed cables, broken or weak return springs and broken outer cables still in service. Some of these perhaps should have been fitted at annual. These cables and springs can be the fiddliest to replace on the entire glider, and can take many hours as well as requiring none generic parts (especially Grob rudder cable adjuster cables with too much internal friction etc).

These frays can cut fingers.

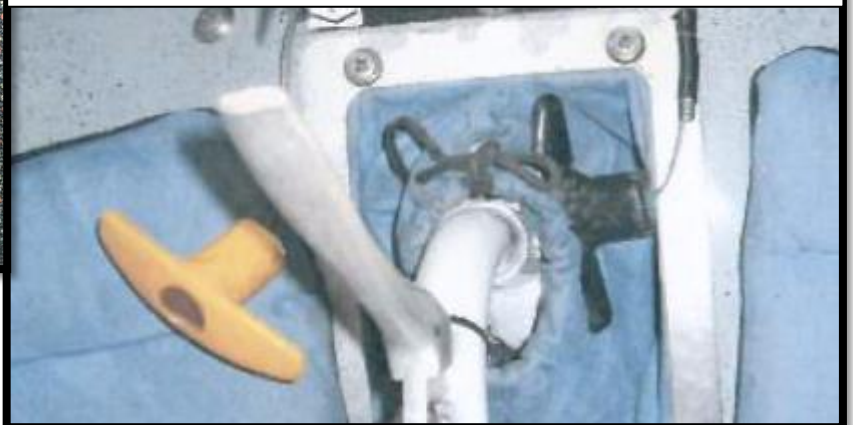
T handles or knobs that can fall in the stick recess are unacceptable. Train pilots to put the glider U/S if this happens.
