ACCIDENT

Aircraft Type and Registration:	Schleicher ASW 24, G-CFNG	
No & Type of Engines:	None	
Year of Manufacture:	1988 (Serial no: 24015)	
Date & Time (UTC):	4 December 2016 at 1235 hrs	
Location:	Brentor Airfield, Devon	
Type of Flight:	Private	
Persons on Board:	Crew - 1	Passengers - None
Injuries:	Crew - 1 (Fatal)	Passengers - N/A
Nature of Damage:	Destroyed	
Commander's Licence:	Sailplane Pilot's Licence (SPL) and Airline Transport Pilot's Licence	
Commander's Age:	47 years	
Commander's Gliding Experience:	1,500 glider hours 130 hours in the last 12 months (Approximate figures as it was not possible to access pilot's electronic logs)	
Information Source:	AAIB Field Investigation

Synopsis

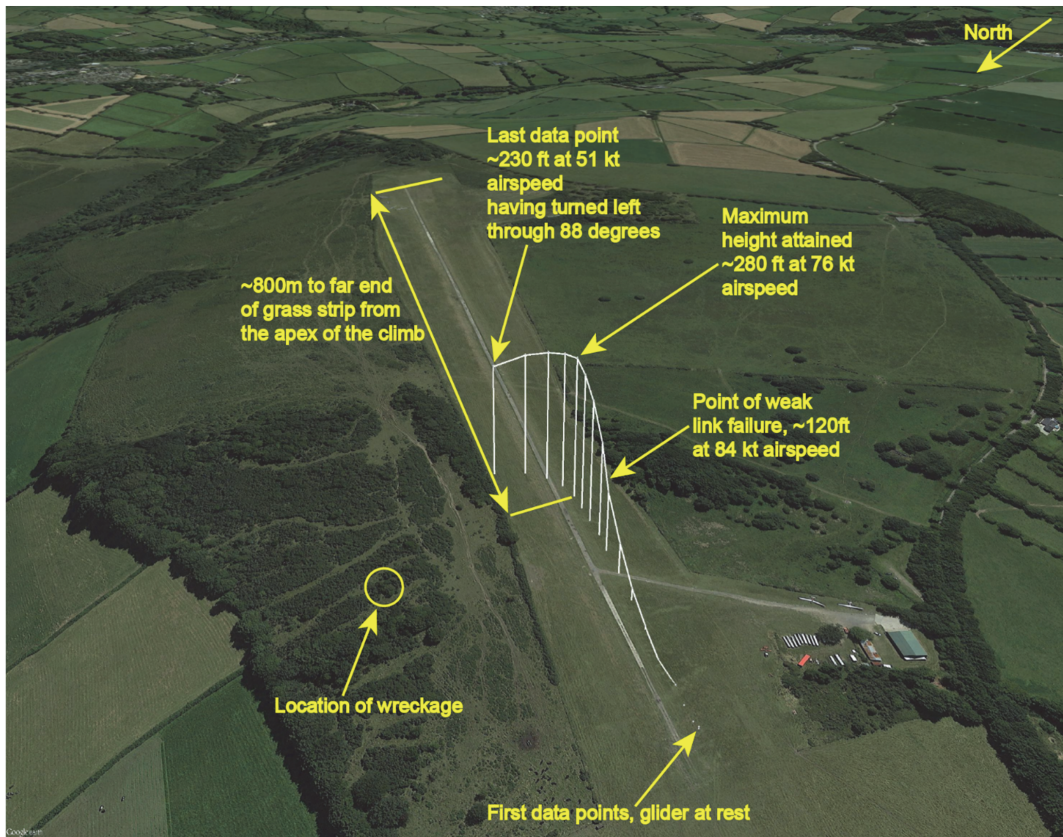
Figure 1

Vertical profile (ft aal⁷), ground track and true airspeed data for the accident flight

The weak link parted at around 120 ft aal, though with a comparatively high speed at the separation point and with the additional energy the aircraft climbed to a peak of approximately 280 ft aal. At this point the pilot promptly began a turn to the left. Very soon after starting the left turn it appears that the aircraft was affected by a significant downdraft and probably a significant decay in airspeed due to wind shear. As a result the aircraft did not gain airspeed for several seconds despite a pronounced nose-down attitude. This increased the rate of descent to a very high value and at this point the situation was beyond recovery.

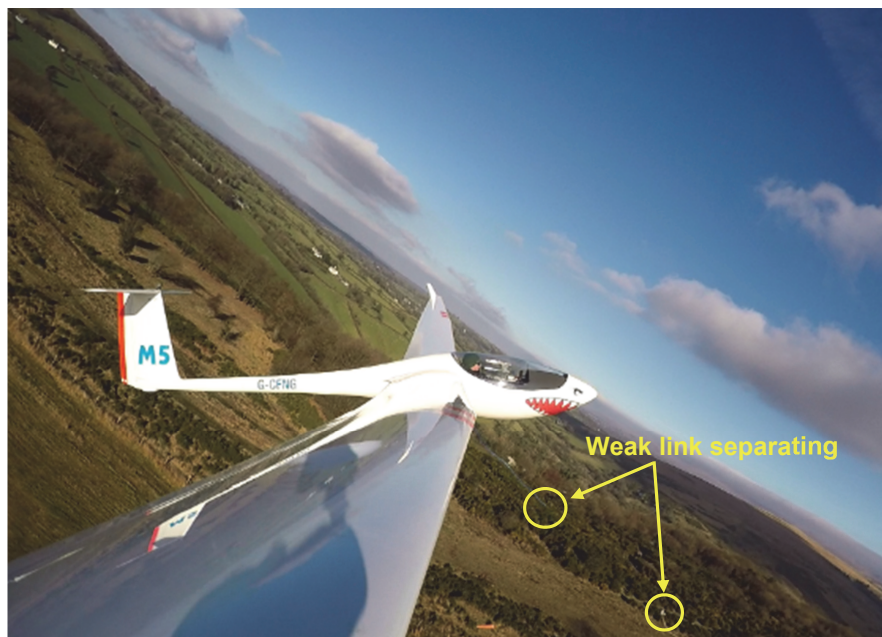
Figure 2

The initial launch appeared normal with the glider becoming airborne at about 53 KIAS, five seconds after the launch started. Three seconds after the glider became airborne it was at 78 KIAS, and about 100 ft aal, when the weak link parted (Figure 2). The pilot immediately looked left and looked left repeatedly from this point on. At no time did the pilot look to the right.

Glider at the moment of launch failure

The winch cable weak link parted due to a load application that was in excess of its yield strength. Weak link separations in turbulent conditions are not uncommon and it is highly likely that the weak link parted due to the turbulent conditions.

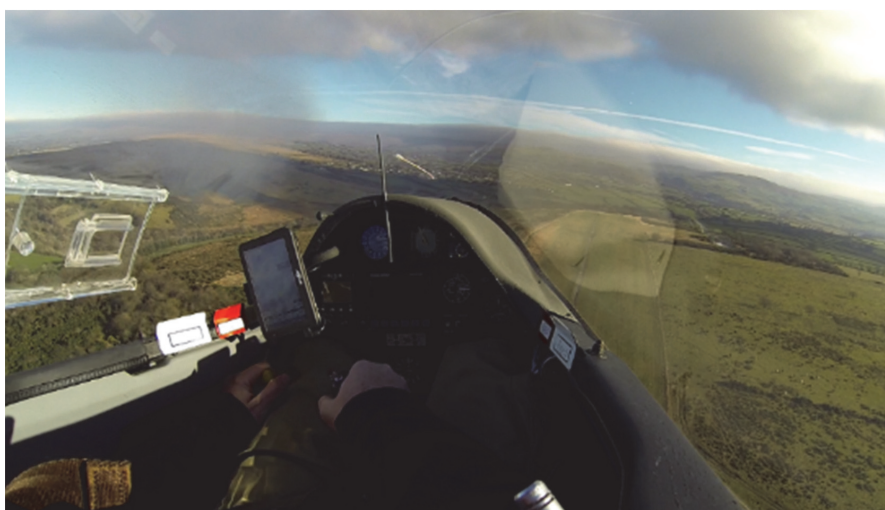
Figure 3

Over the next four seconds the glider pitched gently nose down, gaining height while slowing to 60 KIAS⁸. This pitch-down manoeuvre brought the nose of the glider to approximately level with the horizon. The pilot then made an approximately half-to-two-thirds left roll input on the control stick, while sustaining a neutral to slightly forward pitch input. The glider rolled left, the nose dropped below the horizon and began to turn to the north during which the speed reduced to 51 KIAS (Figure 3).

Cockpit view as left roll input is being made

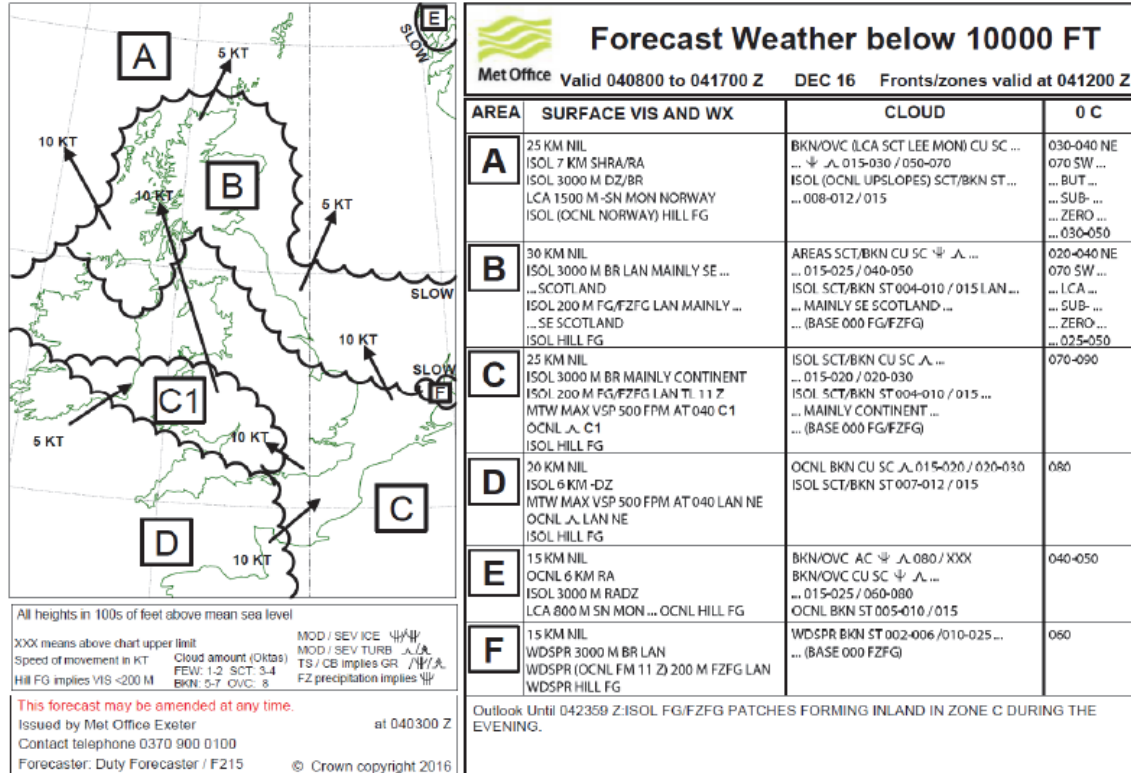
The forecast Metform 215 for the time of the accident (Figure 5) highlights at Area D the risk of mountain waves (MTW) and occasional moderate low-level turbulence near the accident site. In particular, it noted that mountain waves of 500 feet per minute were expected at around 4,000 ft.

Figure 5
Forecast low-level weather, 4 December 2016

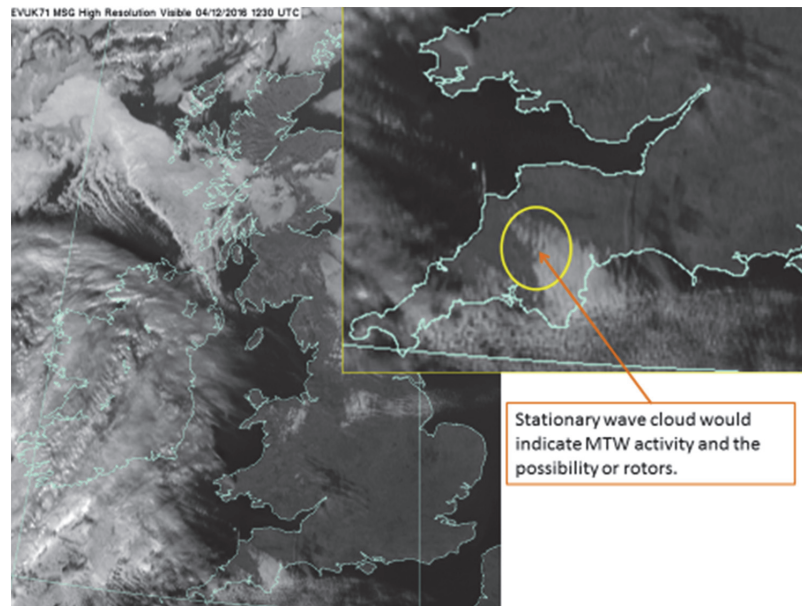
Satellite imagery of the area at the time of the incident confirms the presence of mountain wave activity in the Dartmoor area and therefore a high probability of significant turbulence at low levels (Figure 6).

Figure 6
Satellite image

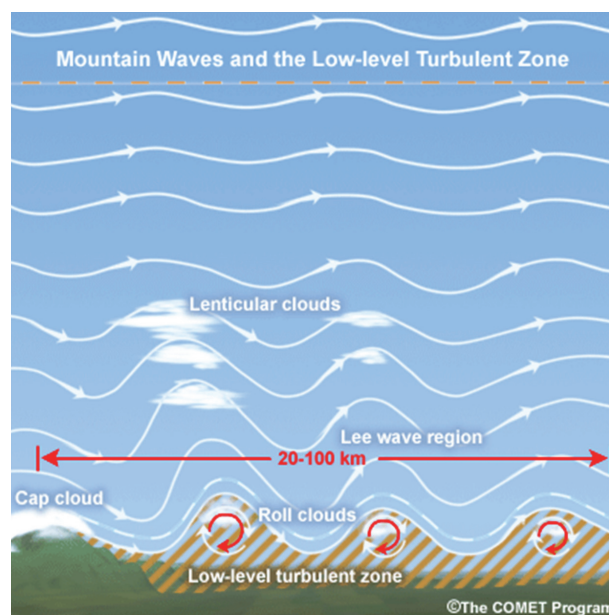
In areas of mountain wave activity a low-level turbulent zone can extend many kilometres downwind from the high ground inducing the phenomena. Brentor Airfield would have been within this zone on the day of the accident (Figure 7).

Figure 7
'Mountain Wave' diagram

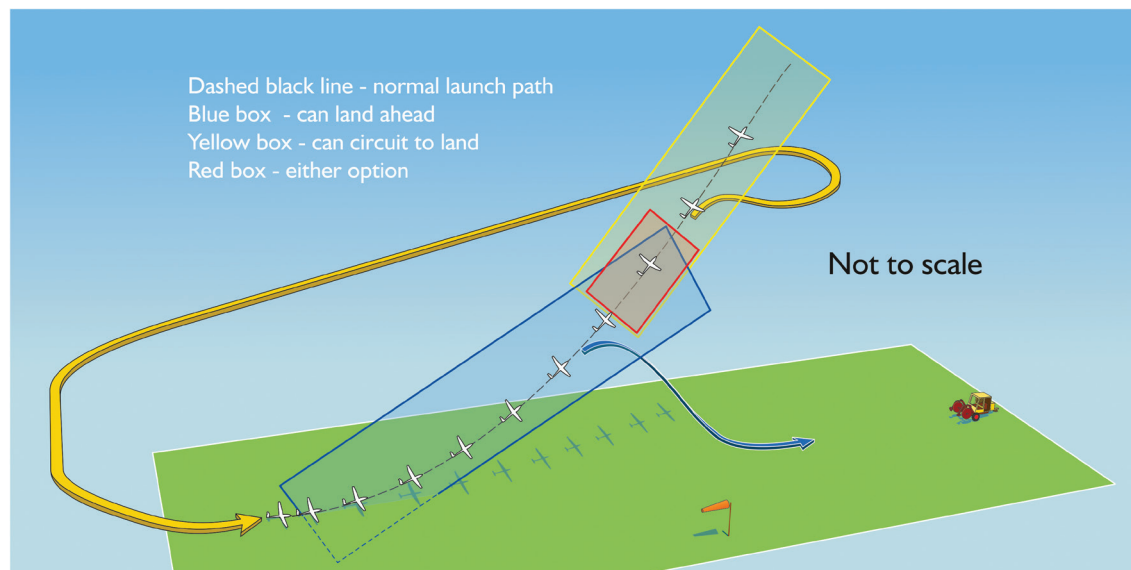
The failure handling can be broken down into phases depending on when it occurs. In the event of a failure during the initial stages of a winch launch the glider should be able to land ahead, on the gliding site (Figure 8). After a short period the glider will reach a height from which it is possible to return to the launch site via some form of abbreviated circuit. The glider site and conditions should be such that one option is always possible and to ensure this happens there will also be a period during which both options will be possible. This overlap is normally in the order of 200 to 300 ft deep and as the headwind or field length increases the depth of this overlap will also increase.

Figure 8
 Launch options picture
