ACCIDENT

Aircraft Type and Registration:	SZD-55-1, G-CKLR	
No & Type of Engines:	None	
Year of Manufacture:	1993 (Serial no: 551193056)	
Date & Time (UTC):	8 April 2017 at 1045 hrs	
Location:	Currock Hill Airfield, Northumbria	
Type of Flight:	Private	
Persons on Board:	Crew - 1	Passengers - None
Injuries:	Crew - 1 (Fatal)	Passengers - N/A
Nature of Damage:	Extensive	
Commander's Licence:	Private Pilot's Licence	
Commander's Age:	62	
Commander's Flying Experience:	18,800 hours (of which 39 were on type) Last 90 days - 1 hour Last 28 days - 0 hours	
Information Source:	AAIB Field Investigation

Synopsis

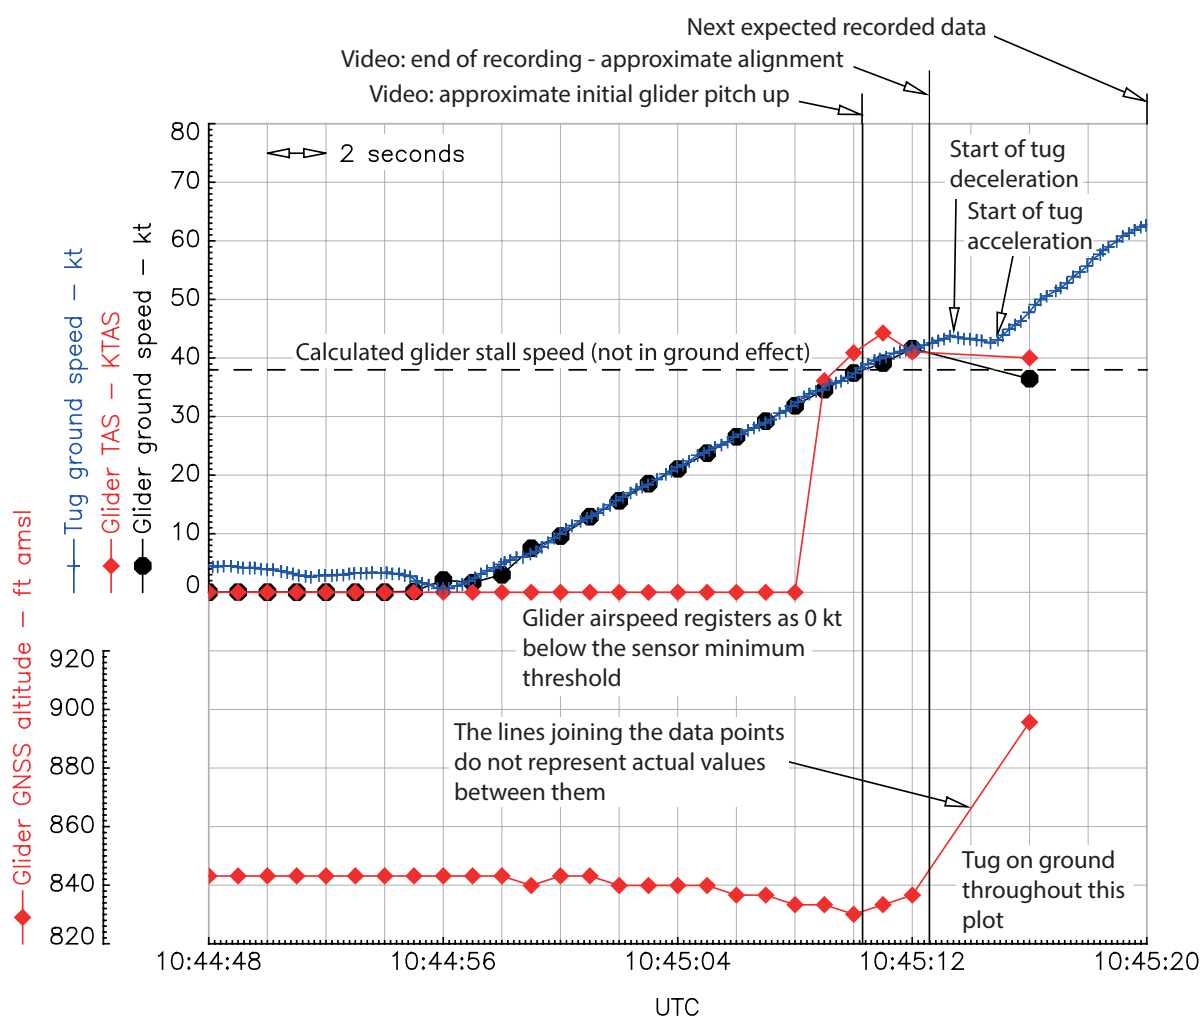
Figure 2

Data recovered from the tug (Figure 2) indicates that in the four second period between the glider's last two data points, the tug, which was still on its takeoff ground roll, experienced a short period of deceleration. Thereafter the tug's acceleration was higher than that evident earlier in the takeoff roll.

Recorded data from the glider and tug

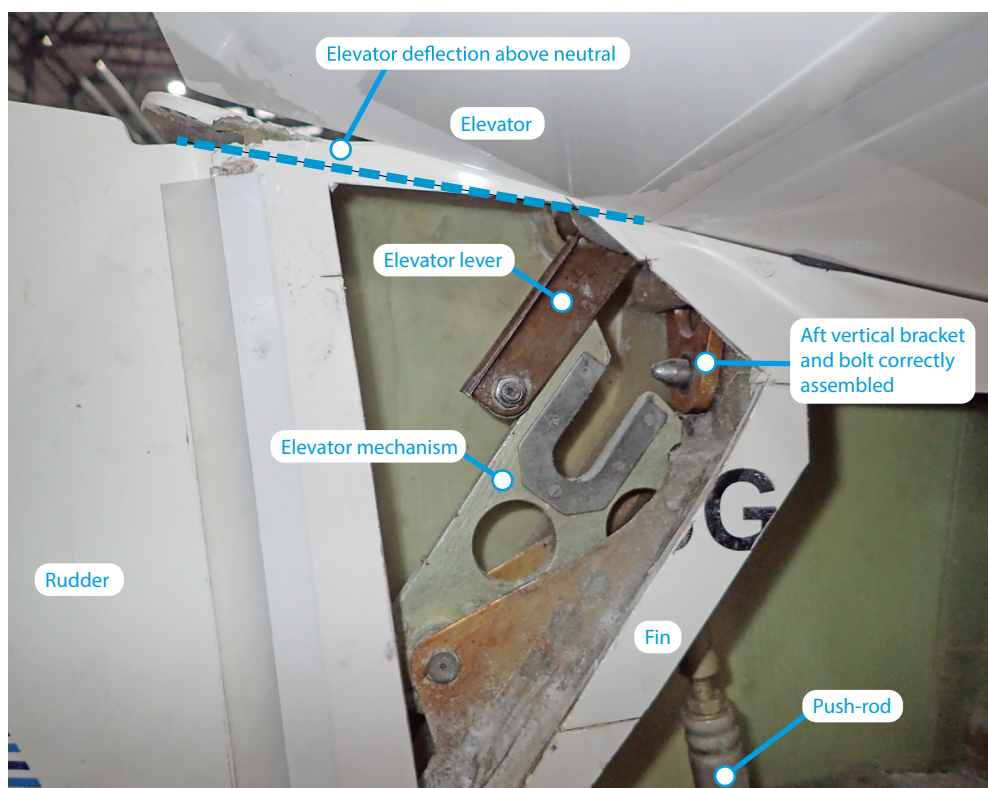
Figure 6

The tailplane was correctly seated on top of the tail fin with no obvious gap between the tailplane and the fin. Access panels were cut in the tail fin to inspect the elevator control connection. It was observed that the tailplane structural connections were correctly made, and the securing bolt correctly inserted. However, the elevator lever was not engaged in the elevator mechanism, but was instead sitting aft of the mechanism (Figure 6).

Position of elevator lever as found on G-CKLR
(Note: elevator lever not engaged in elevator mechanism)

Disruption to the elevator control system, caused by the impact, meant that the control stick was no longer connected to the elevator control mechanism, and the position of the mechanism was therefore not restrained. Consequently, as shown in Figure 6, the elevator mechanism, under its own weight, is resting against a small wooden block, which forms the forward stop of the elevator control system. This corresponds to a position slightly forward of full forward control stick. In normal circumstances, control stops on a bracket at the base of the control stick limit its range of movement and, when the control stick is in the fully forward position, there should be a 0.5 mm gap between the elevator mechanism and the wooden block.

During examination of the wreckage, the horizontal elevator push-rod was moved forward and aft to simulate movement of the control stick. It was demonstrated that in this mis-rigged condition, the elevator surface could be driven upwards by moving the control stick (push-rod) aft. Forward movement of the control stick (push-rod) resulted in the elevator surface moving downwards under gravity, but only to a position above neutral and not into the normal downwards range of elevator deflection. The available range of elevator deflection in the mis-rigged condition was measured as 5° UP to 30° UP; the normal range of elevator deflection is 20° DOWN to 30° UP.

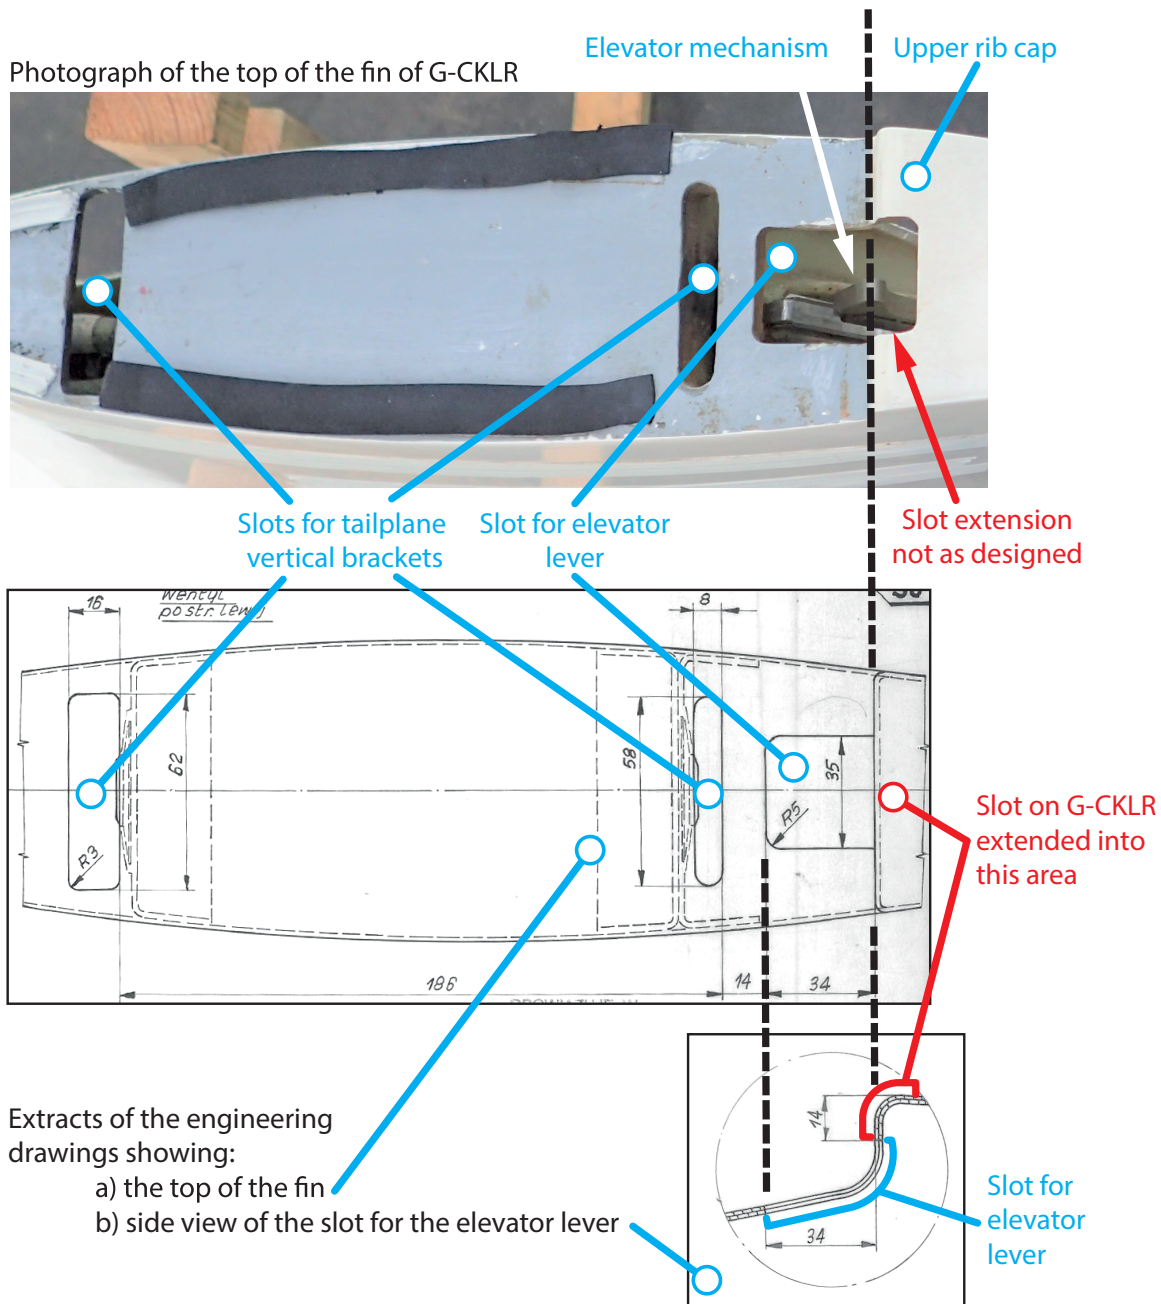
The rigging pin was removed from the fin and it came out smoothly, with no resistance. When the tailplane was removed, it was evident from examination of the horizontal rib of the tail fin, that the elevator lever slot was substantially larger than the original design dimensions. The appearance of the edge of the slot was rough and unfinished and was of uneven thickness. The manufacturer considered that the finish did not correspond to original production standard.

Figure 7 shows a plan view of the horizontal rib from the tail fin of G-CKLR compared with extracts from an engineering drawing provided by the manufacturer.

The design dimensions of the elevator slot in the horizontal rib of the tail fin should be 34 mm x 35 mm. The horizontal rib exhibits an approximately vertical step-change in profile towards its aft end. The design drawings indicate that the elevator lever slot should extend only partially up this vertical step, to a position which is approximately indicated by the dashed line in Figure 8. However, on G-CKLR this slot extends up the entirety of the vertical step and onto the upper rib cap.

G-CKLR tail fin horizontal rib comparison with extracts from engineering drawing showing design dimensions

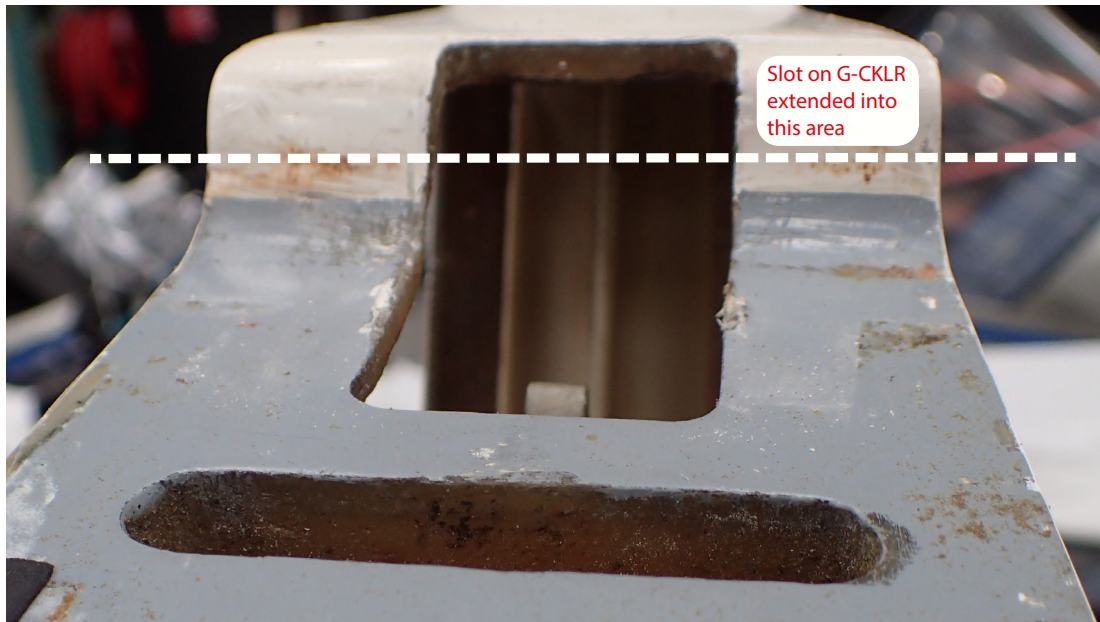
Figure 8

Rearwards view of elevator slot in G-CKLR's tail fin

However, with the elevator mechanism in the fully forward position, if the elevator was held in a range of intermediate positions, the angle of the elevator lever was such that it could very easily and with no resistance enter the empty space behind the mechanism, creating the mis-rigging condition observed following the accident.

In summary, these tests demonstrated that with the enlarged slot, a mis-rigging condition could occur when the elevator mechanism was in a forward position and the tailplane was held such that the elevator was in a slightly up position during rigging.
