## Airworthiness Information

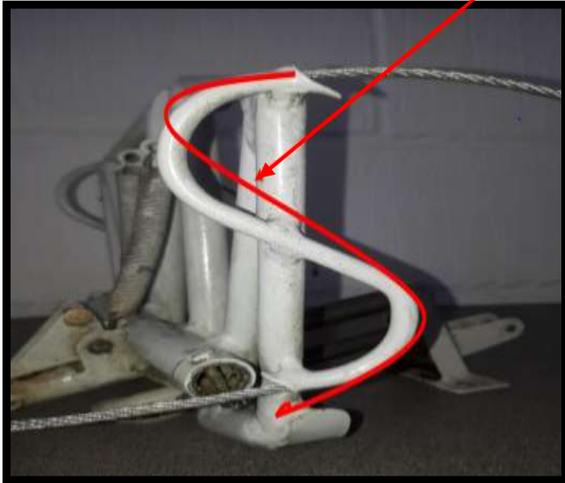
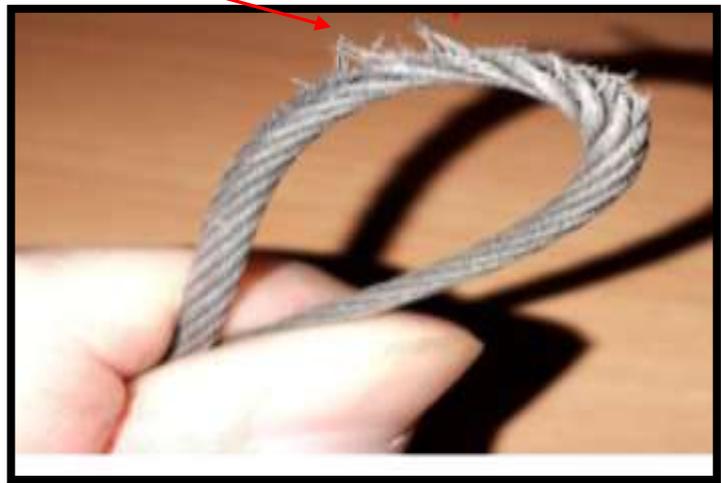
**11. ASW15 RUDDER PEDALS (and possibly many other types)**

The length of cable in the “S” tube is often more than the overall travel on pedal adjuster, so care must be taken when carrying out a visual inspection. A Visual inspection will not always detect badly worn cables in the “S” section. The Distance through “S” tube may be greater than forward and aft pedal adjuster movement. If the rudder cables in the S bend cannot be inspected, consideration to replacing them every 1000 hours should be considered (experience has shown they rarely last more than 1500 hours damage free). Reported by Andrew Brind.

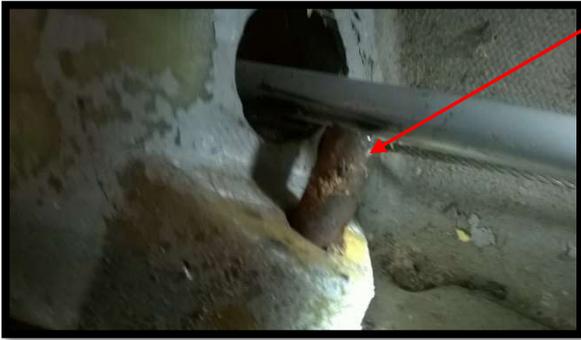
**12. Astir retractable U\C but could apply to many others**

This image shows an Astir U/C bush moving sideways in its mount until it starts to scrape on the elevator pushrod. When removed the shaft was found to be bent. Reported by Carlos Ingram-Luck.

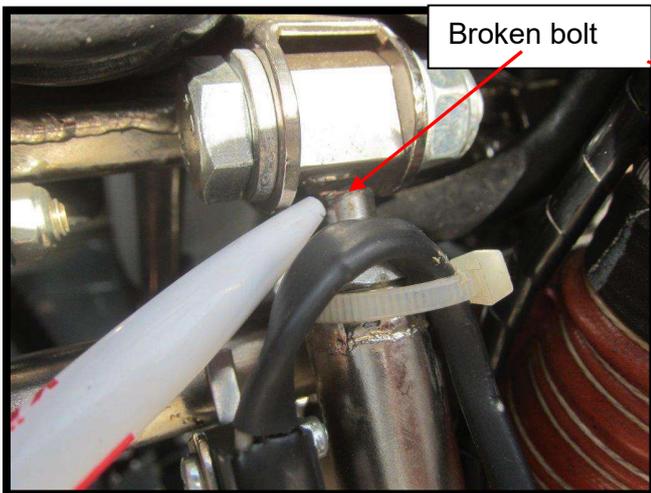
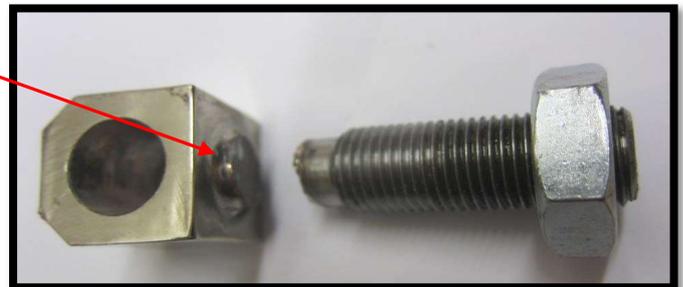
### 13. Wankel engines fitted in Schleicher self launching sailplanes

A fine threaded bolt in the engine/pylon construction has been reported to shear due to possible poor adjustment or overloading. This will stop the engine starting. Inspecting the pylon between flights should be part of the preflight regime. Reported by Dietmar Pol.

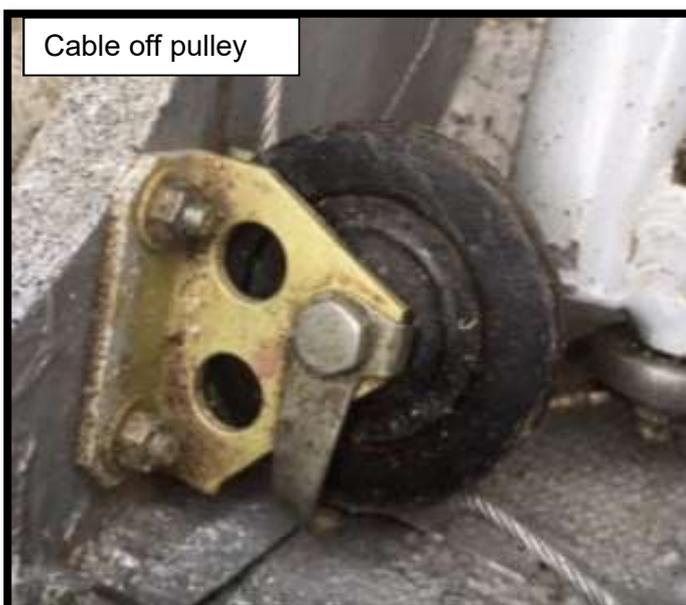
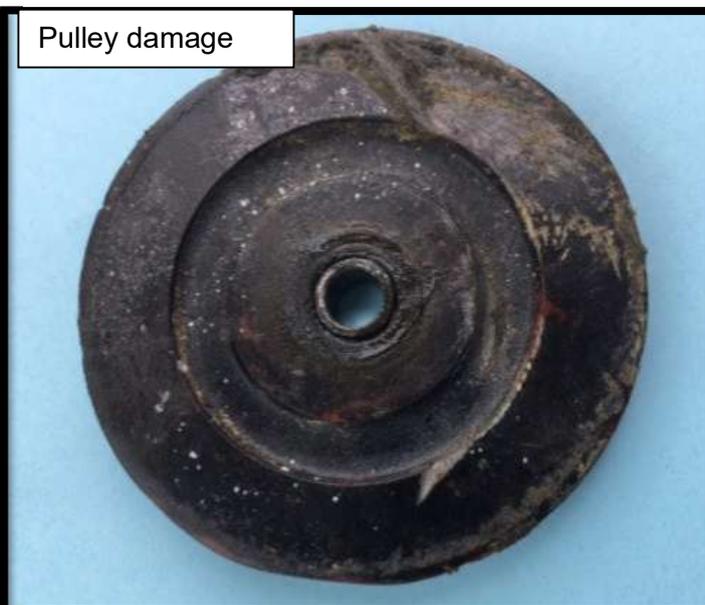
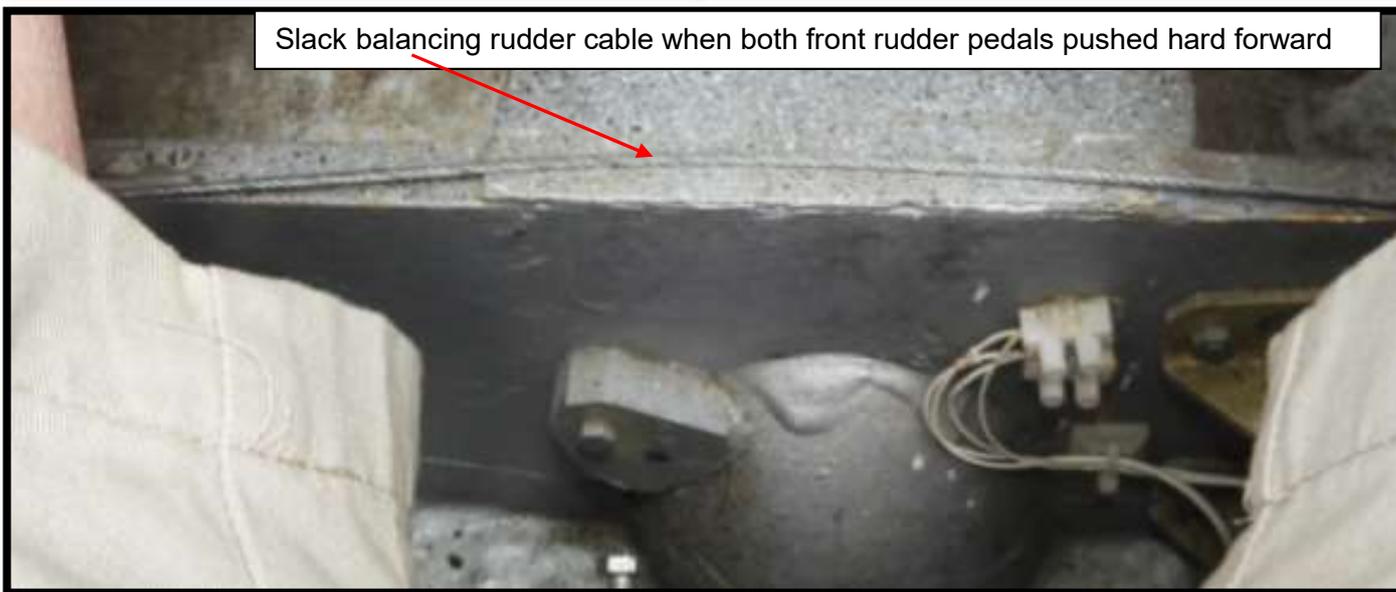
**18 Puchacz rudder cable jumping off pulley**

The rudder was intermittently stiff in flight. Upon investigation it was found a cable had come off a pulley. It was found that the 'balancing' rudder cable in front of the pulleys, could have slack induced into the system when both front rudder pedals were pushed hard forward. This most likely contributed to the cable falling off the pulley. The maintenance manual specifies a cable tension that (in theory) should prevent this problem.

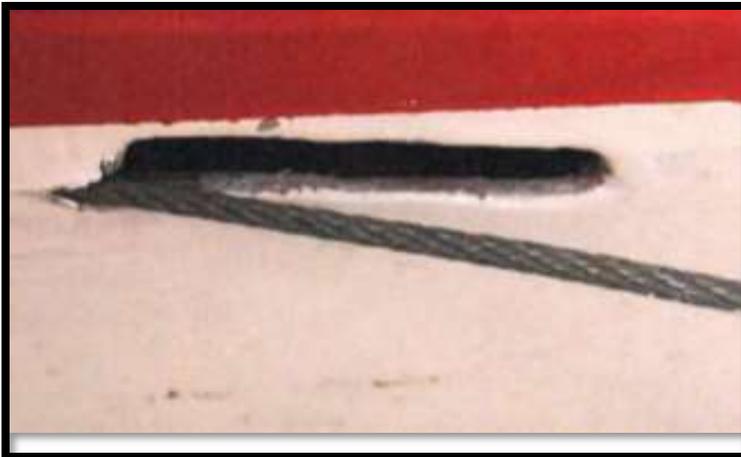
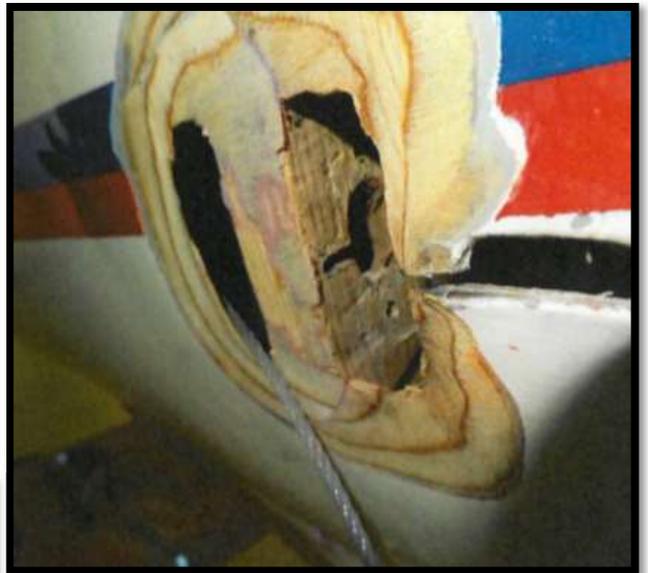
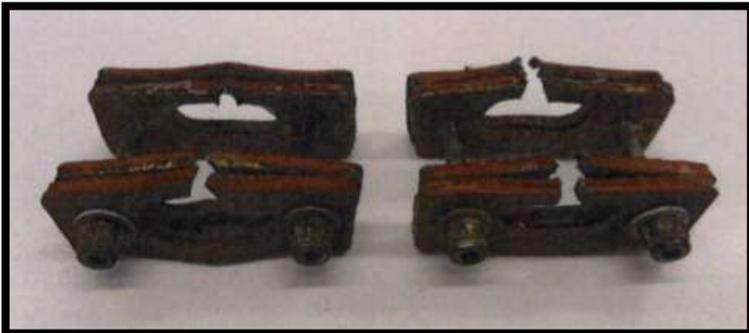
## 20 Slingsby Skylarks and most other wooden types

These extremely worn cable guides and subsequent damage should have been fixed long before they became this worn. With modern very cheap cameras it has never been easier to find this wear. Reported by Richard Lucas.

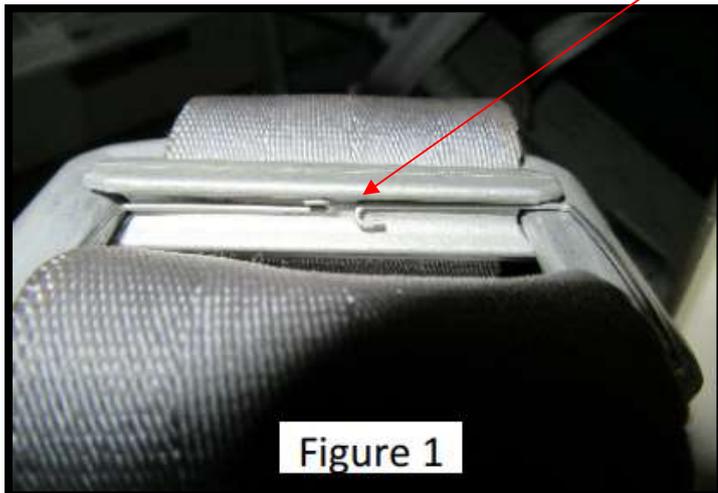
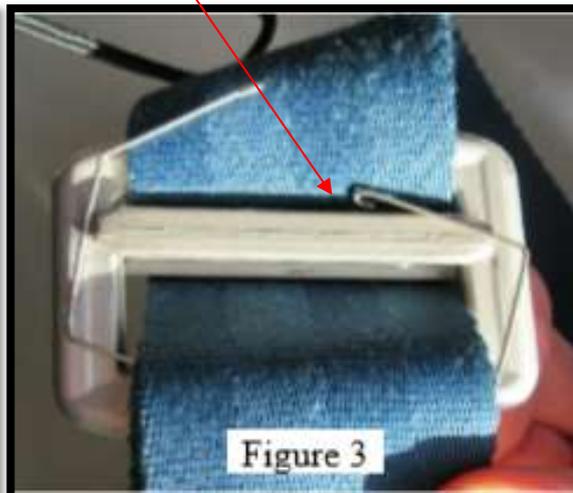
## 21 Gadringer strap maintenance

The retention springs in these Gadringer straps have come undone. Apart from the possible sharp bits of wire causing cuts, the straps will not be locked in place when the tension comes off them. Ideally, this should be spotted on DI by the pilot when the straps are checked. Be careful to ensure these retention springs are fitted properly during annual maintenance. Reported by Robert Baines.

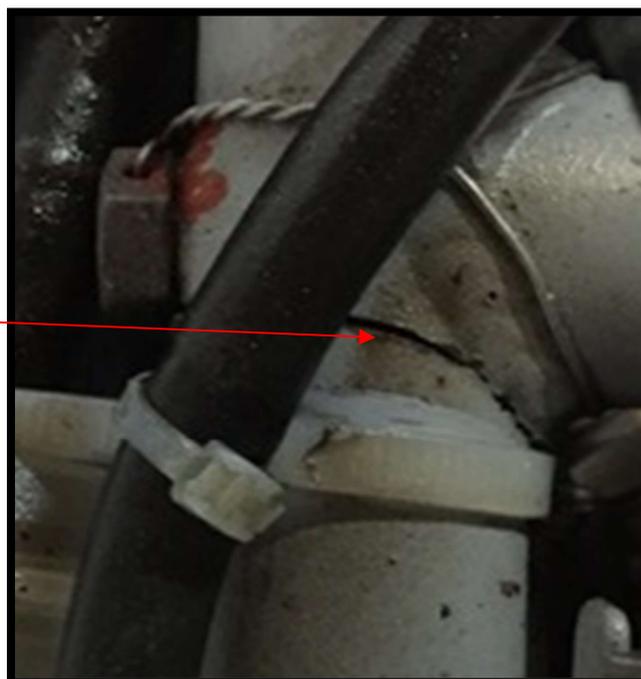
## 22 Ventus CT Pylon (but can apply to most retracting engines)

Cracking pylons and ancillaries are a common problem for all 2 stroke gliders ever since the 2 stroke retracting sustaining/motor gliders were invented 40 years ago.

The Schempp Hirth fully up to date flight manual advises inspecting the engine Pylon and propellers for cracks like this every flight.

Try and remind owners of this requirement so the problems can be found before annual maintenance is due.
