**ACCIDENT**

<b>Aircraft Type and Registration:</b>	1) Cessna 152, G-WACG 2) Guimbal Cabri G2, G-JAMM
<b>No &amp; Type of Engines:</b>	1) 1 Lycoming O-235-L2C piston engine 2) 1 Lycoming O-360-J2A piston engine
<b>Year of Manufacture:</b>	1) 1982 (Serial no: 152-85536) 2) 2017 (Serial no: 1185)
<b>Date &amp; Time (UTC):</b>	17 November 2017 at 1201 hrs
<b>Location:</b>	Near Waddesdon, Buckinghamshire
<b>Type of Flight:</b>	1) Training 2) Training
<b>Persons on Board:</b>	1) Crew - 2                      Passengers - None 2) Crew - 2                      Passengers - None
<b>Injuries:</b>	1) Crew - 2 (Fatal)          Passengers - N/A 2) Crew - 2 (Fatal)          Passengers - N/A
<b>Nature of Damage:</b>	Both aircraft destroyed
<b>Commander's Licence:</b>	1) Commercial Pilot's Licence 2) Airline Transport Pilot's Licence (H)
<b>Commander's Age:</b>	1) 27 years 2) 74 years
<b>Commander's Flying Experience:</b>	1) 419 hours (of which around 400 were on type) Last 90 days - n/k hours Last 28 days - 19 hours  2) 25,000+ hours (of which n/k were on type) Last 90 days - n/k hours Last 28 days - n/k hours

<b>Information Source:</b>	AAIB Field Investigation

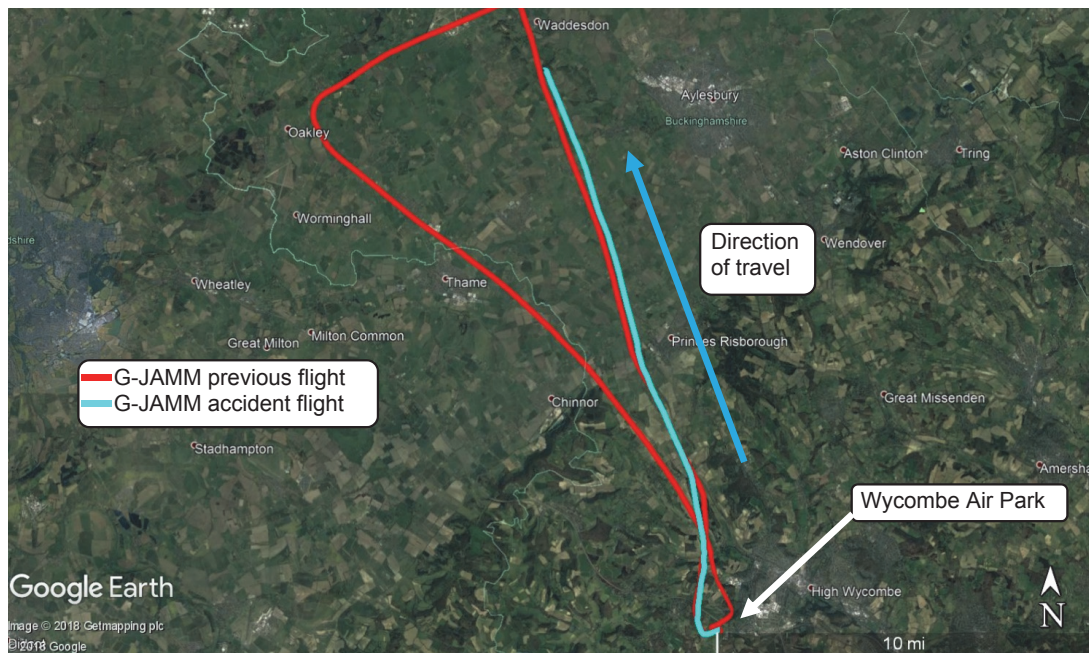
**Figure 2**

Radar-derived tracks of G-JAMM on 17 November 2017  
(First flight red, accident flight blue)

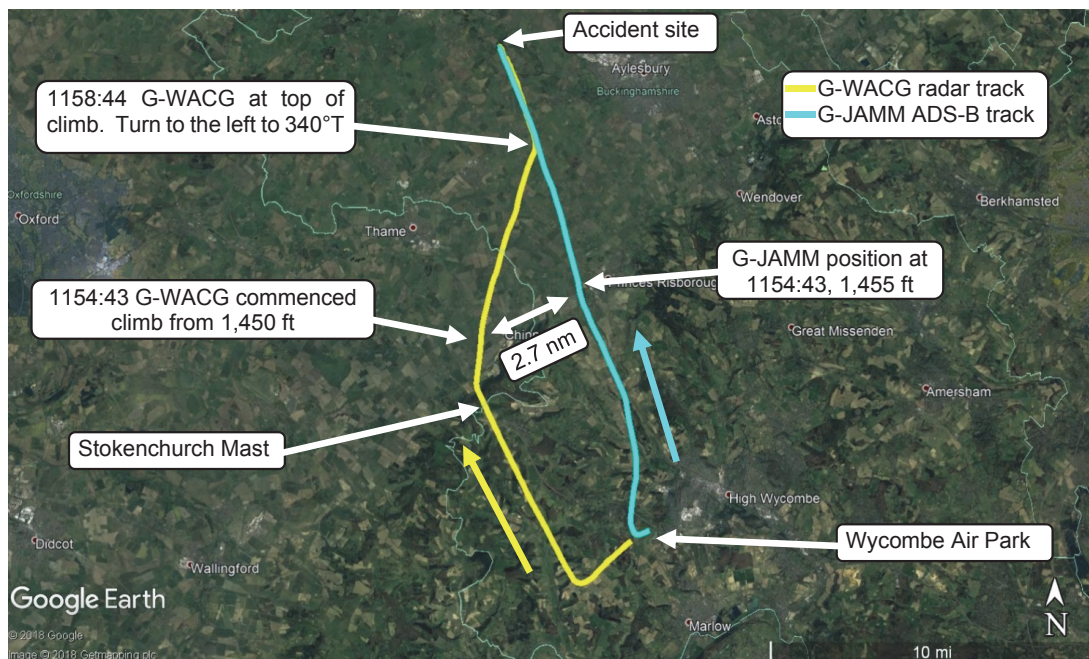
**Figure 3**

G-WACG and G-JAMM position information

During the first six minutes of flight, the distance between the aircraft increased up until the point where G-WACG turned to the right at the Stokenchurch Mast. Just prior to G-WACG commencing its climb, the aircraft were at a similar level, approximately 2.7 nm apart with G-WACG slightly behind and to the left of G-JAMM (Figure 3).

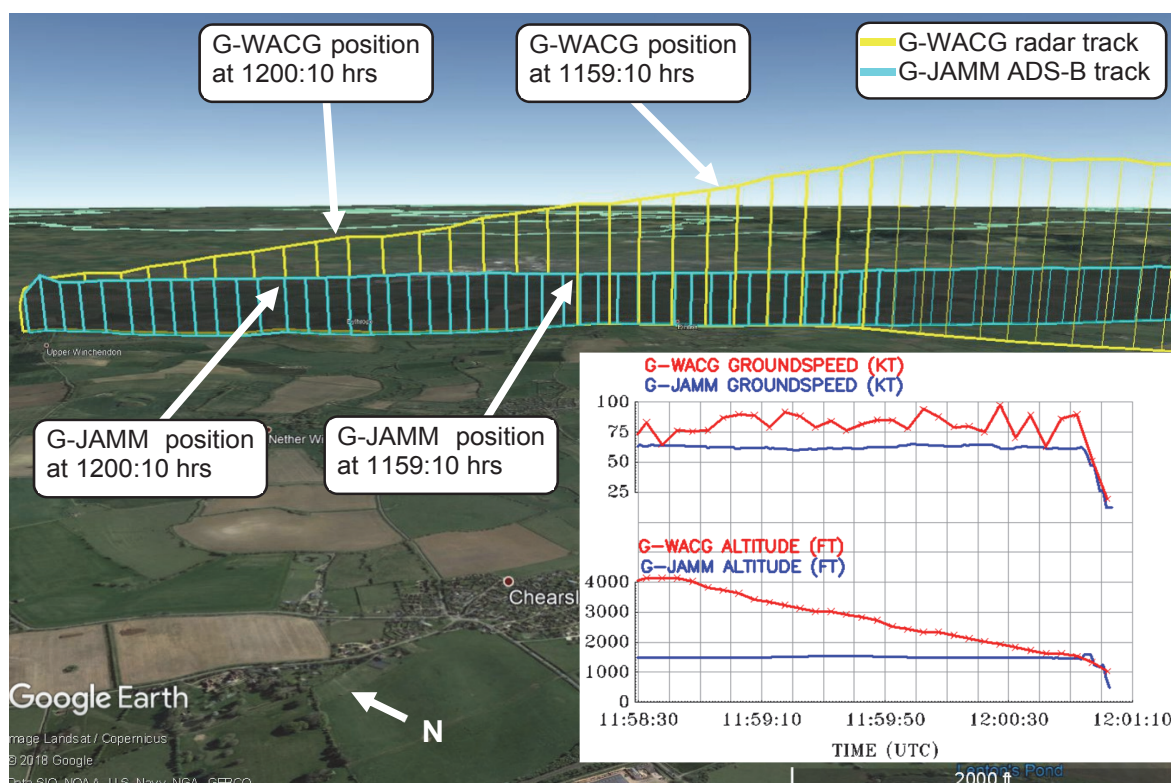
**Figure 4**

As G-WACG climbed, the tracks converged. When G-WACG then turned to track 340°T, the recorded positions show both aircraft following an almost identical path over the ground, albeit initially separated by over 2,500 ft vertically. At 1159:10 hrs, G-WACG, with a higher groundspeed, was approximately 0.5 nm behind G-JAMM and 1,950 ft above. A minute later, G-WACG was 750 ft above and approximately 1,000 ft behind. The vertical and horizontal separation progressively reduced to the point of the collision (Figure 4).

G-WACG and G-JAMM position information, looking to the north-east

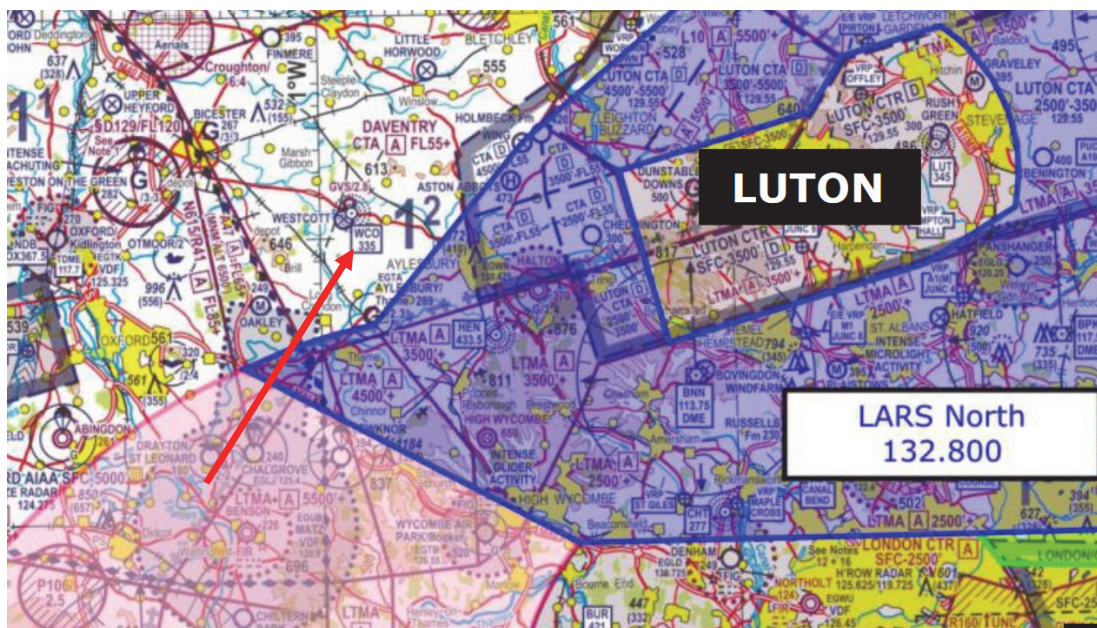
**Figure 6**

The area to the north-west of WAP, where many training flights operate, is partly covered by Farnborough North Lower Airspace Radar Service (LARS), Figure 6. Farnborough LARS provides Air Traffic Services outside controlled airspace to pilots flying under or around the London Terminal Manoeuvring Area. The type of service available depends upon the request made by the pilot and the capacity of the unit. The 'Farnborough LARS Guide' published online by NATS includes the following note:

Accident location (indicated by arrow) relative to Farnborough LARS North

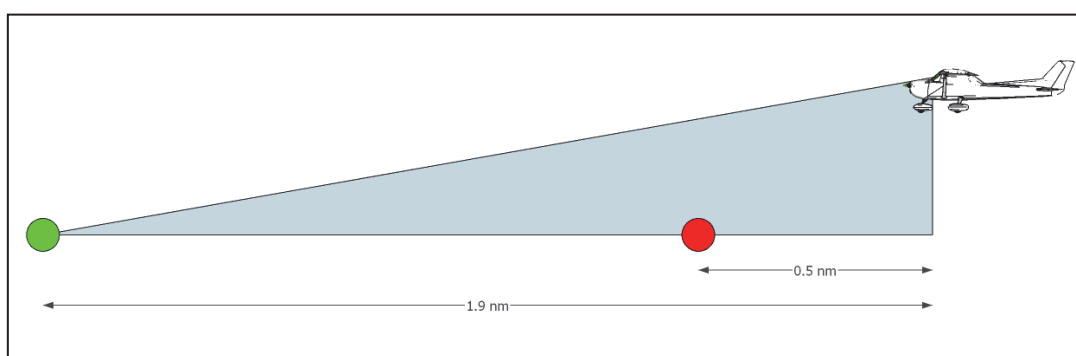
**Figure 10**

Radar data indicated that, when G-WACG was 1,950 ft above G-JAMM, it was only 0.5 nm behind it. A simple assessment indicates that, if G-WACG was straight and level with zero pitch angle at 2,000 ft above G-JAMM, it would have to have been at least 1.9 nm behind for the pilot to have had any opportunity of detecting a possible conflict without additional manoeuvring (Figure 10). In the absence of a turn, the pilot would need to have pitched the aircraft at least 24° nose-down to have had any chance of observing the helicopter. The situation, whereby additional manoeuvring would have been required by G-WACG to bring the helicopter into view, would have persisted up to the point of collision.

Forward visibility from G-WACG  
(grey area is obscured from vision,  
red circle indicates the radar position of G-JAMM,  
green circle indicates the minimum distance at which  
G-JAMM would have been visible)
