British Gliding Association Aircraft Accident Report: Ref 2019005

Aircraft Type and Registration: Schempp-Hirth Flugzeugbau GMBH Duo Discus Turbo, G-CJUM, BGA 4792

Date & Time of Accident: 13th October 2018, 1230 Local.

Location: Base of Beachy Head Cliffs

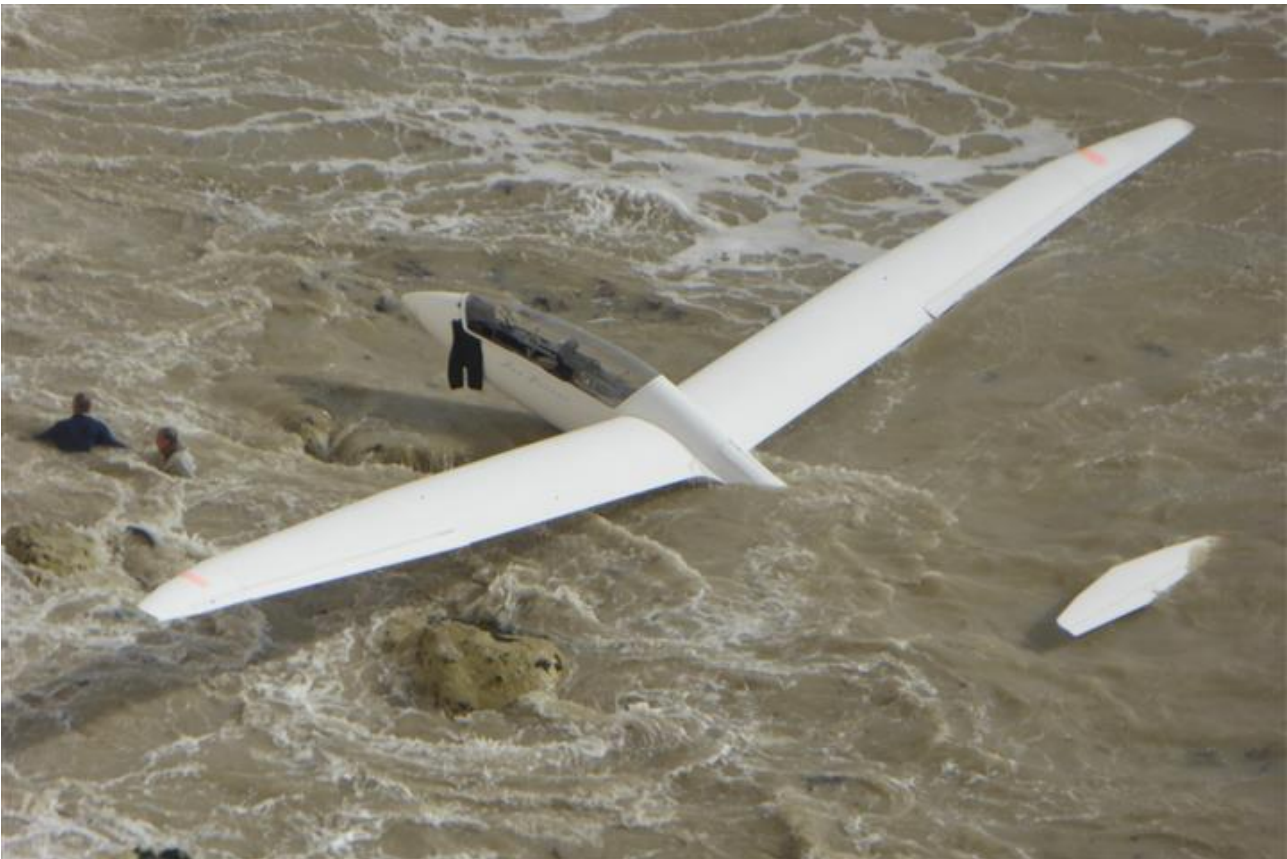
Figure 1: G-CJUM and Both Occupants Shortly After Ditching

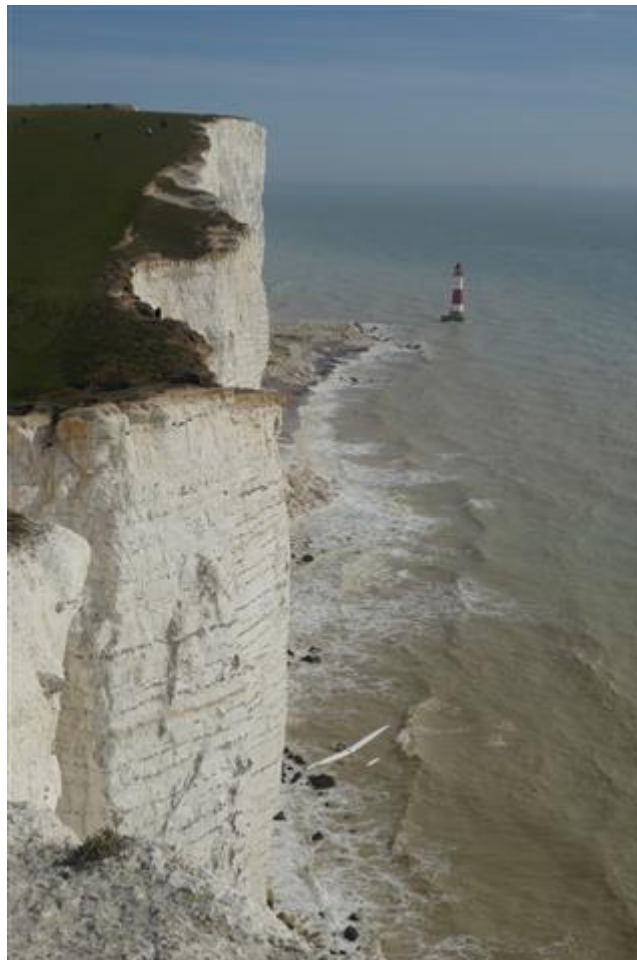
Figure 2: G-CJUM at the Base of the Cliffs with Beachy Head Lighthouse in the Background
