ACCIDENT

Aircraft Type and Registration:	Grob G109B, G-KHEH	
No & Type of Engines:	1 Grob 2500 E1 piston engine	
Year of Manufacture:	1986 (Serial no: 6436)	
Date & Time (UTC):	10 June 2018 at 0959 hrs	
Location:	Near Raglan, Monmouthshire	
Type of Flight:	Training	
Persons on Board:	Crew - 2	Passengers - None
Injuries:	Crew - 2 (Fatal)	Passengers - N/A
Nature of Damage:	Aircraft destroyed	
Commander's Licence:	Private Pilot's Licence	
Commander's Age:	68 years	
Commander's Flying Experience¹:	550 hours (of which 27 were on type) Last 90 days - 7 hours Last 28 days - 2 hours	
Information Source:	AAIB Field Investigation

Synopsis

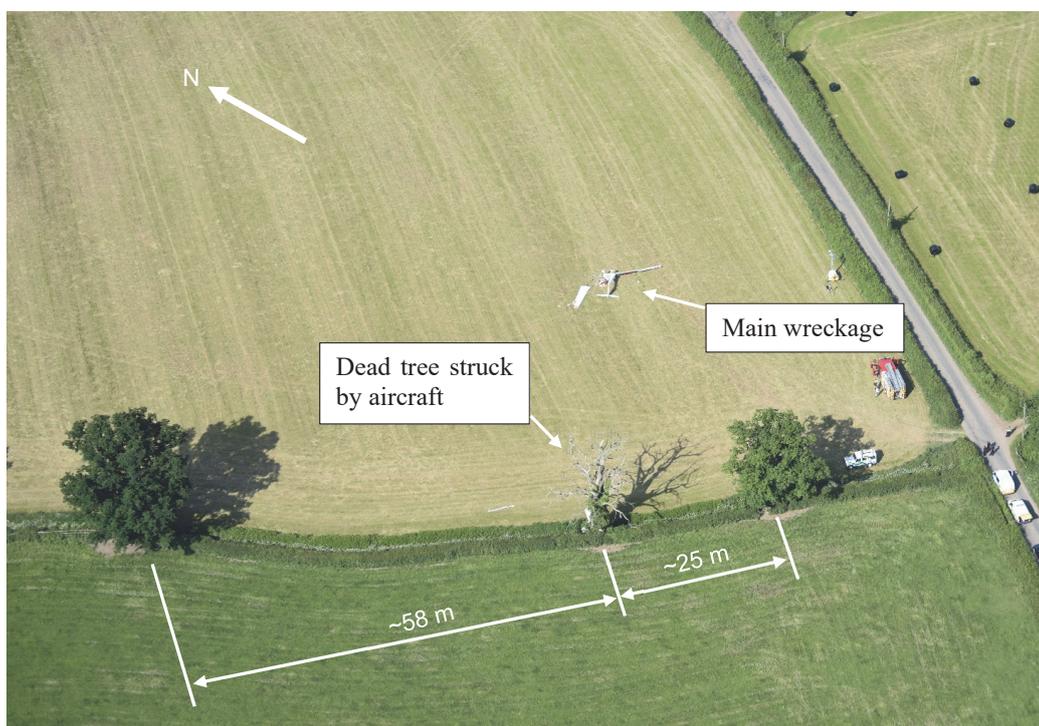
Figure 2
Accident site
(image courtesy of South Wales Police)

The field in which the accident site was located had a hedge running along its south-western perimeter in which there were several mature trees, one of which was a dead oak tree (Figures 2 and 3). A 2 m section of the aircraft's right wingtip was found in this tree suspended together with a broken bough, both having been entangled in the tree by some aircraft wiring. Photogrammetry assessment of the dead tree and examination of the damage to the right wing determined the height of the impact with the tree was approximately 57 ft agl.

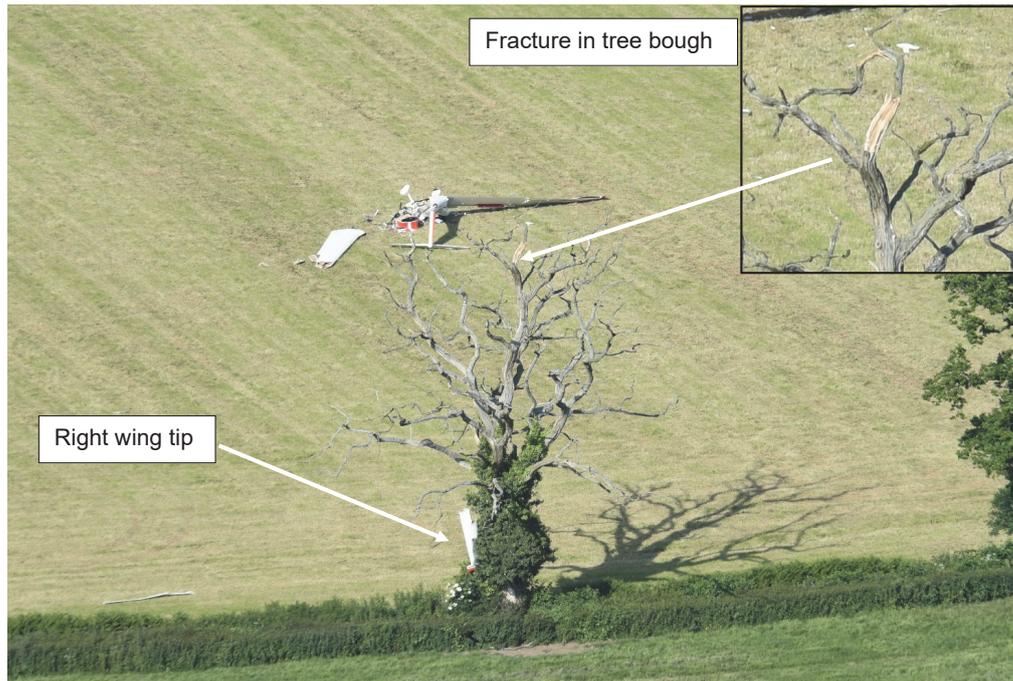
Figure 3

Accident site showing impact point with tree and wreckage
(image courtesy of South Wales Police)

The aircraft had come to rest, inverted, approximately 55 m from the hedge line. There was no post-impact fire. Impact marks showed that the aircraft had struck the ground at a steep angle, inverted. The right wing, which had separated during the impact sequence, was found close to the fuselage.

Evidence from the accident site and examination of the wreckage identified that the aircraft's right wing contacted the dead tree at an approximate height of 57 ft agl. This will have caused the aircraft to yaw rapidly to the right, increasing the lift from the left wing. At the same time, there will have been a marked decrease in lift from the right wing due to the damage it experienced and this, together with the possible effects of entanglement in the tree, caused the aircraft to roll. It is likely that the aircraft rolled through approximately 180° before impacting the ground at a near vertical attitude.

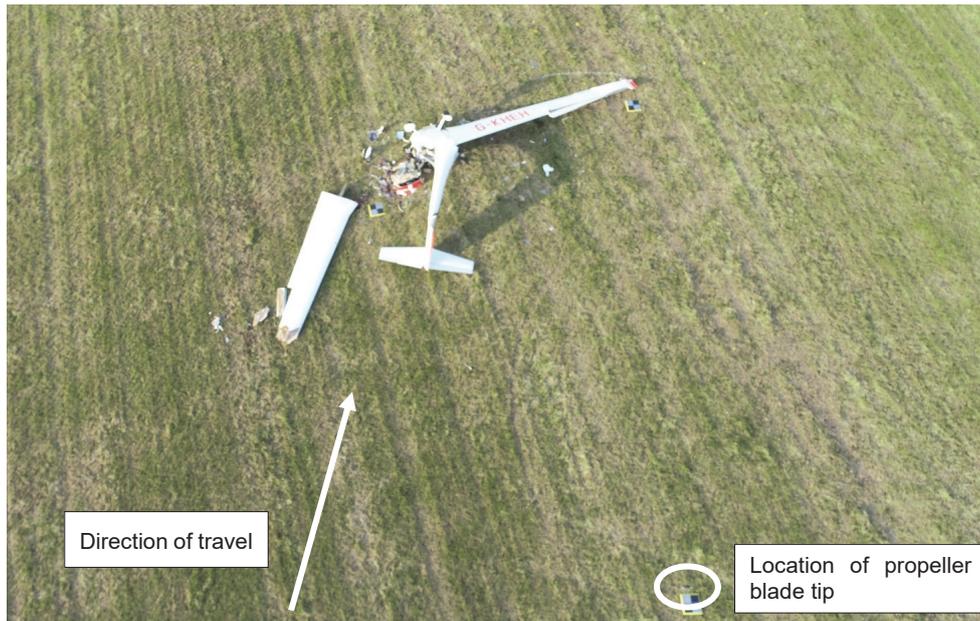
**Figure 4**

Ground marks at the main impact location indicated that the propeller was rotating at the time it contacted the ground. The composite wooden propeller had fragmented and one of the propeller blade tips was located 16 m from the initial impact point (Figure 4), indicating that the engine had been producing power at the time of impact.

Location of propeller blade tip in relation to wreckage

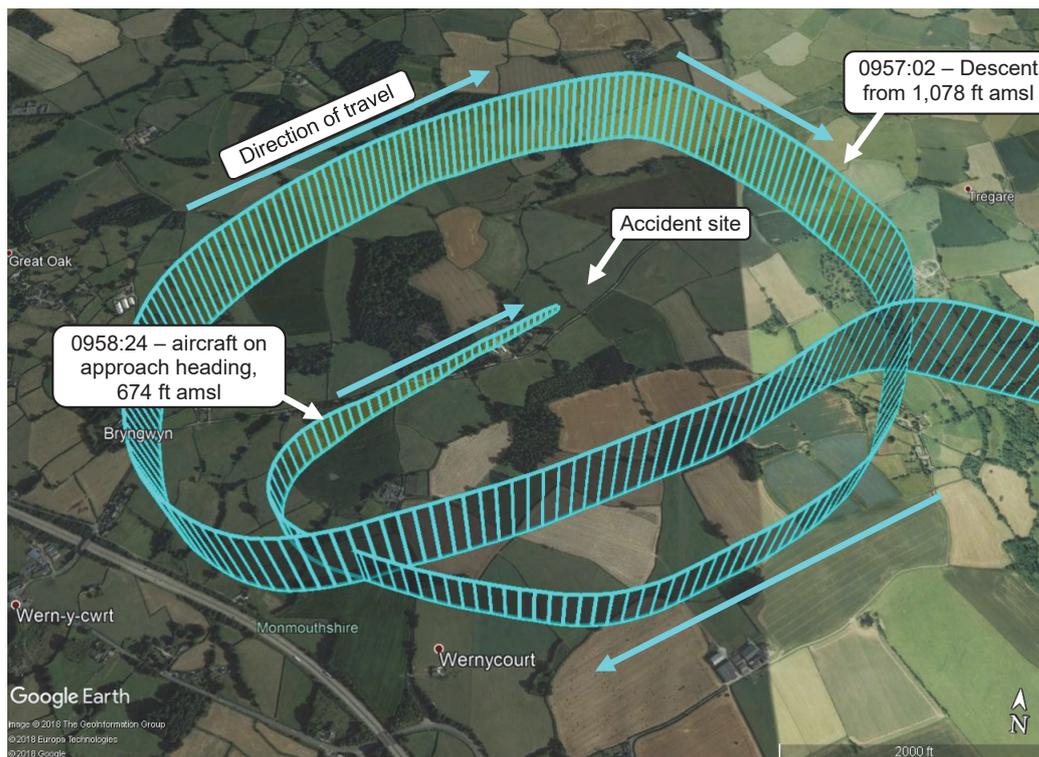
Figure 7

Upon passing abeam Raglan, the aircraft commenced a right hand circuit overhead the accident site at approximately 1,100 ft amsl (Figure 7).

At 0957:02 hrs, while on the crosswind leg, the aircraft commenced a descent which continued for the rest of the flight. Vertical speed was calculated as the rate of change of GPS altitude to ascertain the rate at which the aircraft was descending throughout the manoeuvre. A negative vertical speed represented a rate of descent; a positive vertical speed a rate of climb.

Between the start of the descent and the turn to the final approach track, vertical speed varied at between +100 to -790 ft/min, with the aircraft descending 400 ft over one minute 20 seconds (Figure 8). Ground track covered over this period was approximately 1.6 nm, equating to an average ratio of 1:24. Calculated groundspeed varied between 54 kt and 77 kt.

At 0958:24 hrs the aircraft was positioned on the final approach track at an altitude of approximately 674 ft amsl (about 444 ft agl). The recorded aircraft positions do not show any significant deviation in the aircraft track during the last 30 seconds of the recording.

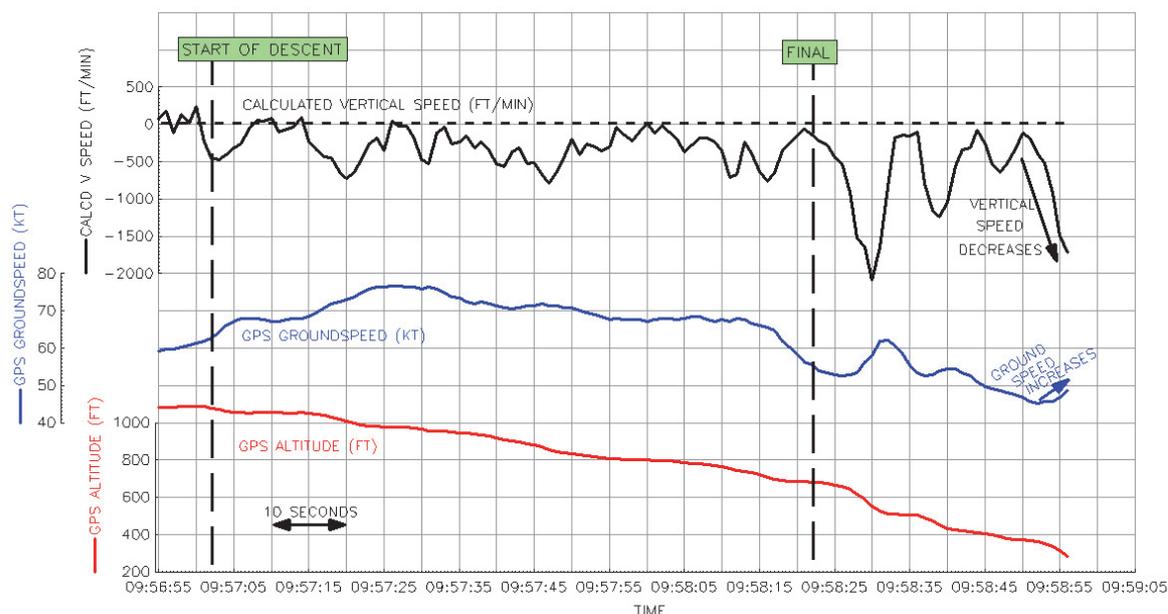
Figure 8

During the turn onto the final approach the groundspeed decreased and, shortly after becoming established on the final approach, this had reduced to about 53 kt. During the subsequent final 30 seconds of the flight, vertical and ground speeds are seen to fluctuate with the vertical speed varying between -100 and -2,000 ft/min and the groundspeed varying between 45 kt and 62 kt (Figure 7). In general, when the vertical speed decreased, the groundspeed increased and vice versa.

During the last four seconds, recorded data shows the aircraft in a descent with decreasing vertical speed and groundspeed increasing from 45 kt. The last recorded position was at 0958:56 hrs with the aircraft at 284 ft amsl (about 54 ft agl) located approximately 43 m before the tree.

The data indicates nothing unusual during the initial part of the descent. The reduction in groundspeed to 48 kt (equivalent to an airspeed of approximately 53-58 kt) coincided with the turn onto the final approach, after which both airspeed and vertical speed fluctuate for the remainder of the flight. This might be explained by the student's lack of experience on the aircraft or his attempts to position the aircraft to make the field, had he been flying it at the time. It could also indicate a distraction within the cockpit whilst dealing with an aircraft issue.
