## Airworthiness Information

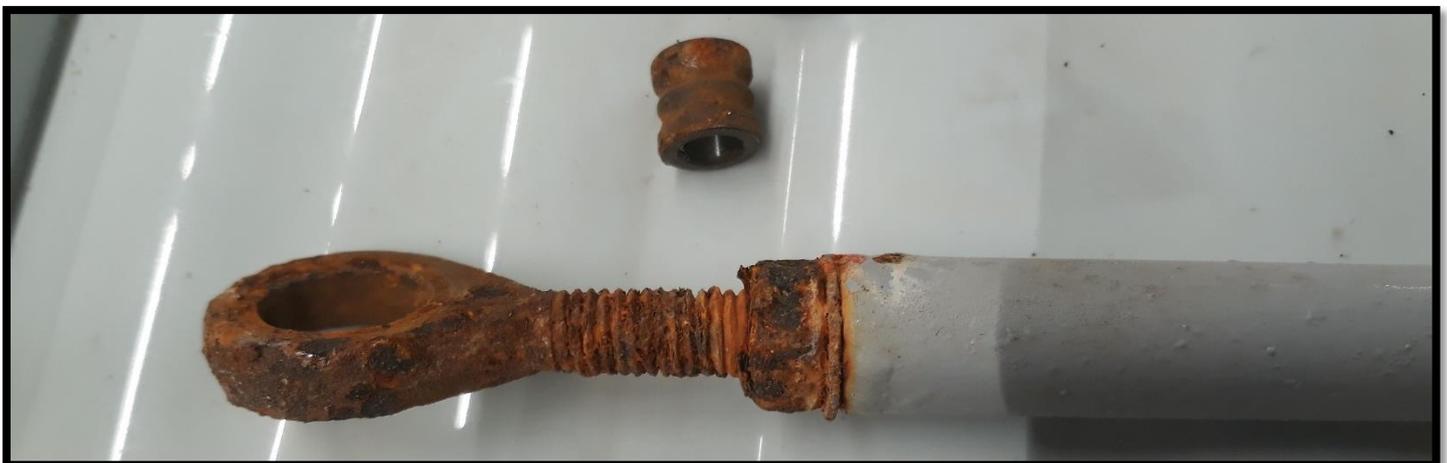
- 6. Schemp Hirth Ventus 2 all variants** **EASA AD 2020-0063** **Mandatory**  
<https://ad.easa.europa.eu/ad/2020-0063>  
Flaperon Control – Inspection / Replacement. This was found on a UK based Ventus 2 using a (£15) 5.5mm camera with a built-in light source. Please keep looking where we do not always look.

This AD addresses inspection and replacement of corroded parts, but not prevention the underlying cause. Be advised the hinges under the mylar are also likely to be affected by the same problem.

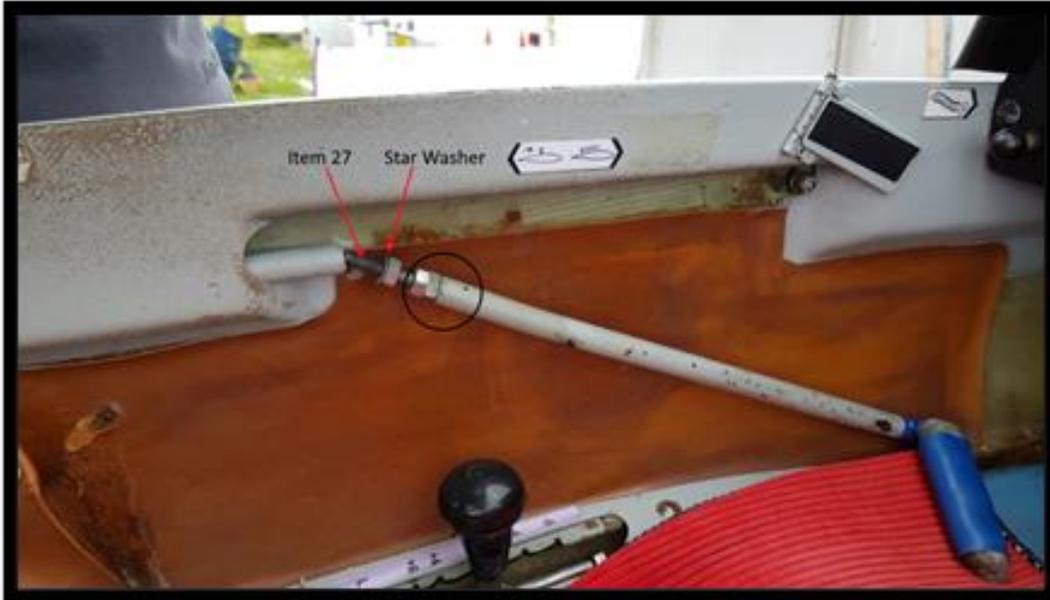
- 15. Nimbus 2 but could be Schemp-Hirth other types**      **Advisory**  
 The airbrake handle became unlocked and unwound itself from the airbrake pushrod (stop nut with start Washer in this case). Luckily this happened on the ground. Please ensure that the handle is locked at every annual. If you find any unlocked, please inform us.

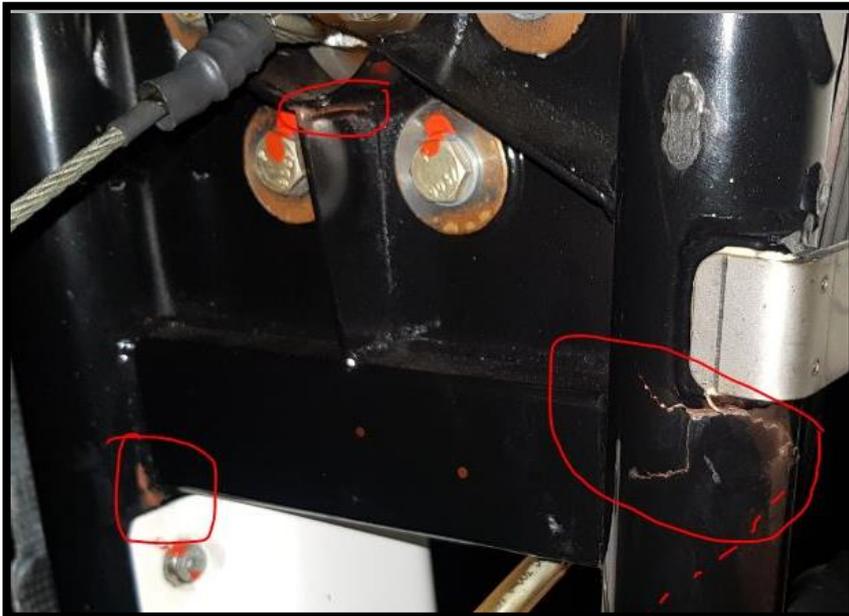
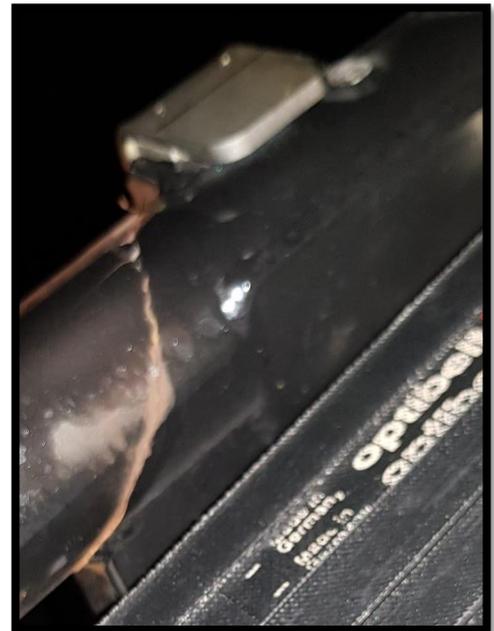
**16. DG 1000M but could apply to all metal engine pylons.**

The technical note is not mandatory but really should be. The Flight Manual suggests the engine pylon is checked daily. But in this case, there are some fairings on the pylon that make a thorough inspection difficult. As you can see there is some rust in the cracks. This is not just a DG issue but can and has happened in most metal pylon type self-launching and sustaining sailplanes. In most cases only repair by replacement is allowed. Please can inspectors, remind owners of the daily inspection recommendation.

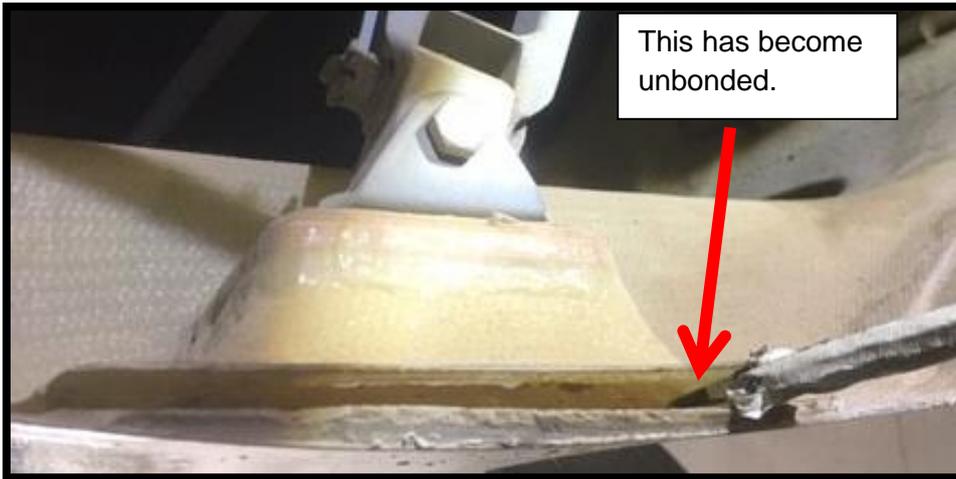
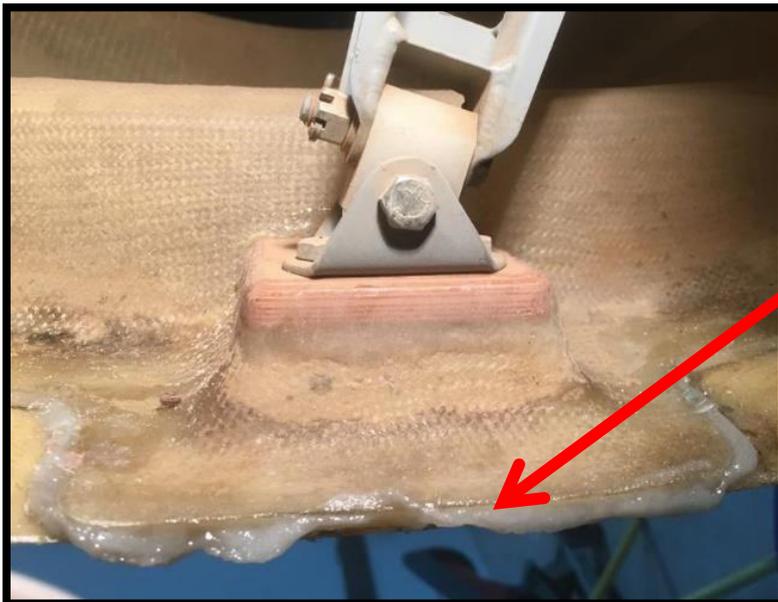
**19. ASK21 Elevator/aileron control rod support frame unbonded**

This delamination was found during an annual inspection. It would have been very easy to miss this. Schliecher have suggested following the details in the above TM17, but Ignore the serial numbers as this glider was out side those. Please inform us if any damage found.

The original joint has been cleaned, dried, degreased, inspected, re abraded and bonded back together. It still needs post curing (55'C for 12 hours) and the excess glue needs trimming on edge of wheel box per the Technical note 17.

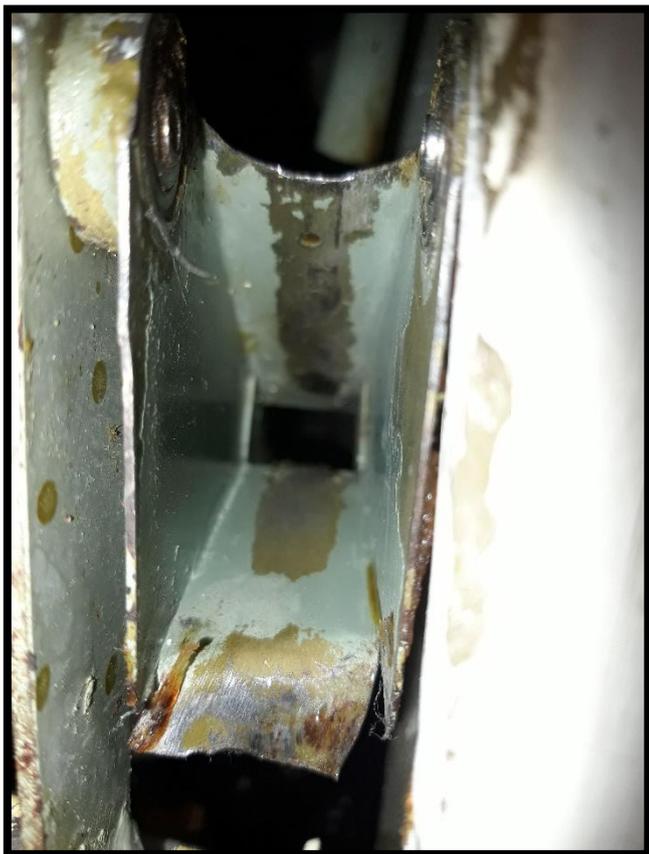
**20. Slingsby T65 Vega Damage to fuselage controls (could apply to other types) Recommended**

This is most likely rigging damage caused by the ailerons and stick not being neutral when inserting the wing into the fuselage. The same could also apply to airbrakes. The bearing of the bell crank bashes the edge of the receiving tunnel and over time it starts to unpeel.

McClean aviation has a few Slingsby spares that would save having to repair them if they are damage.

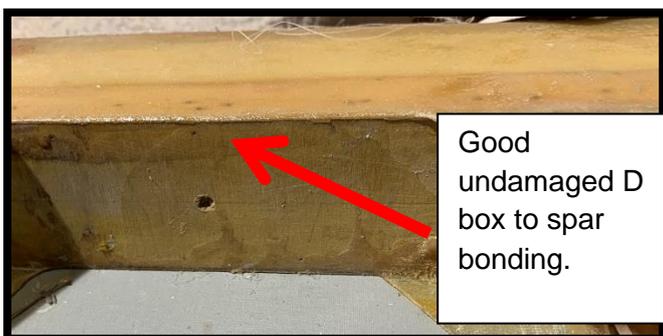
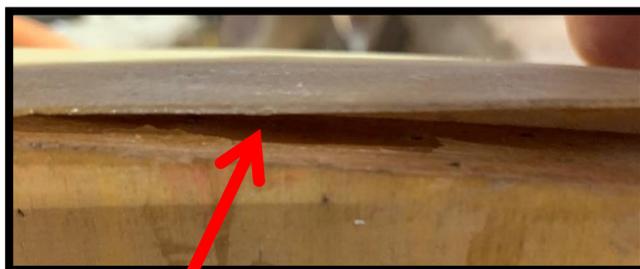
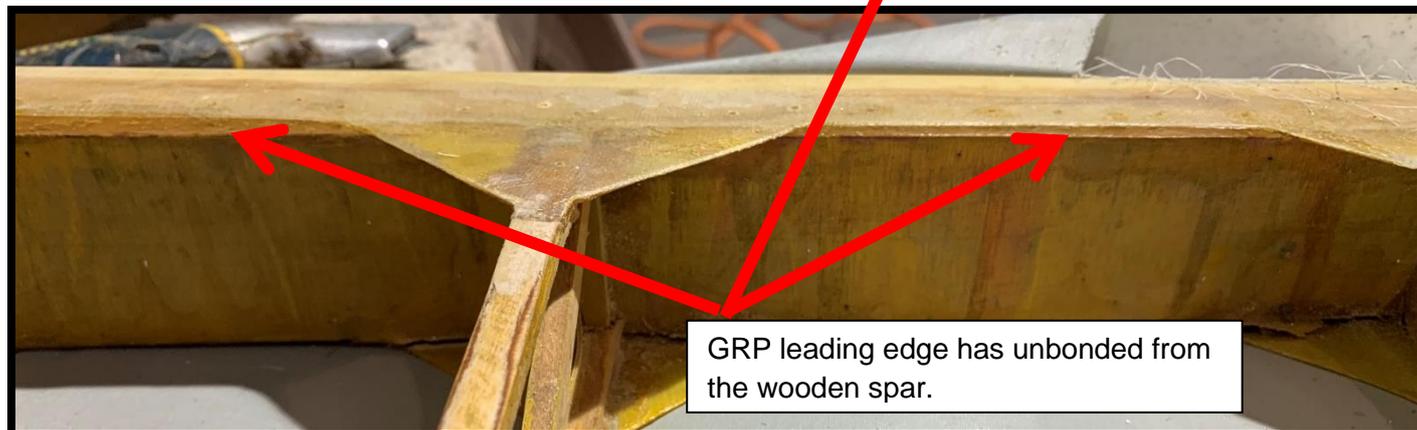
**21. Slingsby T51 Dart Wooden tailplane legacy poor quality repair. Recommended**

This old repair was accomplished by using expanding foam in the GRP leading edge of the tailplane. But as it expanded there was insufficient space and it pushed the skins off the tailplane spar. Years later during a re-cover the damage was found.

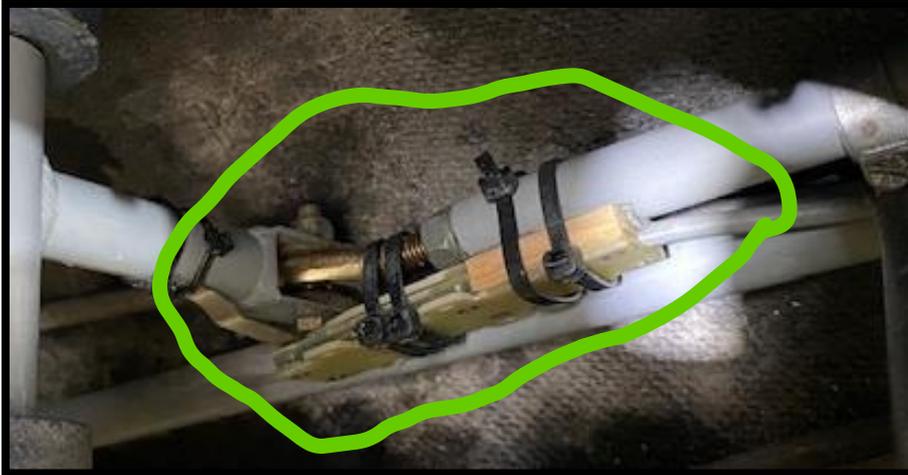
## 22. Fitting switches and attaching hardware to pushrods

This is a flap indicator slider that has been tie wrapped to a pushrod near the joint of the rose bearing. Although this particular installation did not cause a control restriction, more thought must be given to what would happen should on hot day the tie wraps become soft and allow the slider to move, or if the tie wraps become old and brittle. Could this jam the flaps etc? Put simply, it needs to be installed more securely.

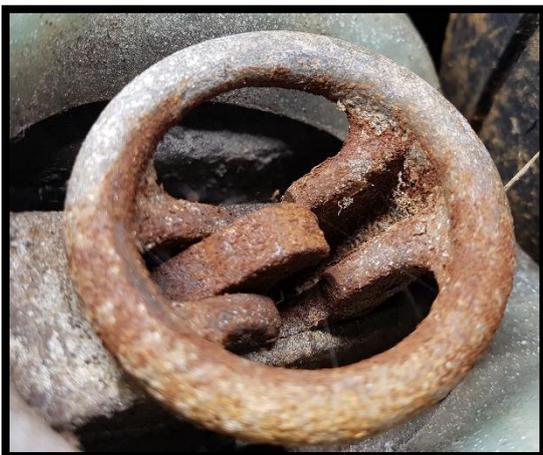
## 23. Hook corrosion caused by pilot relief system

This hook should have been changed before it got this corroded.
