**ACCIDENT**

<b>Aircraft Type and Registration:</b>	Standard Cirrus 75, G-DDGX	
<b>No &amp; Type of Engines:</b>	No engines	
<b>Year of Manufacture:</b>	1975 (Serial no: 619)	
<b>Date &amp; Time (UTC):</b>	27 July 2019 at 1130 hrs	
<b>Location:</b>	Gwernesney Airfield, Monmouthshire	
<b>Type of Flight:</b>	Private	
<b>Persons on Board:</b>	Crew - 1	Passengers - None
<b>Injuries:</b>	Crew - 1 (Fatal)	Passengers - N/A
<b>Nature of Damage:</b>	Aircraft destroyed	
<b>Commander's Licence:</b>	British Gliding Association (BGA) Certificate with B Badge Endorsement	
<b>Commander's Age:</b>	54 years	
<b>Commander's Flying Experience:</b>	Total hours not determined 182 flights totalling 41 hours since August 2015 (of which 2 hours and 20 minutes were on type) Last 90 days - 3 hours and 42 minutes Last 28 days - 1 hour and 38 minutes	
<b>Information Source:</b>	AAIB Field Investigation

**Synopsis**

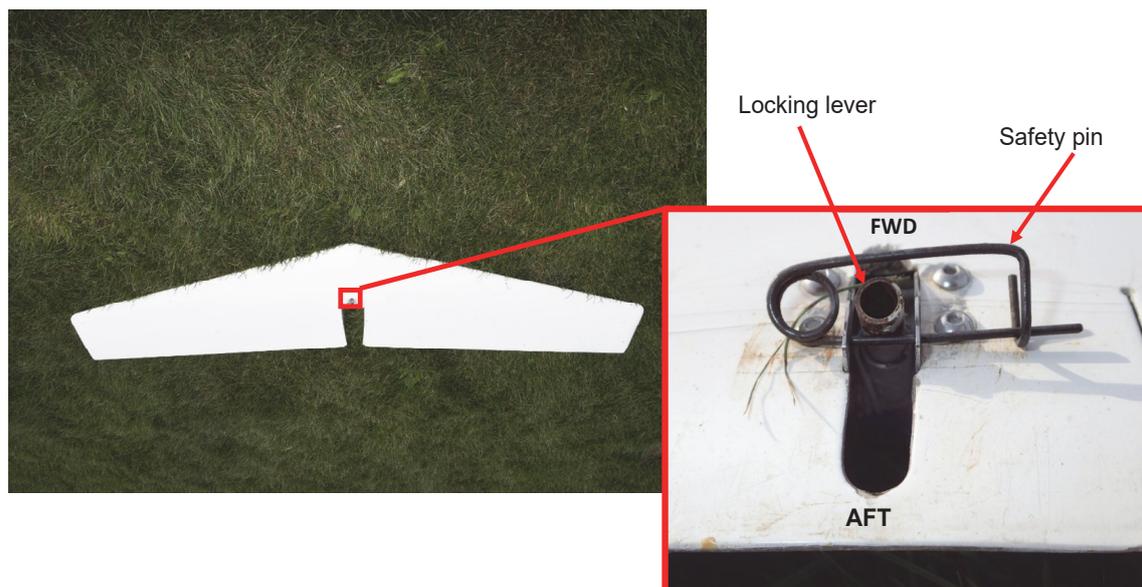
**Figure 3**

The tailplane had come to rest close to the launch point, approximately 237 m from the main wreckage. It was immediately apparent that, although the tailplane safety pin was installed, the tailplane locking lever was forward of, rather than the normal position aft of, the safety pin (Figure 3).

G-DDGX tailplane (as found condition)  
with inset showing locking lever forward of safety pin

The tailplane was undamaged. The locking lever was protruding through the slot in the upper surface of the tailplane and was resting against, and forward of, the safety pin. Upon removal of the safety pin, the locking lever sprang back to its neutral position. The top of the locking lever in the area where it was in contact with the safety pin showed evidence of missing paint and surface corrosion, the extent of which was greater on the rear face of the lever (Figure 9). In normal operation the lever moves freely within the slot and does not come into contact with any other structure.

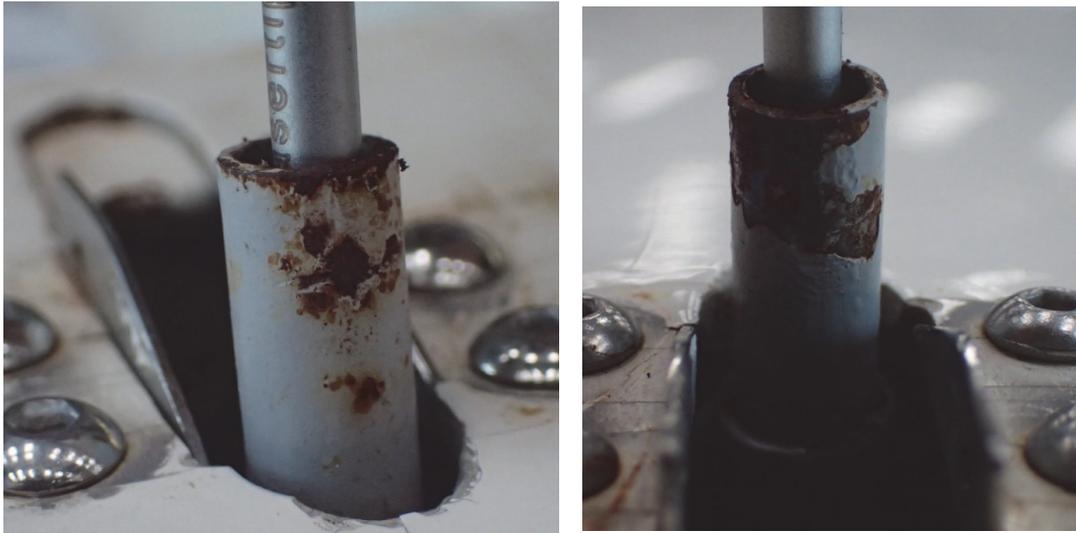
**Figure 9**

Missing paint and surface corrosion on forward face (left image) and rear face (right image) of the locking lever on G-DDGX

Missing paint and the presence of surface corrosion on the rear face of the locking lever may have been incidental or may have been indicative of more frequent contact between the lever and the safety pin.

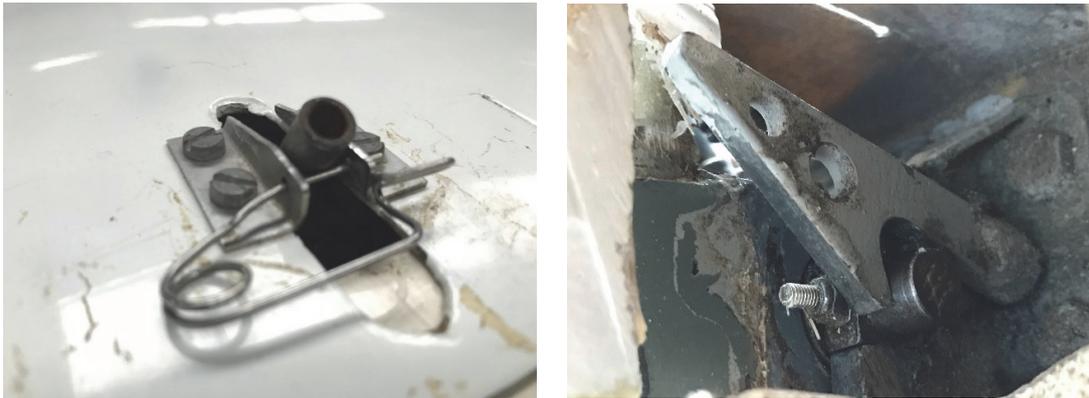
**Figure 11**

If the locking lever was moved forward instead of aft, the safety pin could be inserted behind it and the lever would then spring back to rest against the pin when released. The same condition could be achieved by installing the tailplane in the as-found condition, with the locking lever already resting forward of the safety pin. In both cases this resulted in the rear mechanism being engaged but not locked, as the pin prevented the lever from travelling aft to the fully locked position (Figure 11). In this condition the locking hooks were not fully engaged on the axle but the tailplane felt secure and could not be dislodged.

Position of locking lever and locking hooks with lever forward of safety pin.  
Note: only right hook shown

Regardless of how the locking lever came to be forward of the safety pin, in this condition the lever would rest against the safety pin under spring force, such that the locking hooks would be engaged on the axle of the rear mechanism but not fully locked. Nonetheless, in this condition, it was demonstrated that the locking hooks appeared to provide a reasonable degree of attachment and the tailplane could not be dislodged. Although an undesirable condition, with a correctly engaged front fitting, this condition alone may not have accounted for the separation of the tailplane.

It is recommended that the European Union Aviation Safety Agency require a means to detect incorrect alignment of the tailplane locking lever on gliders with locking features similar to the Standard Cirrus 75.

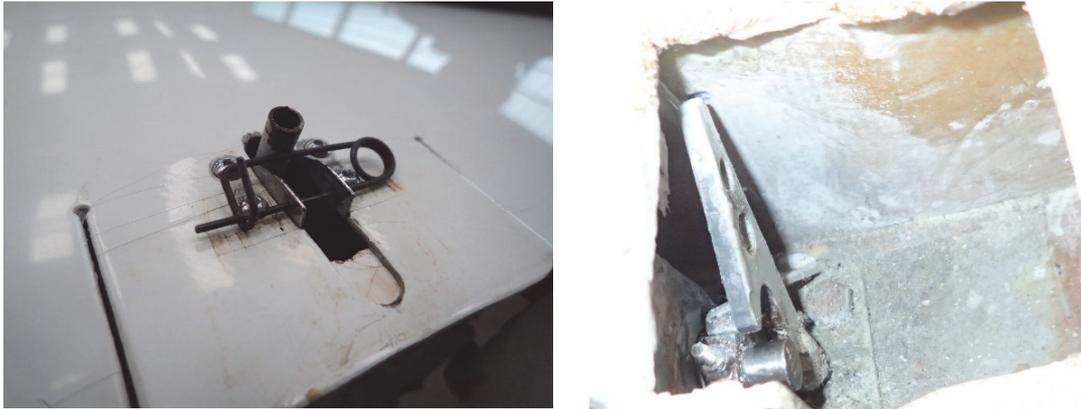
**Figure 12**

With the lever forward of the safety pin, it was possible to fold the safety pin forward such that the locking lever rested against the 'free' unrestrained arm of the safety pin (Figure 12). The lever was in a forward position and the locking hooks were not engaged on the axle, with the effect that the rear mechanism was entirely unlocked and the tailplane could easily separate from the fin. In this condition, the position of the unrestrained arm of the pin was somewhat tenuous as the spring force of the lever was acting to push it out of the way. It was demonstrated that movement or light force could cause the unrestrained arm of the pin to be dislodged, such that the lever sprung back against the restrained arm of the pin. Nonetheless a positive control check could be conducted without revealing any anomalies.

Position of locking lever and locking hooks when safety pin folded forward.  
Note: only right hook shown

It was demonstrated that the locking lever could remain in a forward position, either in isolation or because the safety pin was folded forward. In this condition the locking hooks were not engaged on the axle, and thus the rear mechanism was entirely unlocked.

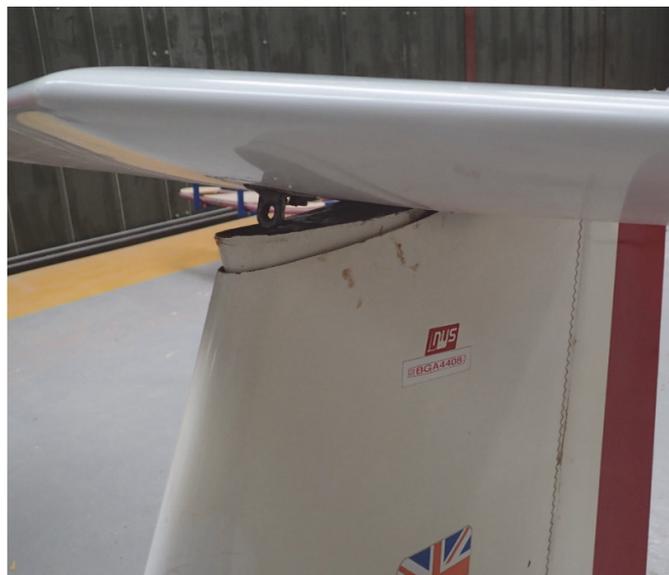
**Figure 13**

If the tailplane was offered up to the fin in a trailing-edge down orientation, it was possible to achieve full engagement of the locking hooks on the axle and move the lever aft to the fully locked position, while the tapered bolt was not engaged in the lug of the front fitting. If the locking lever was already resting forward of the safety pin when this was done, it was possible to achieve a condition where the rear mechanism was engaged but not locked (as previously described) and the front fitting was entirely disengaged. In both cases a large gap was present between the leading edge of the tailplane and the moveable fairing, where it was visually evident that the tapered bolt was not engaged in the front fitting (Figure 13). These two scenarios were demonstrated on the comparison glider but could not be replicated on G-DDGX.

Rear tailplane mechanism partially engaged, front fitting disengaged

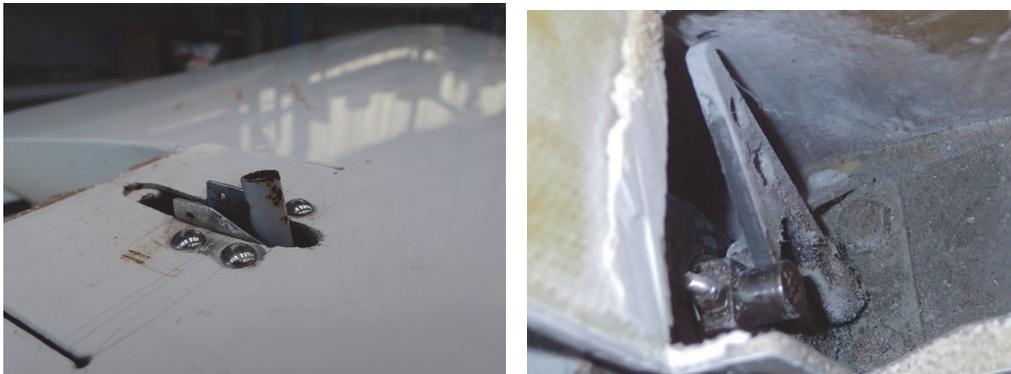
**Figure 14**

However, it was possible on G-DDGX to achieve a condition where the locking lever was in the fully forward position and the tapered bolt was only partially engaged in the front fitting (Figure 14). In this condition neither the rear mechanism nor the front fitting were properly

Position of locking lever and locking hooks when lever in fully forward position (safety pin not shown) and forward fitting partially engaged.  
Note: only right hook shown

Rigging trials also demonstrated that it was possible to achieve partial engagement of the rear mechanism (locking lever forward of safety pin), while the tapered bolt was entirely disengaged from the front fitting. Although visually identifiable due to a large gap between the tailplane and moveable fairing, in this condition it is possible the tailplane could pivot upwards, applying spring force to open the locking lever and hooks.

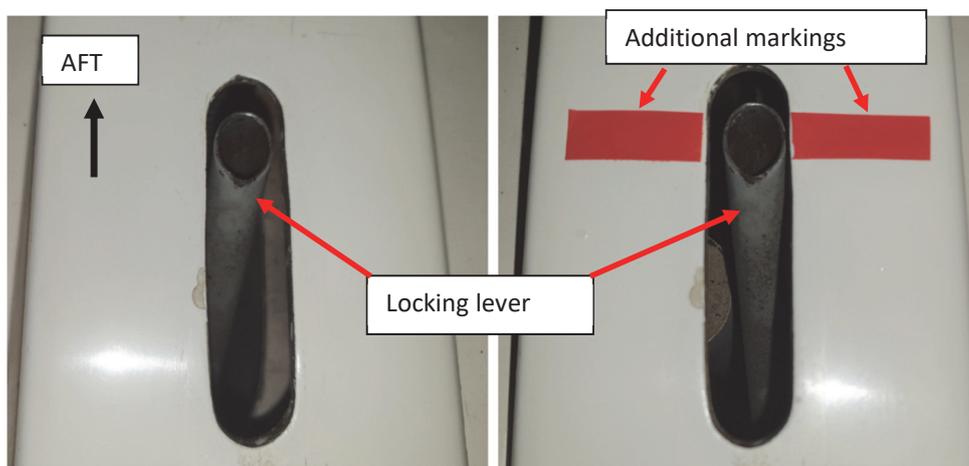
**Figure 16**

Standard Cirrus tailplane (original T-fitting elevator connection) with and without (left) locally-applied indicator for correct locking lever alignment

Following this accident, for gliders with similar tailplane locking features to that of the Standard Cirrus 75, the gliding club introduced tell-tale markings to show the approximate required position of the locking lever and make it easier to detect incorrect alignment. The EASA recommended that such markings indicating the correct position for locking levers should be green in colour. Similar tailplane attachment mechanisms are known to be used on other types of glider and therefore, the following Safety Recommendation is made:
