## Airworthiness Directives (ADs)

## Reported issues

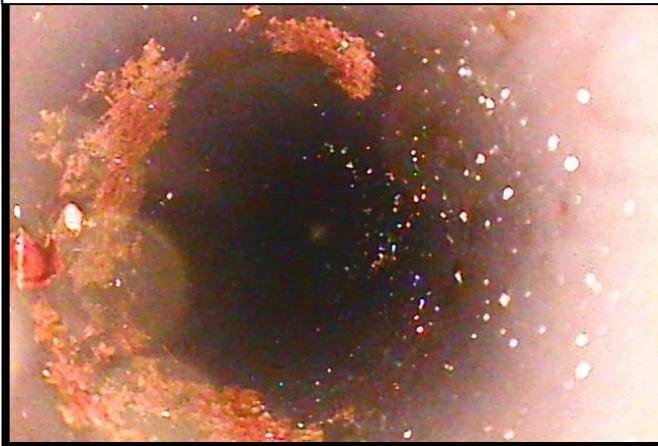
Note this AD states, '*If possible, the first 100 mm of the inside of the pushrod behind the control hole should be inspected for corrosion with an endoscope.*' This implies that using an endoscope is not mandatory. A 5.5mm endoscope that WiFi's to your phone goes in the 6mm a drain hole in the pushrod (costs around £25 from Ebay/Amazon).

This pushrod passed the inspection as per the AD, but upon putting an endoscope inside showed that it was corroded. On contacting the TC holder (Lindner LTB), they decided this Pushrod must be changed. We strongly recommended that the pushrod is inspected with an endoscope as recommended by the AD.

Corrosion spots in the pushrod. Lindner said replace it despite passing the AD test.

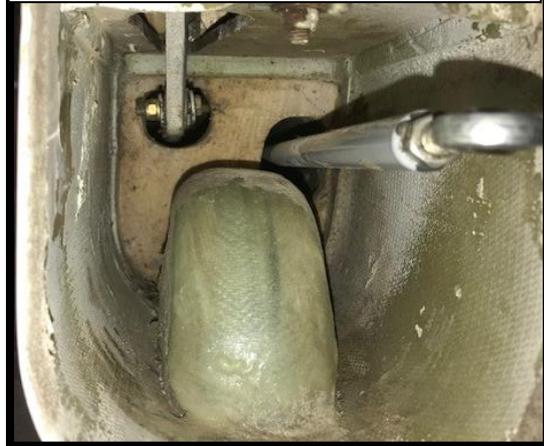
Also be careful the that reversing the bolts that connect the pushrod to the bell crank have lots of clearance as a few have been assemble with the bolts reversed and then restricted movement.

Be careful of reversed elevator system bolts causing a restriction

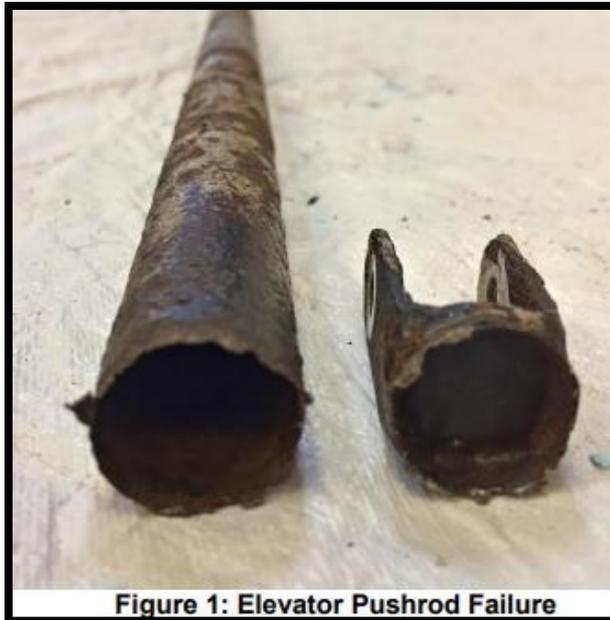
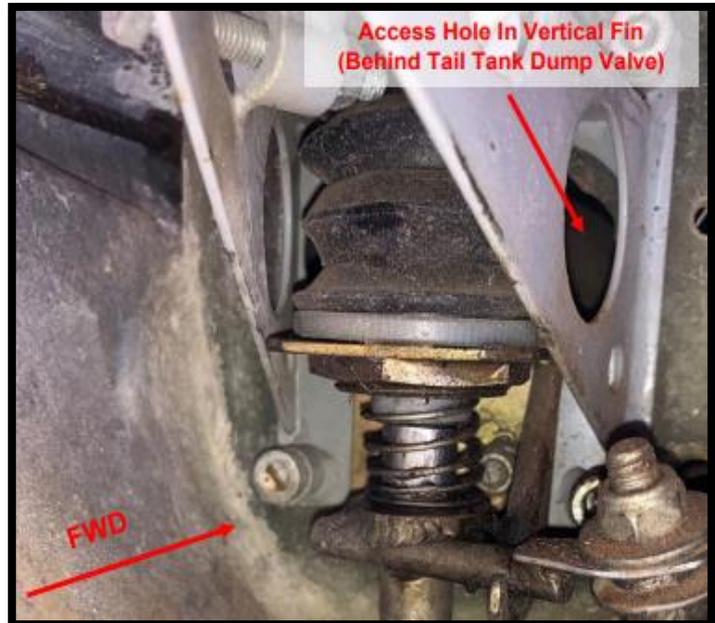
Figure 1: Elevator Pushrod Failure

This is from the Gliding Federation of Australia and is not mandatory in UK. This highlights an issue that we have seen many times before, where release hooks and U/C assemblies have suffered heavy corrosion due to urine contamination. Based on the recent Ventus 2 AD where water ballast is sucked into the wing that caused extreme corrosion, it may be that other parts of many gliders could have the same issue.

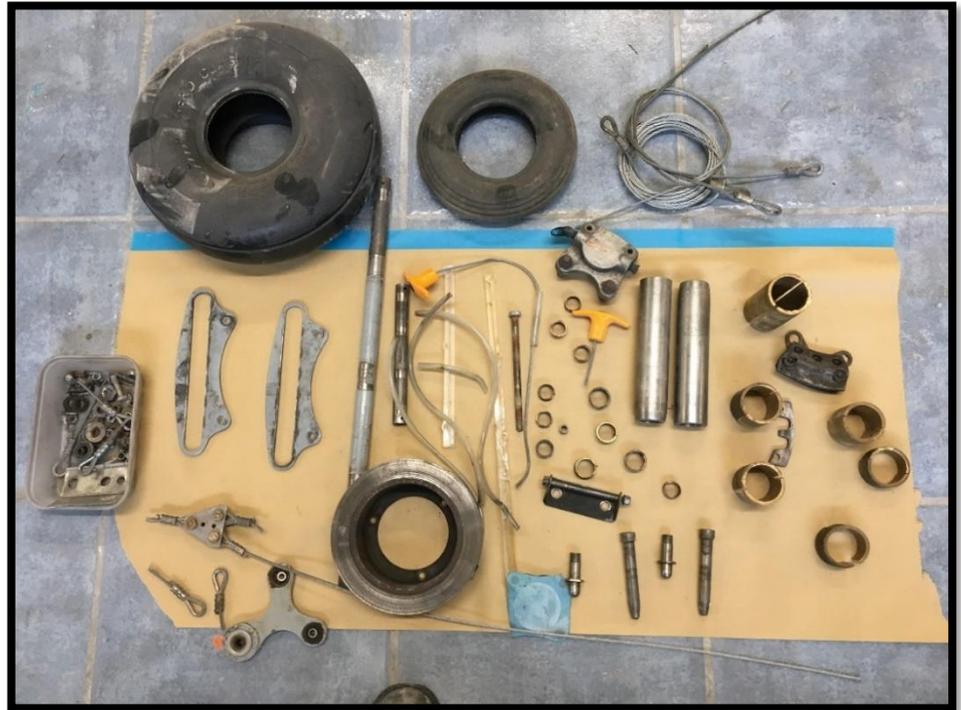
applies to all types, but particularly K21 with lots of launches and landings. All intermediate 3000 hours inspections are not just inspections. There is usually a requirement for some new parts, oversize pins, new bearings, new cables, new bushes, control mass balance plus a mandatory thorough look inside the normally sealed parts of the airframe. Either by cutting holes or nowadays by camera.

Please look at the old parts in the picture that were replaced during a K21 intermediate 3000 hour inspection.

Note the rubber suspension donuts are not shown in the picture, but usually need changing too.

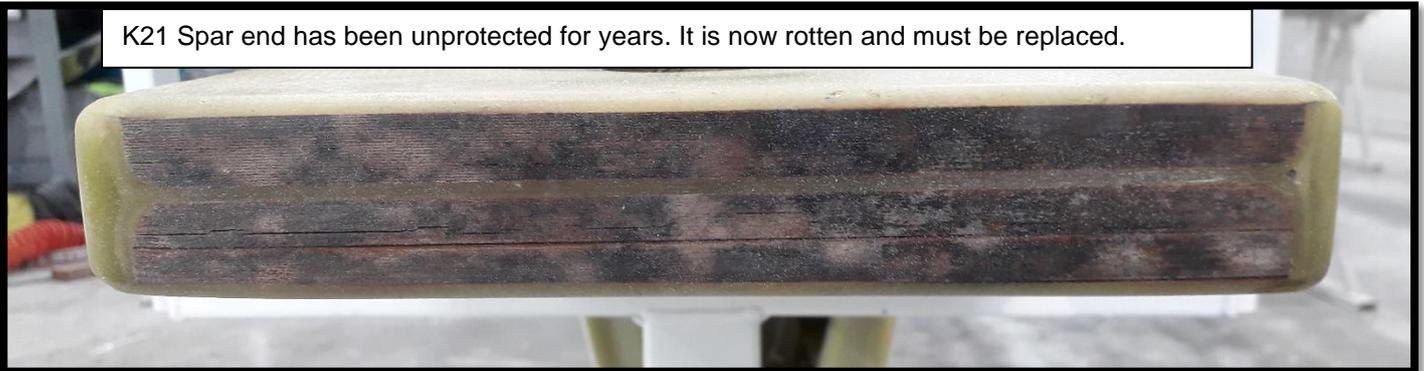
K21 Spar end has been unprotected for years. It is now rotten and must be replaced.

The end grain of the wooden spar web was totally unprotected and porous. This could and should have been spotted on many previous annual inspections before it went rotten. It was expanding due to moisture ingress and was now a little wider than the spar bush.

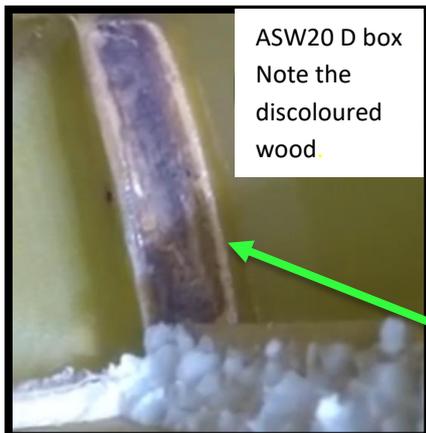
ASW20 D box  
Note the  
discoloured  
wood.

This is a picture inside an ASW20 wing D box while a water bag was being changed. Note the discolouration. In this situation Schleicher should be consulted for advice before next flight.

This could have been prevented with some dehumidifying, some keying up of the end grain and resin painting on the end. But because it was not spotted in time, this required an expensive factory approved repair scheme (it was close to writing the wing off because it was built with an obsolete resin) and some very skilled work to replace the spar web wood and new spar wrap without disturbing the GRP Spar cap or web or running through the middle of the wood.

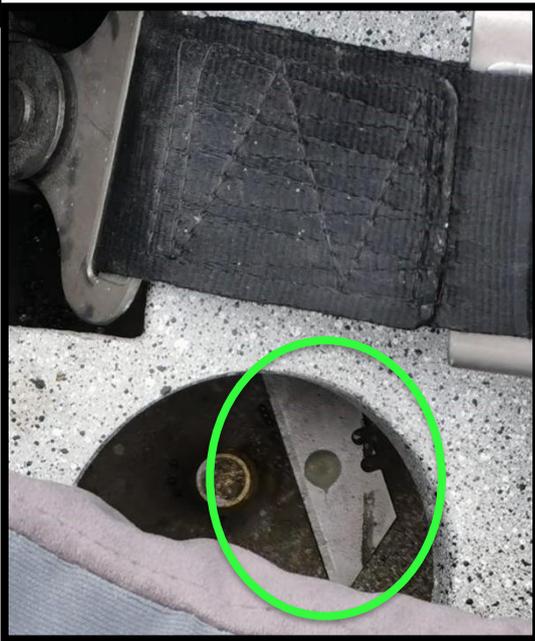
Knife blade under seat of Puchacz

With about 2500 aircraft and aeroplanes in the BGA CAMO, the issue of tool control can never be relaxed. Have a system in place for checking after every job.

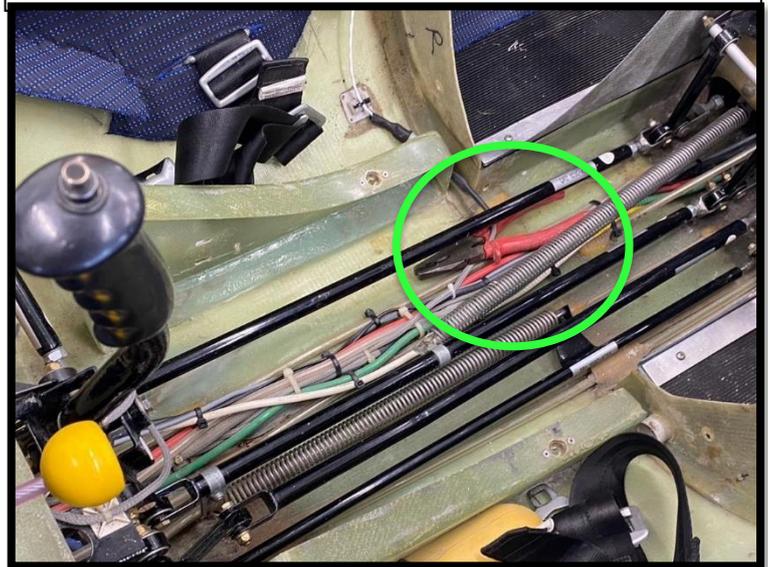
Pliers with handles the same colour as some of the Grob 103 tubes. It cannot be proven, but it is possible these were left in this glider by a foreign CAMO after a refinish.

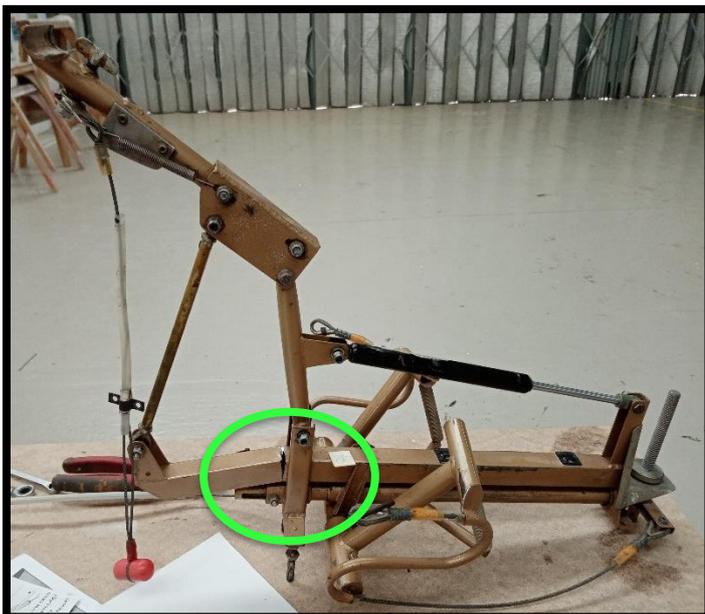
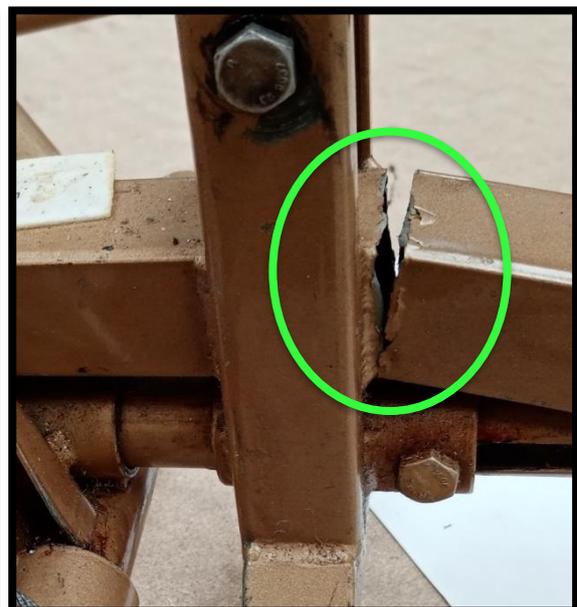
This 38 year old LS4 suffered what appears to be a fatigue failure (see images below). This subsequently resulted in the top of the instrument panel being forced down and bending it and damaging the vario. Please check during annual maintenance and advise the BGA if any problems are found.

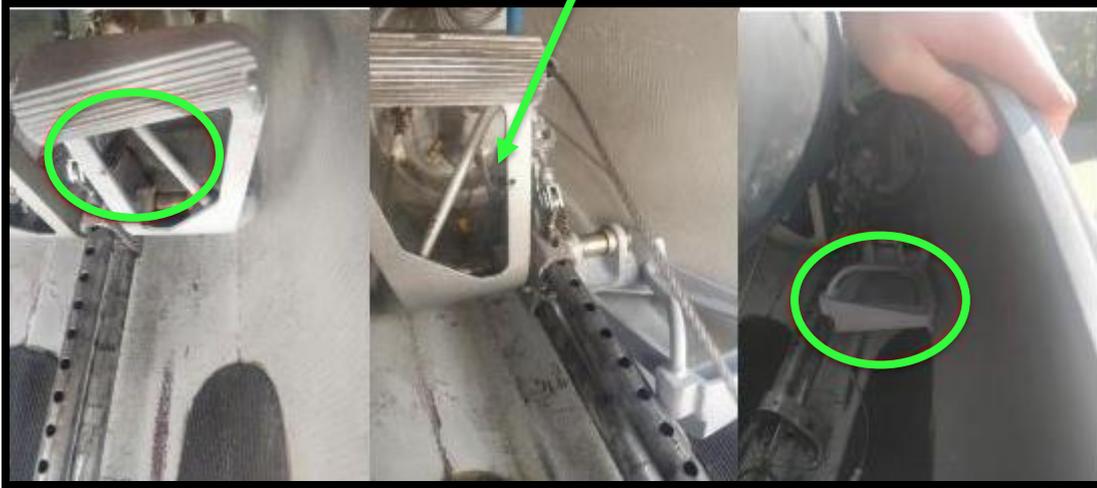
Please see image below of a failed Astir rudder pedal return spring (right picture) which should prevent the pedal from folding down. A lot of these springs are now 40 plus years old and becoming fatigued. Consider replacing them before they break.

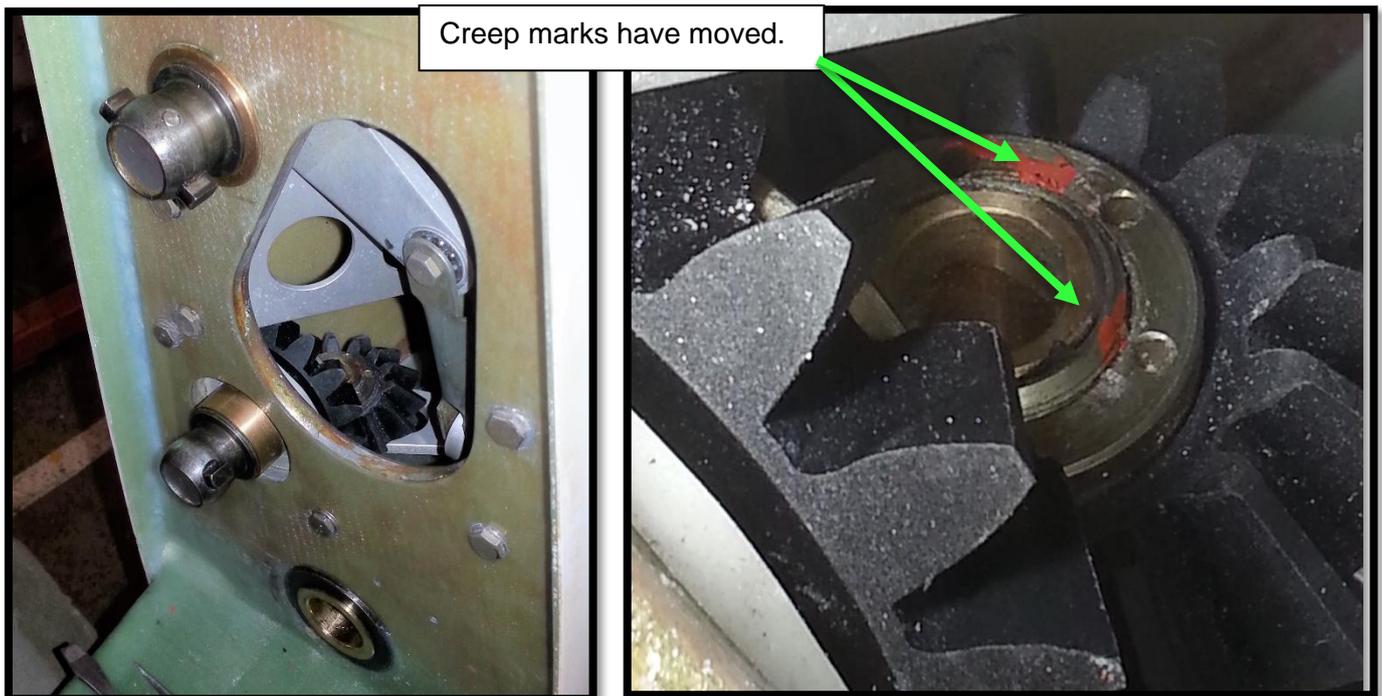
On annual inspection on the port wing it was found that the locking ring on one of the airbrake bevel gears was loose. The creep marks indicate that the ring has turned. The corresponding locking ring on the other wing seems to be loose but has not actually turned on its thread. Allstar say it cannot fall off. If found, contact Allstar for advice

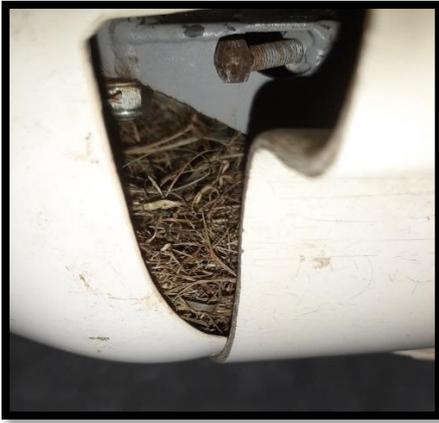
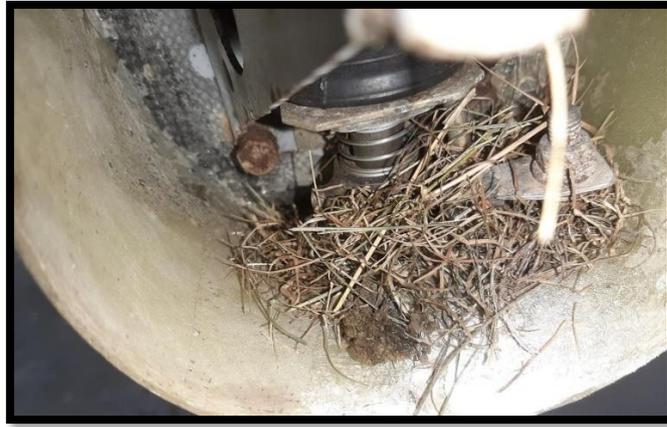
This looks like a mouse nest. I am not sure a pilot would spot this on a DI

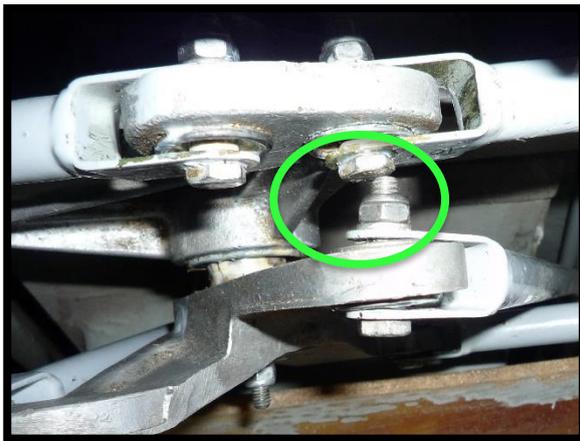
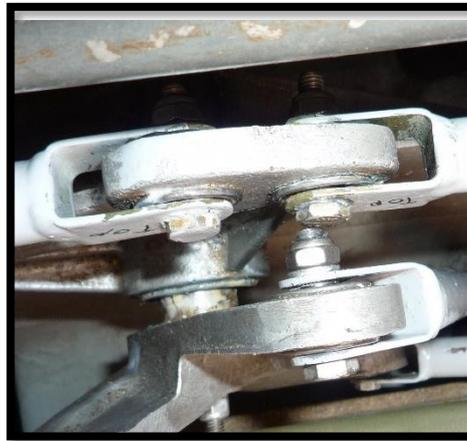
**22. Astir but applies to many others. Interference caused by too long bolt.**

Sometimes what seems like a common-sense solution of using a new bolt that is fractionally longer than the original seems ok. But it can cause problems. Please ensure all replacements are the same size and orientation as the original.

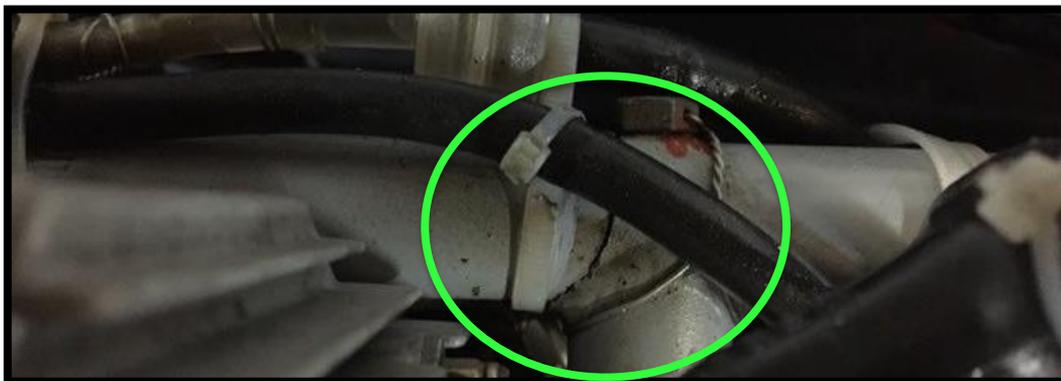
**24 Ventus Engine Pylon cracks but applies to metal pylons**

The flight manual says check this every single flight. Cracks/splits are quite common. Please show owners how to find this.
