ACCIDENT

Aircraft Type and Registration:	Scheibe Super Falke SF25E, G-KDEY
No & Type of Engines:	1 Limbach SL 1700-EA1 piston engine
Year of Manufacture:	1976 (Serial no: 4325)
Date & Time (UTC):	23 March 2020 at 1651 hrs
Location:	Aston Down Airfield, Gloucestershire
Type of Flight:	Private
Persons on Board:	Crew - 1 Passengers - None
Injuries:	Crew - 1 (Serious) Passengers - N/A
Nature of Damage:	Destroyed
Commander's Licence:	Private Pilot's Licence
Commander's Age:	72 years
Commander's Flying Experience:	3,446 hours (of which 344 were on type) Last 90 days - 1 hour Last 28 days - 1 hour
Information Source:	AAIB Field Investigation

Synopsis

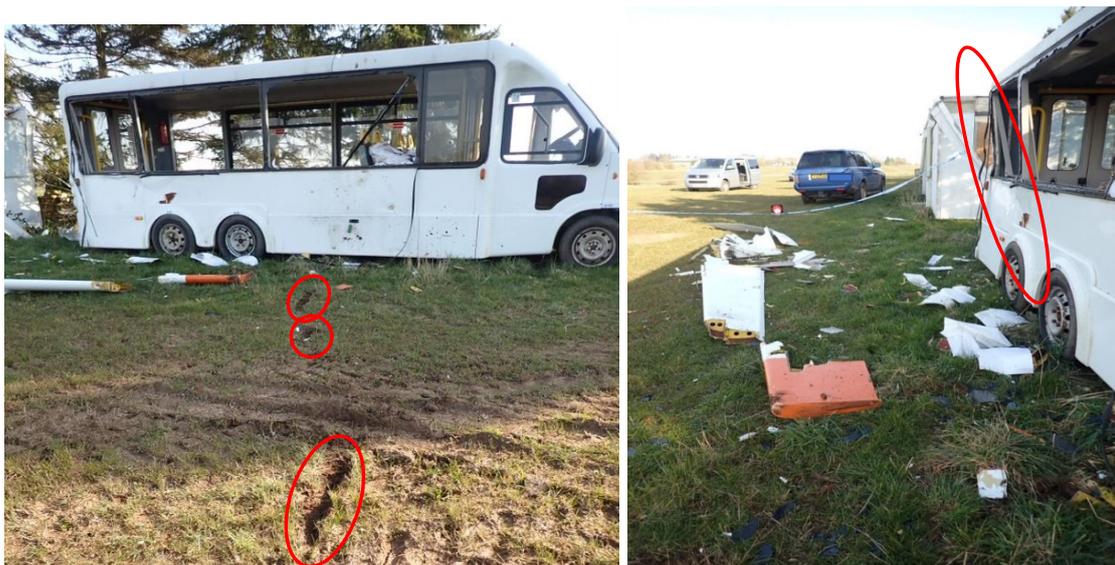
Figure 2

From the ground marks it was evident the aircraft was heading east towards the airfield at the time of the accident. The first impact marks were made by the right wing tip, which touched the ground three times before the leading edge of the wing hit a small bus parked along the treeline of the west field (Figure 2).

Ground impact marks, detached right wing and impact angle on the bus

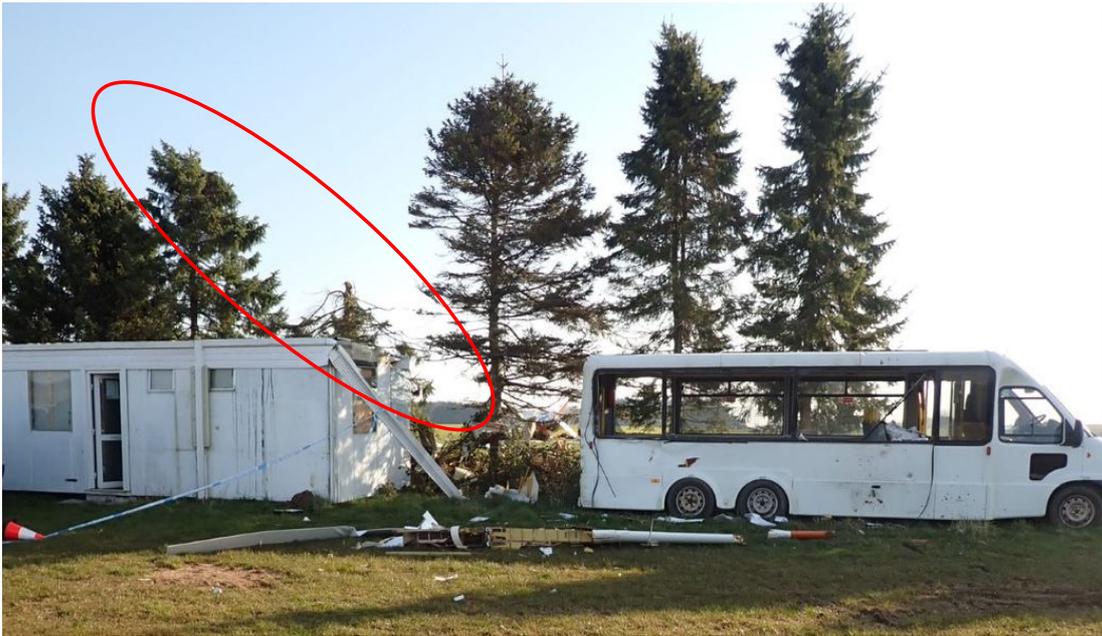
Figure 3

Damage to the cabin roof and the angle sliced through the tree line

The fuselage bounced off the top right side corner of the building's roof and continued into the treeline. The left wing and fuselage sliced through the trees (Figure 3) before hitting the east field at a shallow angle.

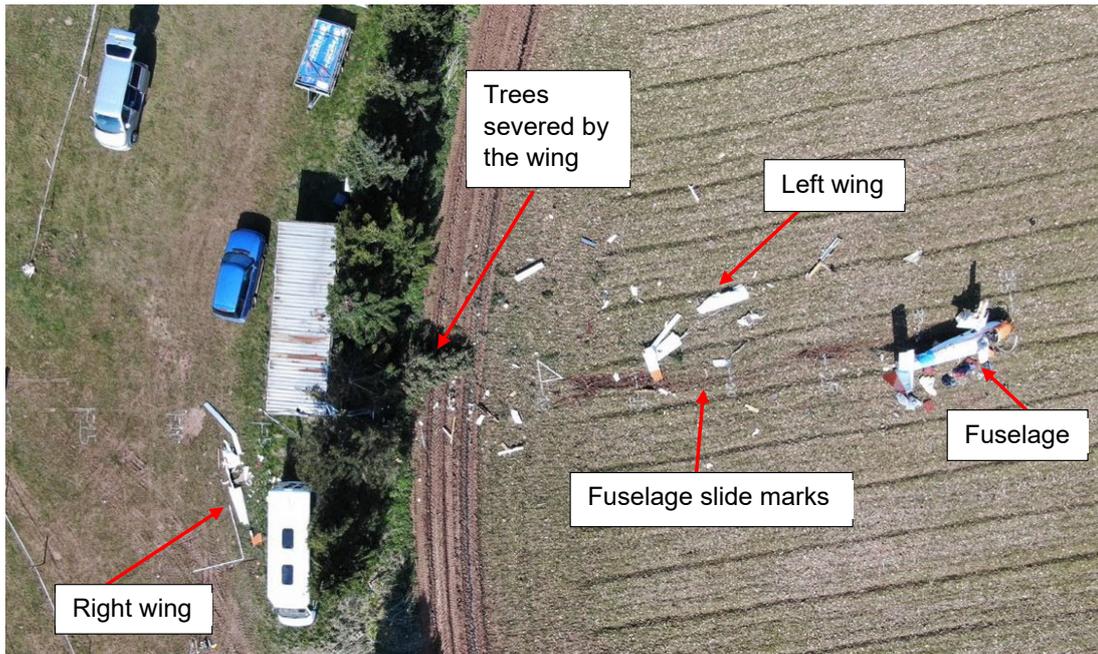
Figure 4

The remaining wing detached and landed to the left of the aircraft's path. The fuselage continued sliding along the ground before finally stopping in a slightly right nose down attitude pointing towards the airfield (Figure 4). One of the propeller blades broke away from the hub between hitting the trees and the ground in the east field and the remains were found under the left wing.

Overhead view of the final positions of the fuselage and wings

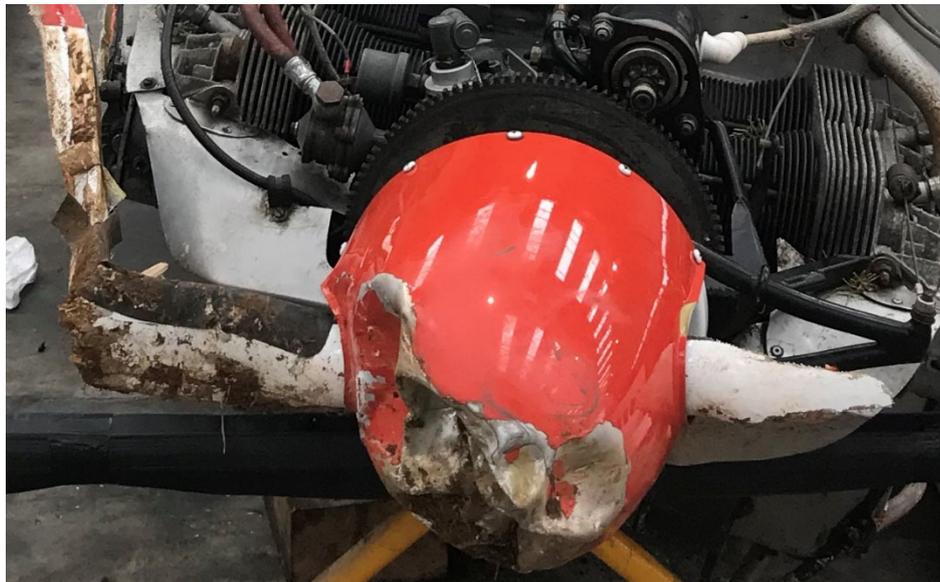
Figure 5

The propeller's spinner had large impact dents but there were no radial score marks to indicate the propeller was rotating under power when it hit the ground (Figure 5). The tail and fuselage behind the cockpit were largely intact, with minor damage to the leading edges of the fin and left tailplane.

Remains of the propeller blades and the dented spinner

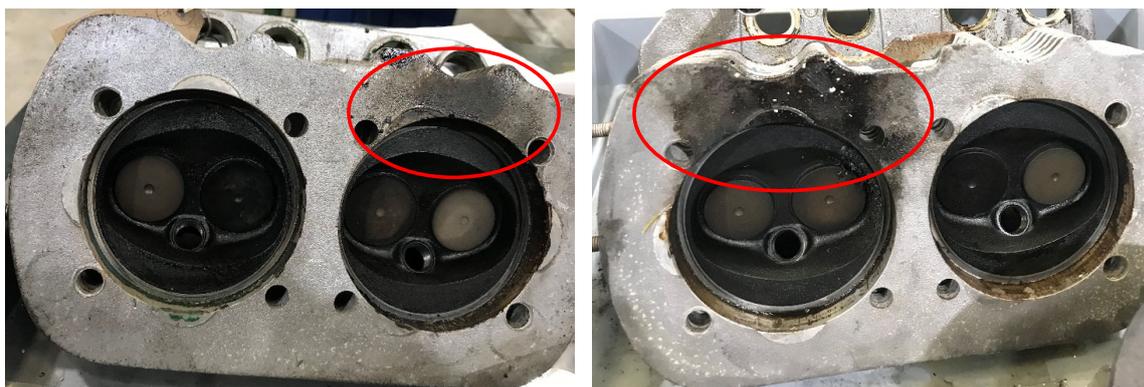
Figure 7

No 3 and 4 cylinder heads showing signs of staining

The engine manufacturer stated that the staining visible on the cylinder heads was condensation mixed with soot and may contain traces of fuel and oil. On engines that have been overheated, a slight deformation of the cylinders and cylinder heads occurs as operating time increases. For the Limbach 1700 engine, deformation only occurs at the cylinder head and the cylinders are made of grey cast iron. This means that during cold

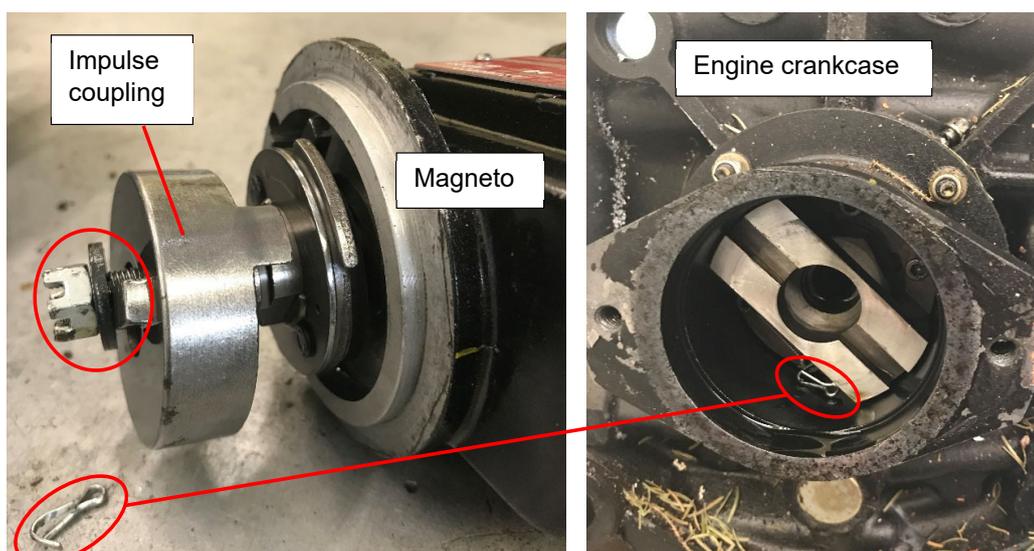
Figure 8

While the ignition system was being removed from the engine, the castellated nut and washer holding the magneto's impulse coupling onto the drive shaft was found to be held on only by the last few threads of the shaft. The split-pin that should have prevented the nut and washer from unwinding was found in the engine's magneto housing with one leg bent and the other leg broken in half (Figure 8). The magneto had been overhauled in 2017.

Magneto impulse coupling, nut, washer, split-pin and engine magneto housing

The magneto impulse coupling securing-nut and washer were found partially unwound but still on the shaft, and the split pin not fitted. It is likely the nut and washer would have unwound completely in time, although the magneto's impulse coupling would not have disconnected from the magneto. This did not contribute to the accident.

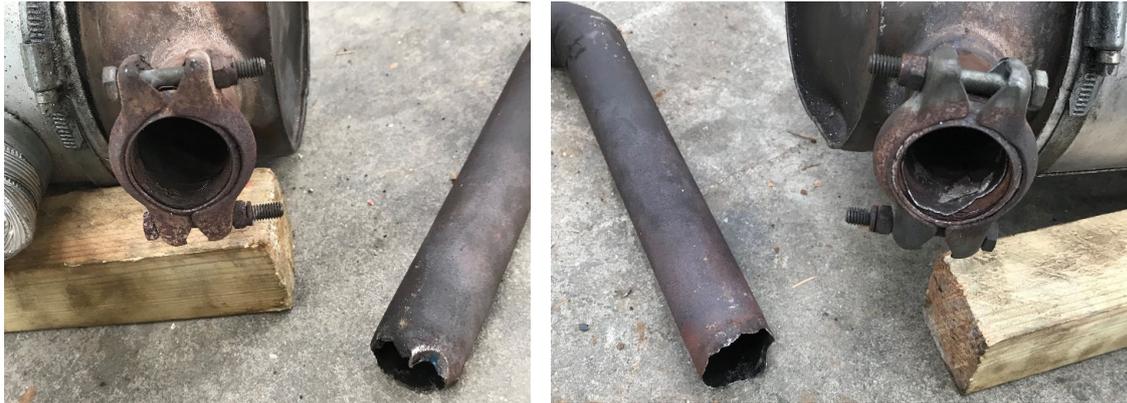
**Figure 9**

On dismantling the remaining exhaust system, the down pipes from No 1 and 2 cylinders were easily removed by hand from the silencer despite their securing clamps and sealing rings remaining in place. Visual examination revealed the ends of both pipes had corroded and fractured completely around their diameter. The detached ends of the pipes were still fitted in the silencer. The jagged edge of No 1 cylinder's down pipe had bent inwards as the pipe was pushed further into the silencer during the accident (Figure 9). The two exhaust down pipes from No 3 and 4 cylinders were removed and visually inspected but only minor surface corrosion was evident.

Forensic analysis found that although the exhaust down pipe from No 2 cylinder was corroded and the wall thickness had reduced, it had fractured during ground impact. The down pipe from No 1 cylinder was severely corroded and forensic analysis found that it had already failed some time before the accident. Both the pipe and its sealing ring showed traces of exhaust gas leakage. The evidence was very difficult to detect visually with the exhaust still fitted to the engine and in the engine bay. The signs of leakage were not easily discernable even with the system dismantled and required forensic examination to confirm that leaks had occurred.

No 1 and 2 cylinders' exhaust down pipes and silencer pipes showing failures

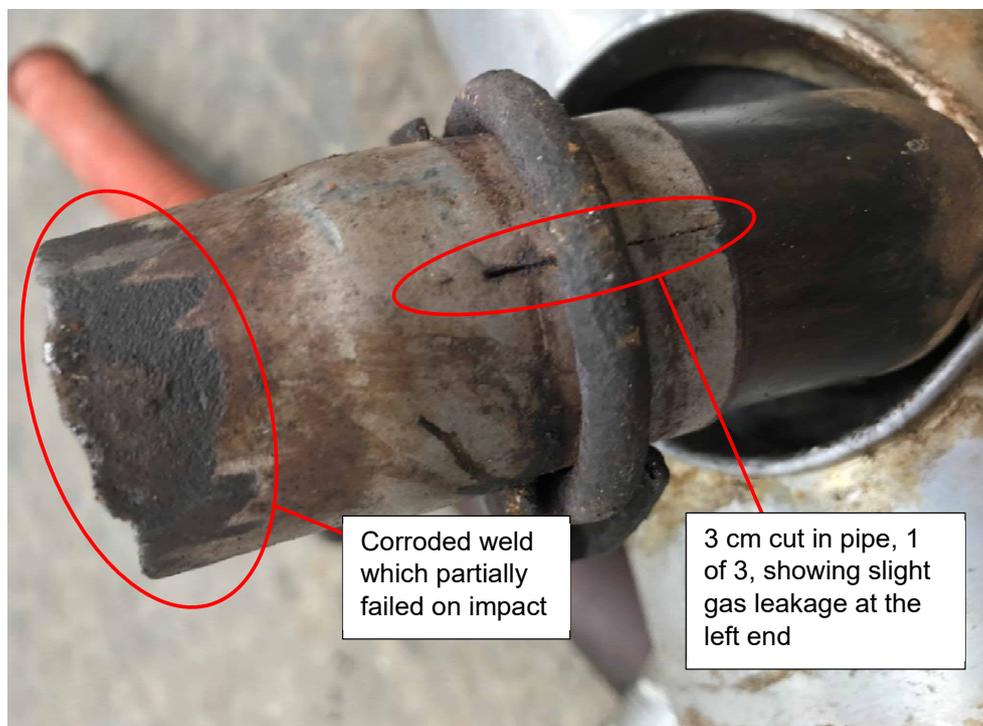
**Figure 10**

Whilst the partial failure of the exhaust tail pipe at the weld was due to ground impact, there was evidence that gas leakage had also occurred at the connection of the tail pipe to the silencer. The tail pipe had three, 3 cm cuts along the length of the pipe from the end to enable it to expand to fit over the silencer connection. A clamp was placed over the cut end of the pipe to secure it in place. As the pipe had not been fully pushed over the connection, the cuts were not completely blanketed by the silencer pipe, which allowed gas to escape when the engine was running (Figure 10). The aircraft manufacturer stated that the tail pipe fitted was not an approved design.

Partially fractured tail pipe attached to the silencer

EASA Safety Information Bulletin 2010-19⁴ (EASA SIB 2010-19) was issued following reports of numerous events resulting from failed exhaust system components on piston engine aircraft and helicopters. In most cases, the causes of the events were CO poisoning, partial or complete loss of engine power, fire or a combination of these. Standard maintenance manuals or procedures do not always contain adequate inspection procedures for exhaust systems. The bulletin stresses the importance of properly inspecting and maintaining exhaust system components to reduce the hazards associated with their failure.

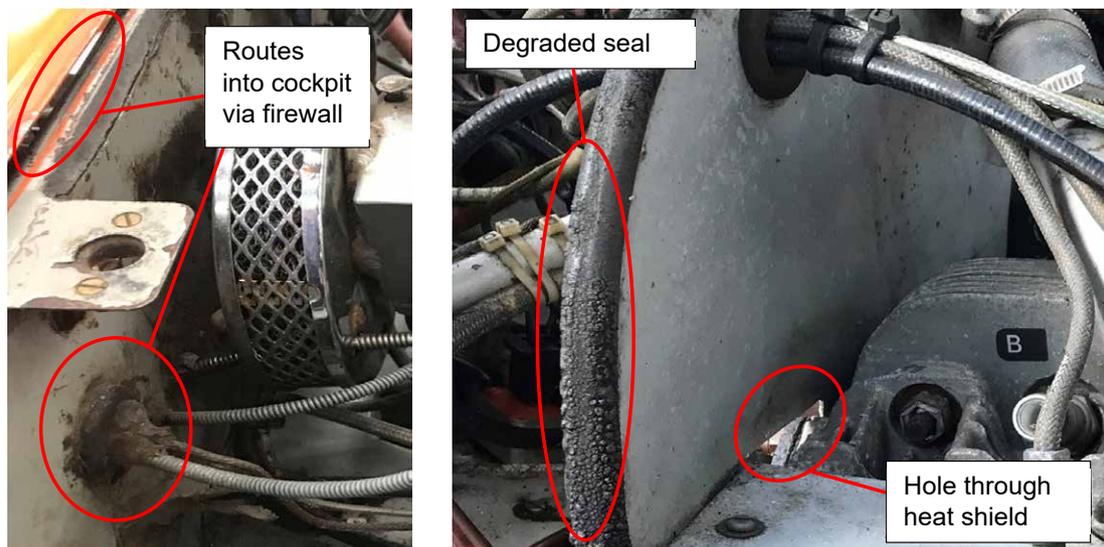
Figure 11

During engine removal, it was evident that the seals and grommets used in the engine firewall to protect the cockpit from engine bay gases had deteriorated and perished. It was likely that gases in the engine compartment could flow into the cockpit through the firewall (Figure 11).

Exhaust gas routes into the cockpit through bulkheads and firewalls

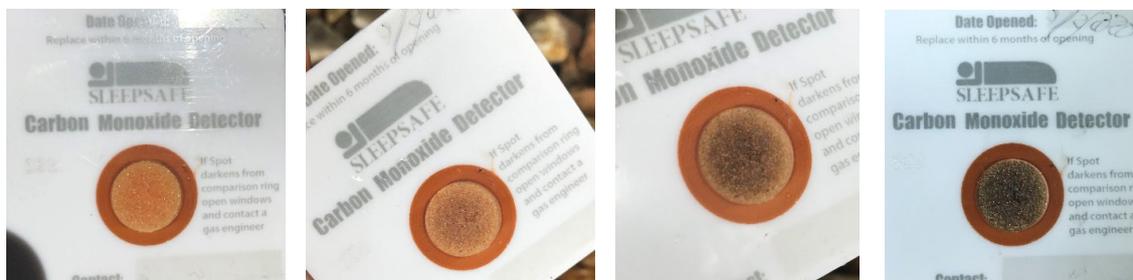
Figure 13

A CO spot detector was fitted to the centre of G-KDEY's instrument panel to warn the pilot if CO entered the cockpit. The detector's tan coloured spot turns black in the presence of CO. It was purchased from a non-aviation specific store in February 2020. The detector was removed and placed in front of a petrol mower exhaust to check its operation. The spot had to be held directly in the exhaust flow for 4 to 5 minutes before it started to discolour and approximately 7 minutes to turn it black (Figure 13). After an hour in fresh air, the spot reverted to its original colour.

Spot detector colour change when exposed to CO
