Airworthiness Directives post Brexit (from 1st January 2021)

CAA Airworthiness Directives (ADs)

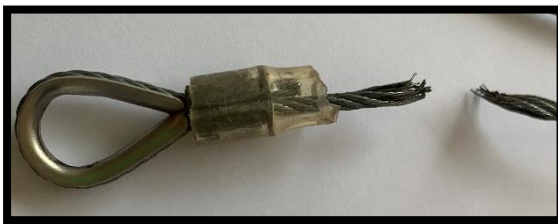
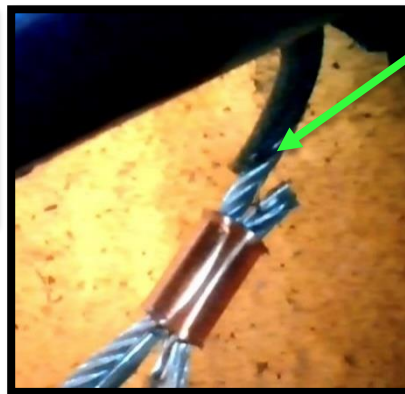
7 All Libelle and Kestrel 401 LBA AD 74-323/2

[TN201-6.pdf \(streifly.de\)](#) This is not a new AD (it was issued in 1971) but we are highlighting it to ensure it is complied with correctly, as there has been some confusion with it. The AD says inspect S bends every 100 hours. But the nature of the failure you are looking for is not always a conventionally frayed cable.

If the rudder pedals are flown mostly in the fully forward position, the end of the S bend is very near the front rudder cable end crimp. Every time it moves there is little space for flexing and puts a point load on the rudder cable as it exits the S bend. This was known about in 1971 and hence the AD for 100 inspections. But the AD does not convey the nature of the problem well.

In addition, some crimps have tubing put over them to stop the sharp ends of the cable snagging on shoes etc.

This makes the fatigue failure harder to spot. This repeat AD should be in the SDMP as an annual and 100hour AD.

S bend to crimp is a very short distance. The Fatigue happens where the S bend ends.

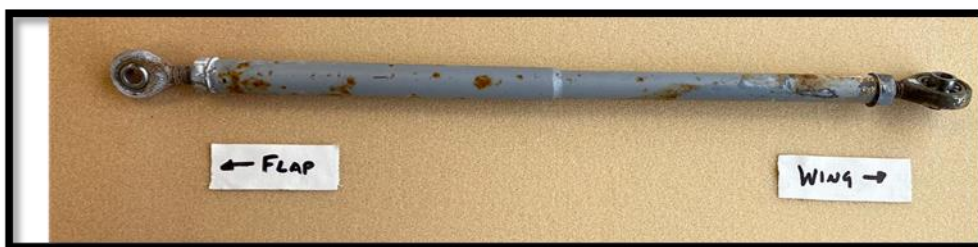
16 Duo Discus XLT Could apply to many other types

See image of corroded pushrods. Would you all spot this on an annual inspection? With modern cheap 5.5mm wide cameras this is quite easy to find on annual inspections. This is a 2008 glider, do not assume newer gliders cannot have these problems.

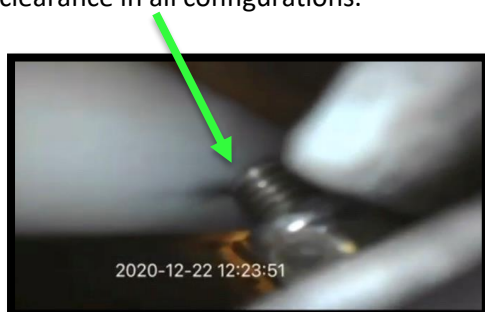
18 Poor quality Battery box installation Any sailplane with a battery box

See Video <https://youtu.be/NvvZ3biwrMQ> During the annual maintenance a slight scraping sound was heard when the stick was moved. Upon investigation it was found to be a bolt that was too long inserted during a previous battery box installation. After a any work is done its worth moving all the controls and U/C there is adequate clearance in all configurations.

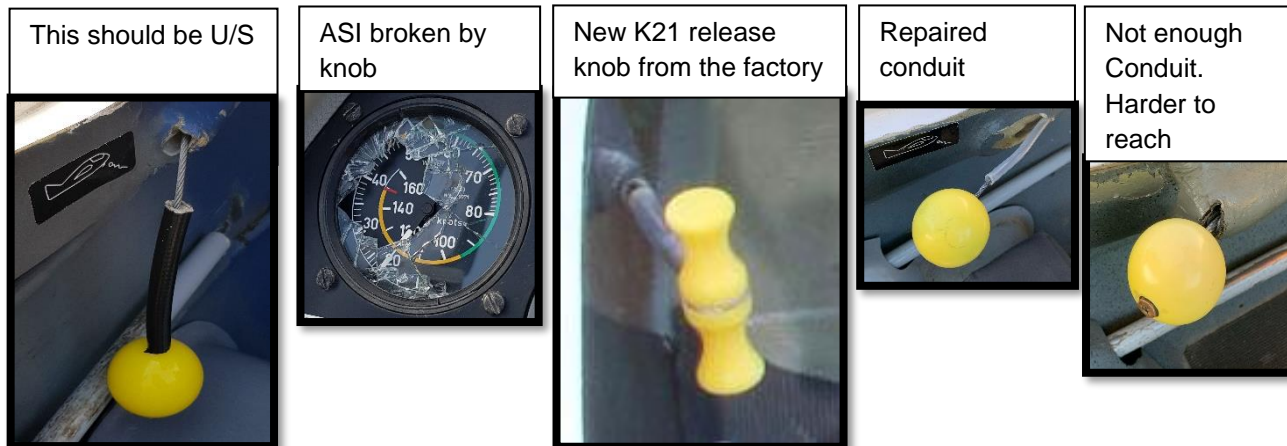
19 ASK21 Cable front release knob (can apply to Schemp Hirth, DG and Grob). Reported by Allan Tribe
Advisory A K21 release knob (see pictures) has the outer conduit broken allowing it to swing with gravity. It also might not be where the pilot expects to find it (on aerotow etc). In this case it smashed the ASI glass.

These usually fail in service between annual maintenance. Pilots should be trained to put the glider U/S when they see the defect. The same goes for the Front rudder cable adjustment cable as well if the return spring fails.

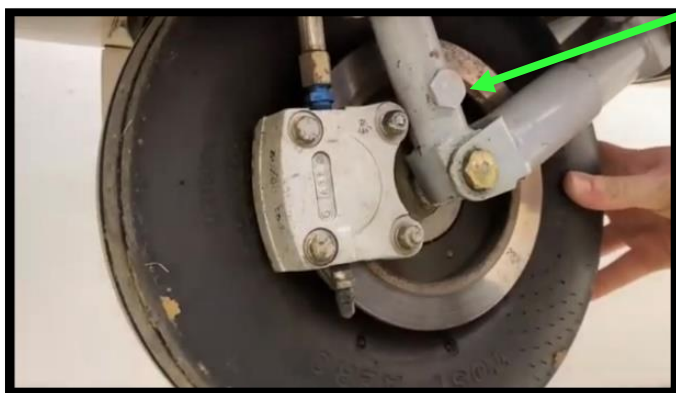
20 Wheel brake retaining studs Any glider with a drum or disc wheel brake.

Advisory See video <https://youtu.be/RpvHwa8PKhU> Any play in the wheel brake torque stud can lead to the stud fatiguing and sheering off. On gliders with drum wheel brakes this stud breaking can cause the stick to be pulled forward as the wheel brake cable is wrapped around the axle.

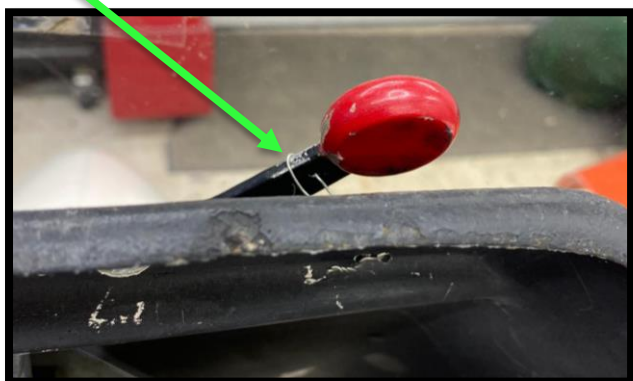
21 ASK21 (but applies to all gliders that use breakable tell-tale wire on canopy jettison systems) **Advisory** Yet another canopy found to be locked using locking wire. This canopy was extremely difficult to jettison. Imagine a child training just before solo at 14. Could they easily pull this lever to jettison the canopy?

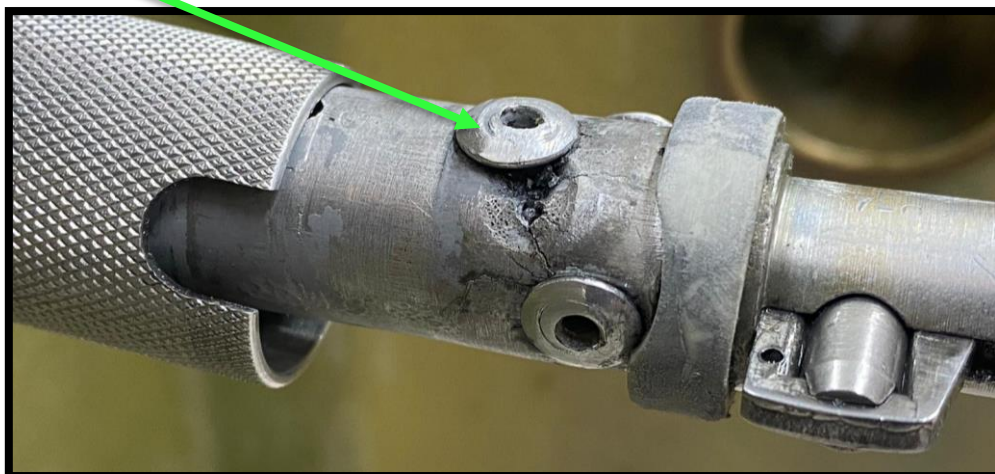
22 Poorly fitted L'hotelier/Wederkind fitting Can apply to any glider with these fittings. **Advisory**

These previously drilled holes should not exist. This is in very poor condition and not fit for purpose.
