EASA Airworthiness Directives (ADs)

EASA Proposed Airworthiness Directives (PAD)

Reported issues

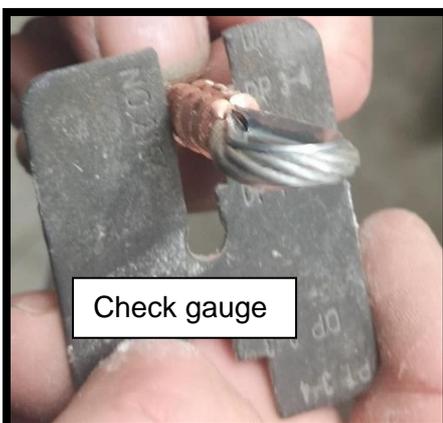
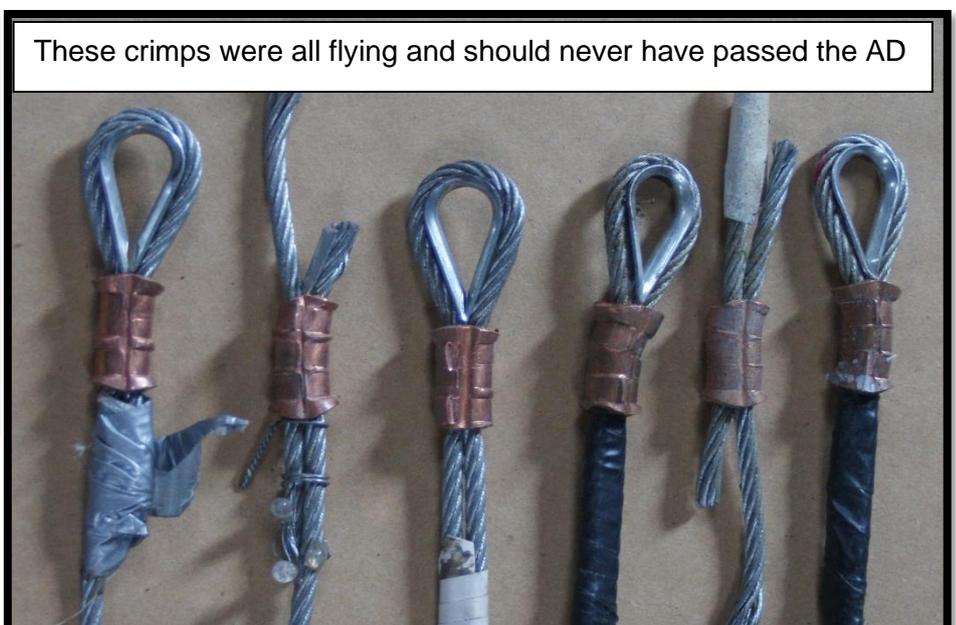
2 Nico press Swages and tooling

Nearly 40 years after this AD was issued, we are still occasionally finding incorrectly crimped cables. If you see a cable with only 2 squeezes, then it must be corrected. Do not forget you also need the gauge (see photo below) to check it is correctly squeezed to the correct thickness. Light Aircraft Spares LAS) [Part Search LAS Aerospace Ltd](#) or Aircraft Spruce are [Search Results | Aircraft Spruce](#) are good sources for these tools, cables and sleeves.

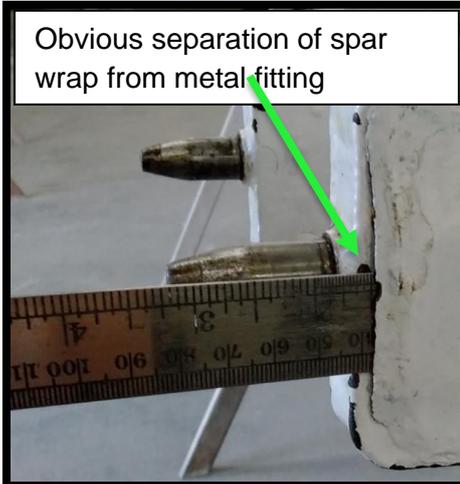
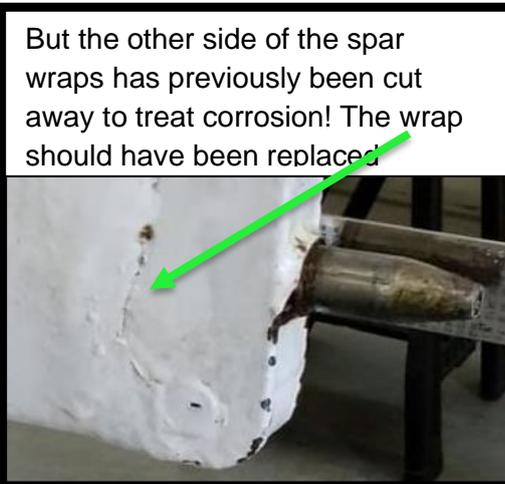
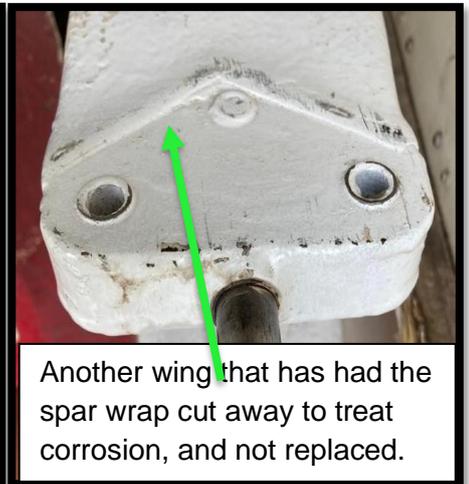
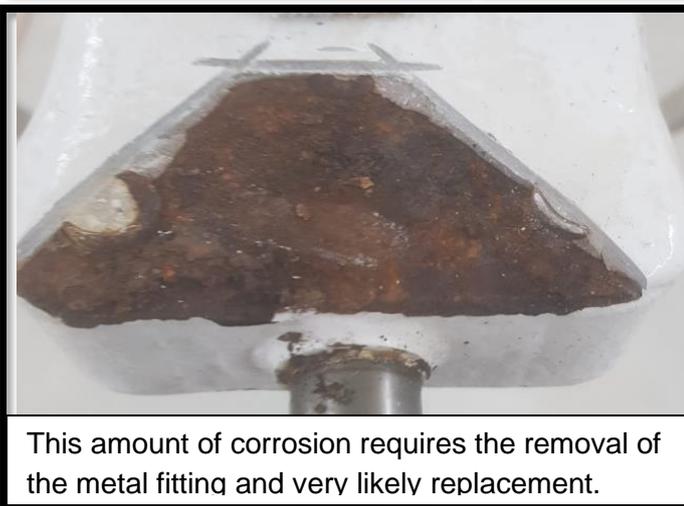
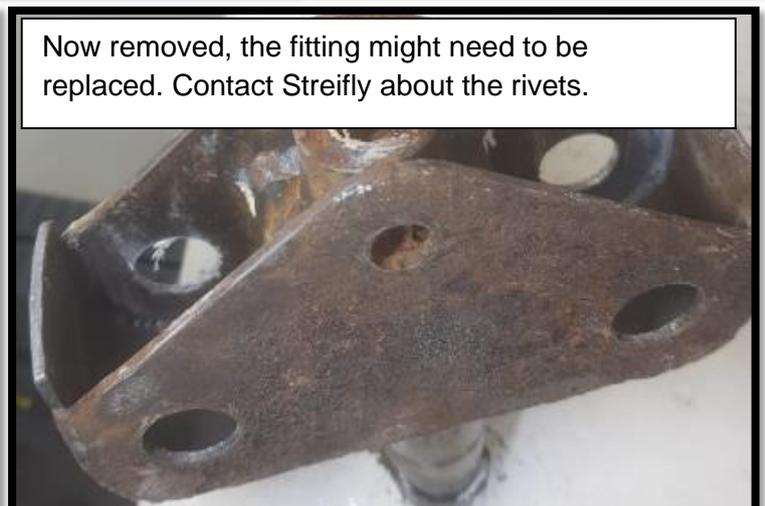
Annual check of Spar fitting corrosion and GRP wrap delamination. We have found that this old AD from 1996 has not always been repeated annually and is not well understood. The end of the spar requires annual inspections for the GRP spar wrap separating from the metal fitting underneath it. But when separation is found (usually due to corrosion of the metal), we are finding that the correct repair scheme has not always been followed. Contact Streifly for support. [Glasfaser Flugzeugservice \(streifly.de\)](#)

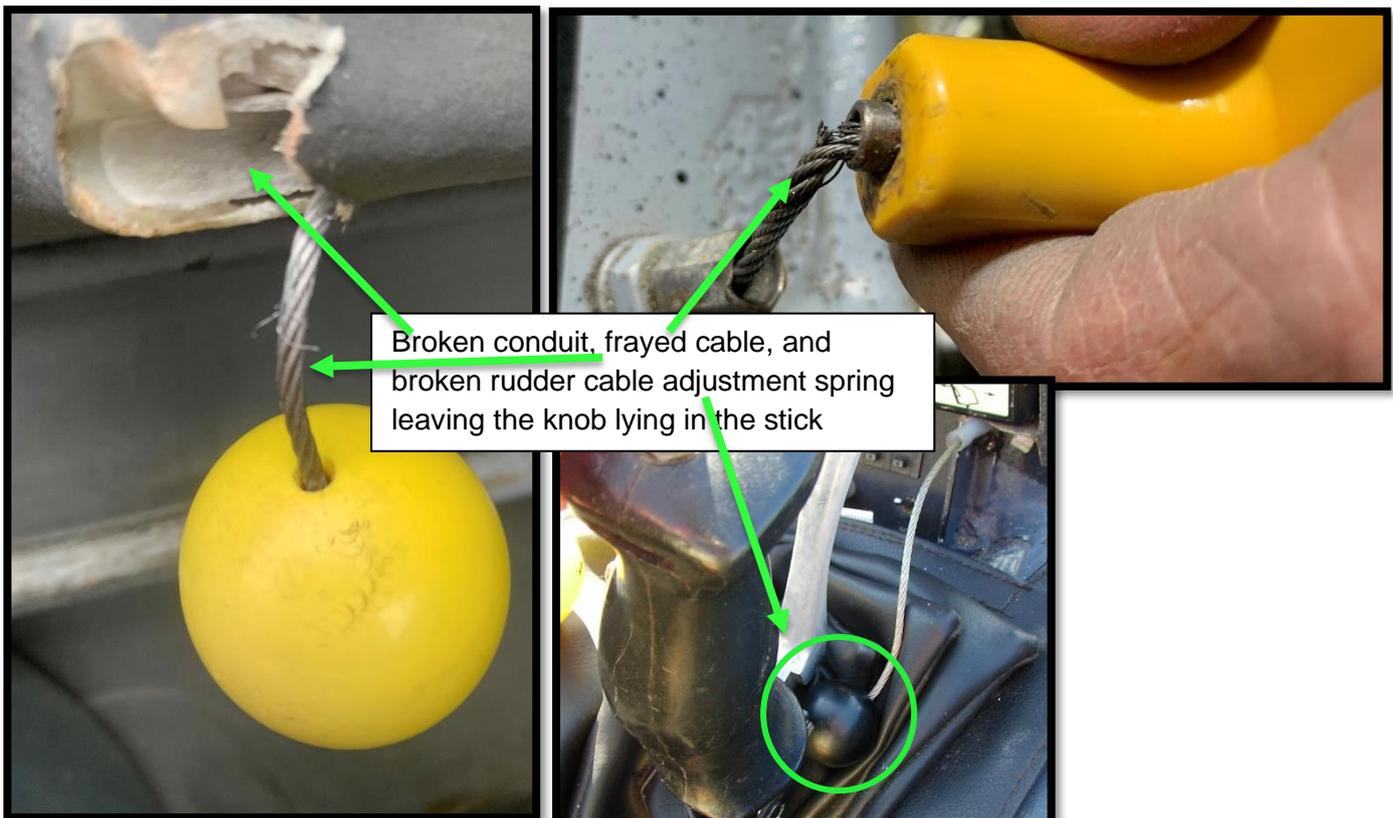
If not, they rapidly deteriorate (see below). Frayed cables (many of them draw blood from the users), nylon guide ripped, and a pedal return spring broken are correct reasons to make these glider U/S. Pilots performing a DI should be taught this is not acceptable. For high utilization club gliders, an occasional thorough DI by a BGA inspector should find these problems and get them fixed in a timely manner.

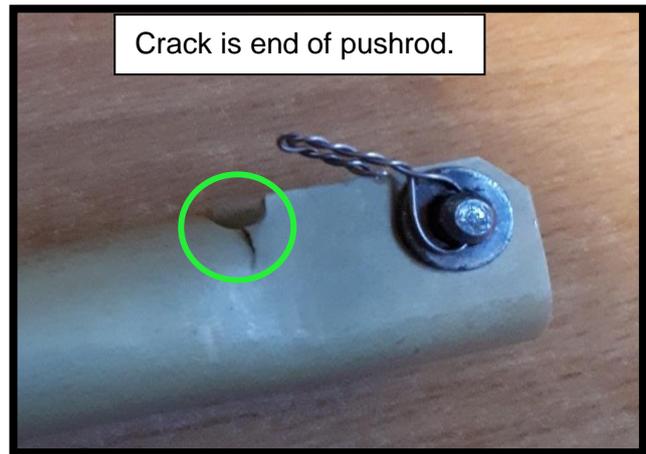
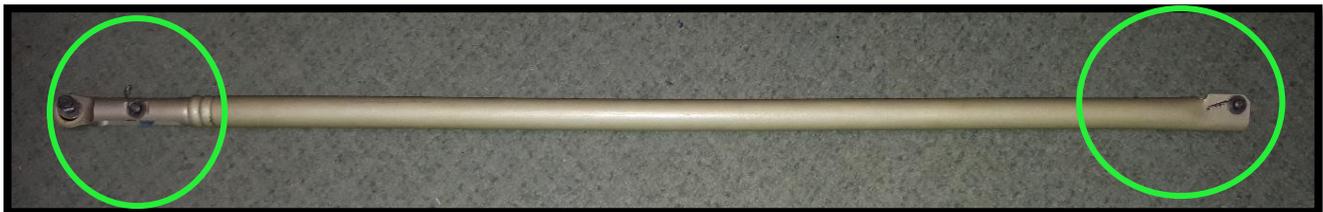
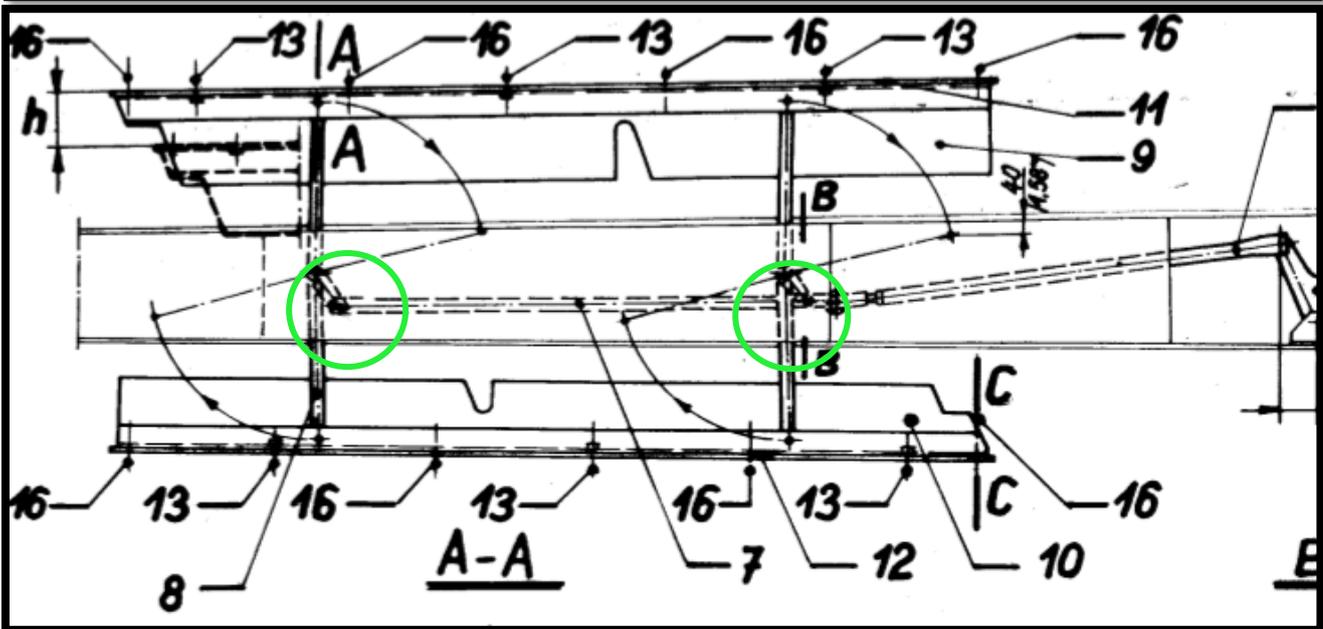
This is not an easy spot. There is not much space in the air brake box (note, some later Puchacz's have a different end fitting). Inspect thoroughly at next maintenance and report to the BGA if any problems found.

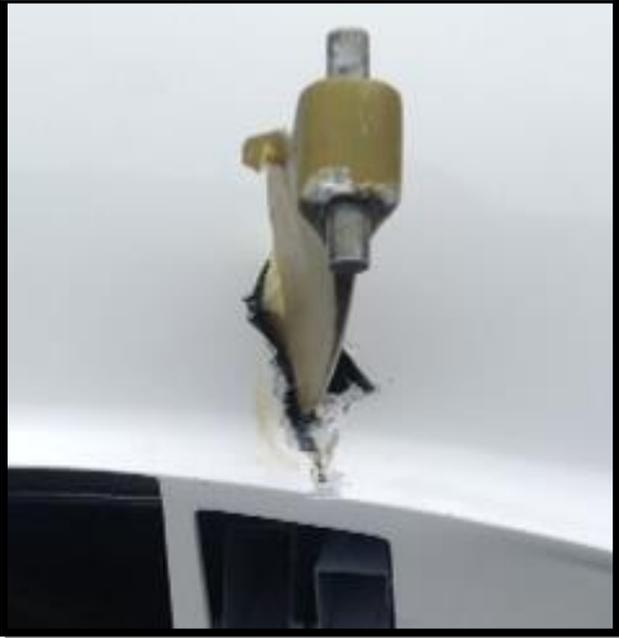
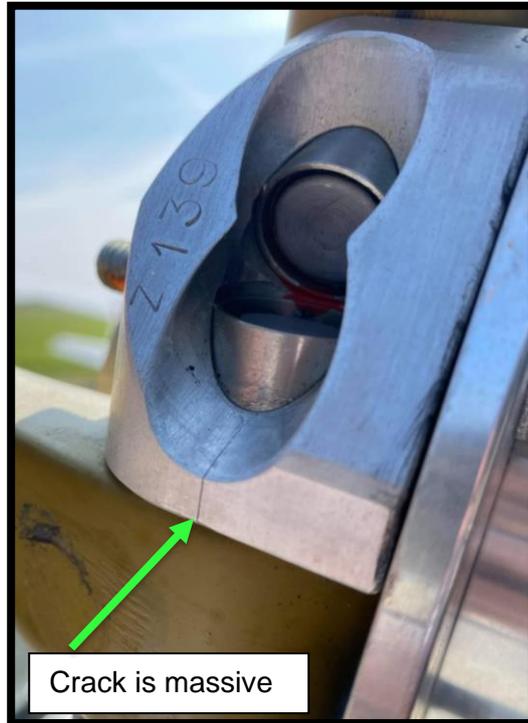
8 Duo XLT and other types with is propellor engine combination

The manual says check this daily. With good reason - the hubs still crack on a very regular basis. The pilots must know what to look for. This one had 44 hours. Failure to spot this on the DI has previously resulted in blade separation with a lot of associated damage (and having to land with restricted controlled because the blade was embedded in the fuselage).

Damage done when a previous crack was not spotted early enough

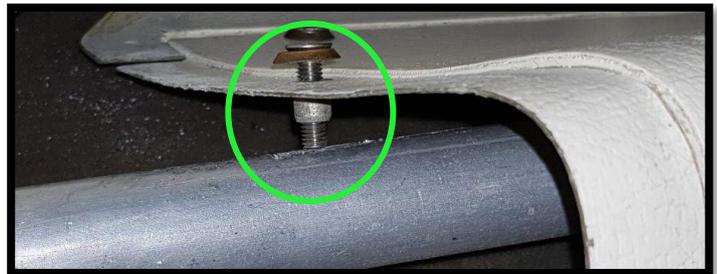
9 Wrong size screw in wrong hole causes control restriction and damages pushrod

A lot of gliders have very specific size screws for specific holes. Alas, the sailplane manufacturers often neglect to tell us this in their manuals. So, if after taking the cockpit screws out if there are some screws of different length, there is most likely a good reason for it! You must put the correct screw in the correct hole.

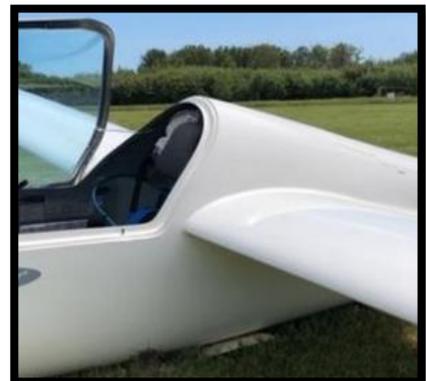
10 Duo XL and possible Arcus with manual U/C

An interesting report on Duo XL (Arcus is believed to be similar) U/C failure. Apart from the suggested welded metal improvements, the gas strut is a factor as well, as this drives the U/C directly rather than through the retract mechanism.

If the gas strut has failed (quite common), the increased load on the retract mechanism will hasten its failure. Check the gas strut regularly and change it the moment you notice U/C retraction/extension loads change.

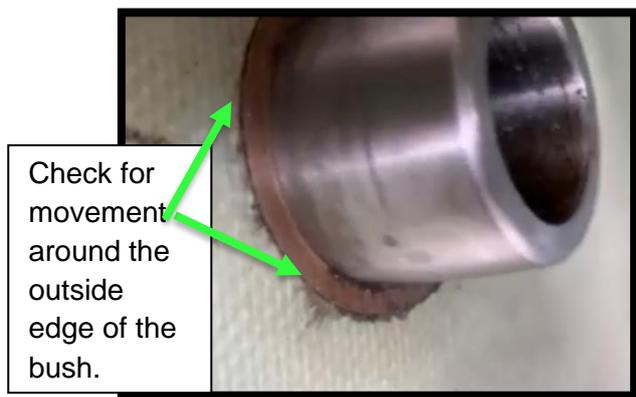
11 How to check spar bushes are secure in the wings on composite gliders

Look at this video and make sure all spar bushes are attached when doing inspections for heavy landings, annuals, and ground loops.

Only use approved repair schemes if having to replace them.

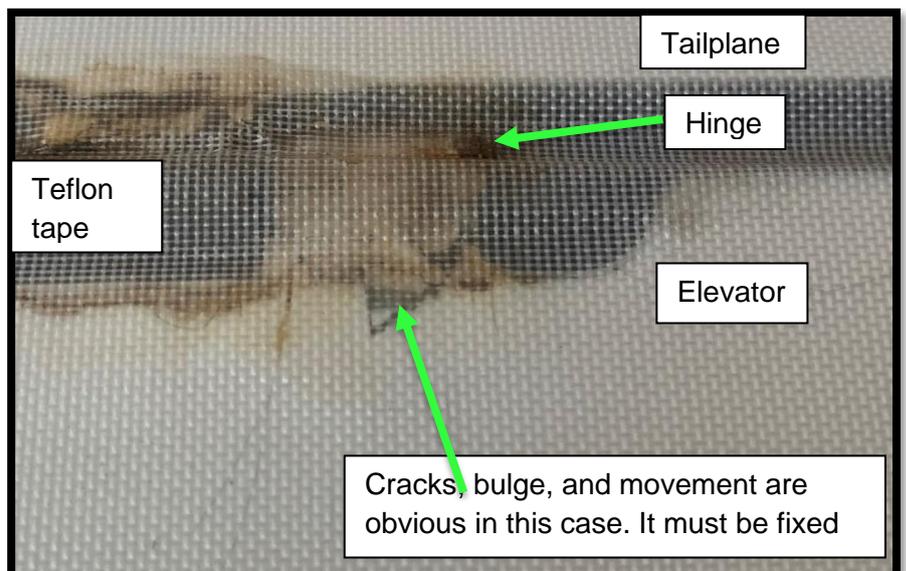
12 Astir/Twin Astir hinges and importance of inspecting them

The original Astirs and Twin Astirs are now well over 40 years. Unfortunately, the corrosion protection of the steel hinges sandwiched in the GRP in aileron, rudder and elevator was minimal. As a result, most of them have corrosion. The hinge becomes unbonded from the inner surface of the control surface, then it is only held in place by the top skin. When you apply a up/down force on the hinge the excess play and movement becomes obvious. Too many inspectors are not finding this defect. Do not be afraid to remove mylar to check it if there is any doubt.

The picture is a Twin Astir hinge that was covered in Teflon tape that was bleached clear by UV.

The only way to fix this is to cut away the top skin, remove the hinge, treat the hinge corrosion, or replace the hinge, prepare the GRP (most likely it has a layer of rust with 40 years of oil on it!), jig and bond the hinge into place and then splice new GRP skin, paint, and lastly check for mass balance limit compliance (do this before you start, I would suggest!)

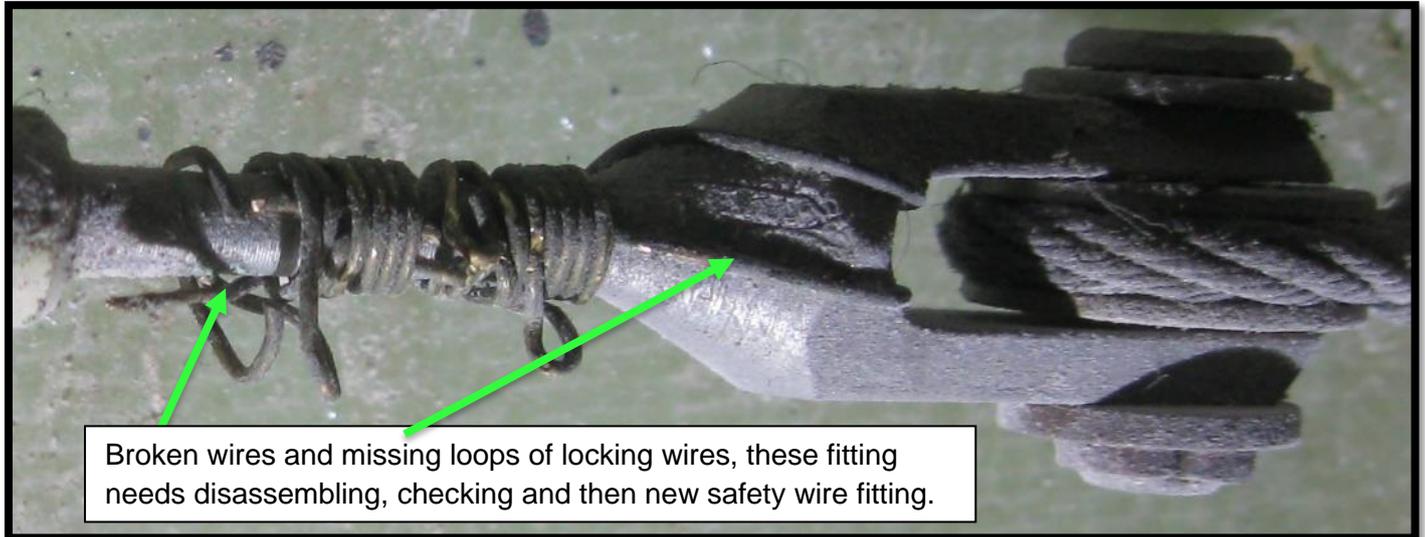
Some Polish gliders used a different type of locking wire of turnbuckles compared to the standard locking wire used in other gliders. In this case there is a suspicion that the locking wires were contaminated with hydraulic fluid because the reservoir sits above them.

They then became brittle and started breaking. If you have this cable system, inspect them to make sure they have not become brittle and broken. Please inform the BGA if you find a problem.
