ACCIDENT

Aircraft Type and Registration:	Rolland-Schneider LS8-18, G-CJNB
No & Type of Engines:	No engines
Year of Manufacture:	1998 (Serial no: 8227)
Date & Time (UTC):	5 September 2021 at 1240 hrs
Location:	Seighford Airfield, Staffordshire
Type of Flight:	Private
Persons on Board:	Crew - 1 Passengers - None
Injuries:	Crew - 1 (Serious) Passengers - N/A
Nature of Damage:	Extensive damage to the fuselage and wings
Commander's Licence:	UK Sailplane Pilot's Licence
Commander's Age:	62 years
Commander's Flying Experience:	113 hours (of which 20 were on type) Last 90 days - 19 hours Last 28 days - 1 hour
Information Source:	Aircraft Accident Report Form submitted by the pilot and additional information provided by others

Synopsis

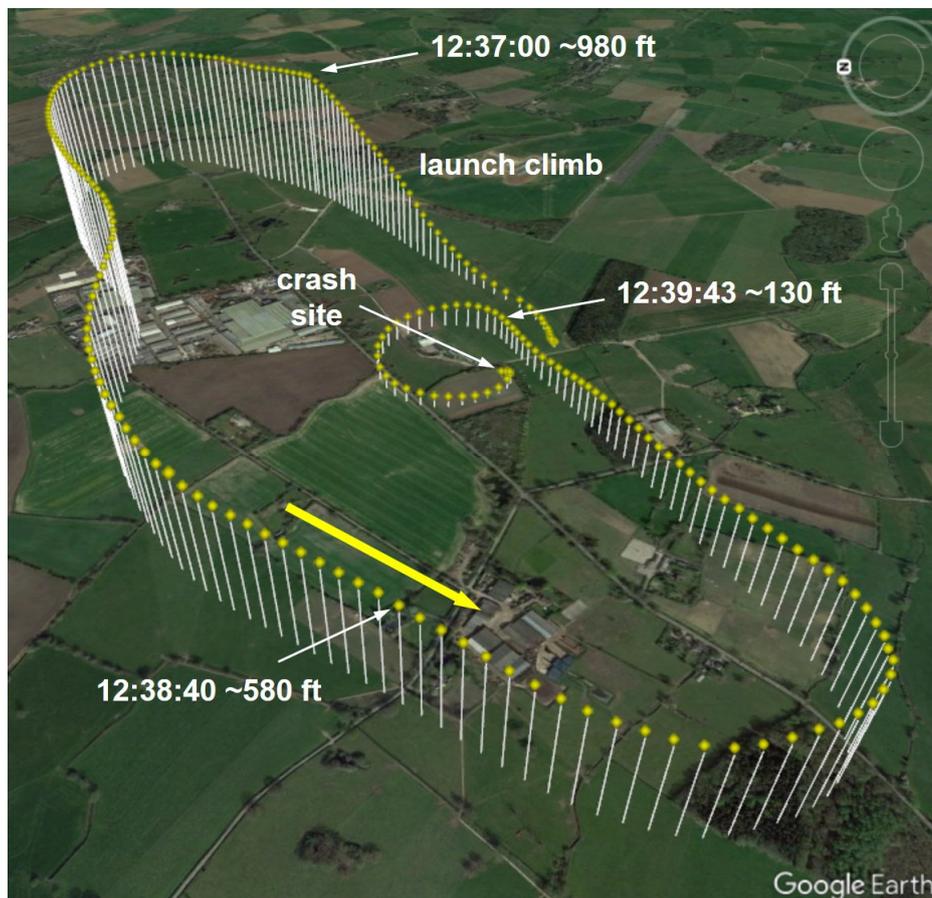
Figure 1

Accident flight profile showing the circuit, approach and orbit (heights are aal)

The flight logs show a normal winch launch and circuit up to the approach back to the airfield. The approach was flown at an average ground speed of approximately 55 kt¹. After crossing the airfield boundary hedge, at a height of 130 ft above the ground, the glider

started a left turn. Just prior to commencing a left turn the ground speed reduced to 40 kt. The turn continued with a diameter of approximately 350 m. The ground speed increased during the turn to approximately 60 kt.

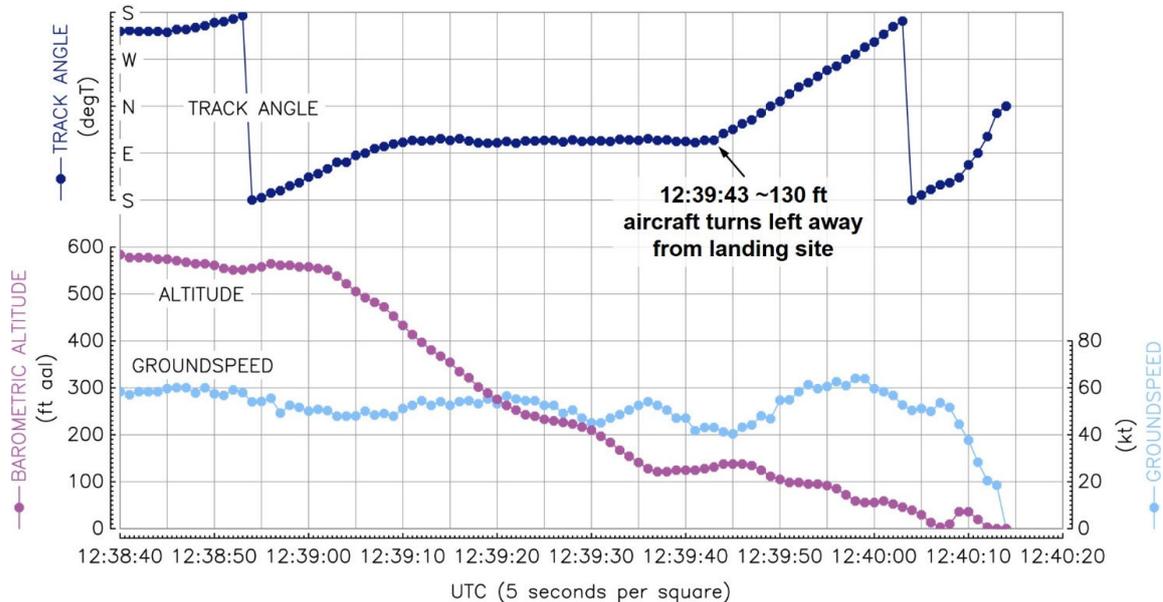
Figure 2

Chart showing the glider's altitude, ground speed and heading during the approach

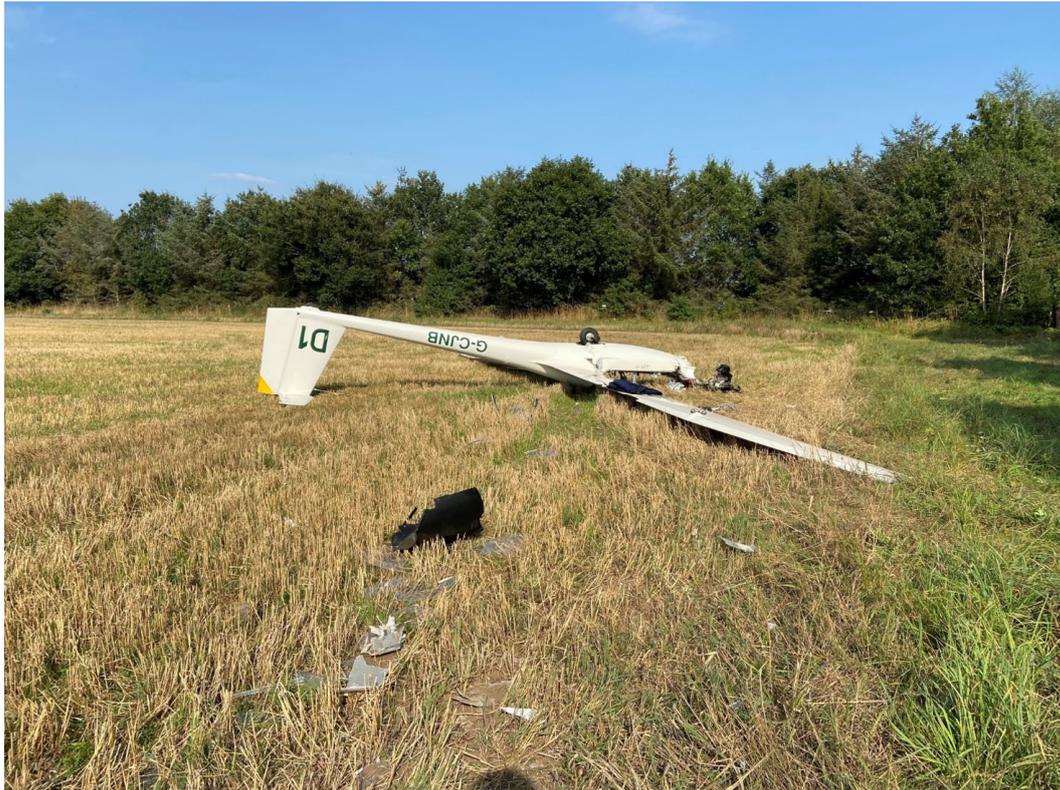
Figure 3 shows the glider after the accident; the airfield is just beyond the trees in the background.

The accident site and glider were examined by several experienced members of the gliding club. They reported that the fuselage was very badly damaged forward of the wing and was also broken behind the wing. The right wing had a small diameter impact mark which penetrated the leading edge at about two-thirds span, and there were two large creases in the trailing edge inboard of the impact damage. It was thought this damage was caused by an impact with a tree branch. There was impact damage on the left wingtip but the wing itself was less damaged than the right one. On the underside of the left tip, there were marks showing it had dragged across the ground. The left wingtip extension was detached and closer inspection showed that it had torn the fitting from the main wing. The tail, fin and rudder were essentially undamaged.

There was a one to two-inch-deep ground mark just behind the eventual resting place of the glider. The shape of this and the surrounding debris, including multiple canopy fragments, suggested that this is where the nose struck in a very steep attitude and with little forward speed.

G-CJNB after the accident

All the damage appeared to be consistent with the glider colliding with trees and rotating across the field to its eventual resting point. There was no evidence of any pre-existing damage which could have contributed to the accident.
