ACCIDENT

Aircraft Type and Registration:	Silent 2 Electro, G-CIRK	
No & Type of Engines:	1 FES electric motor	
Year of Manufacture:	2013 (Serial no: 2054)	
Date & Time (UTC):	23 April 2021 at 1305 hrs	
Location:	Wormingford Airfield, Colchester, Essex	
Type of Flight:	Private	
Persons on Board:	Crew - 1	Passengers - None
Injuries:	Crew - 1 (Serious)	Passengers - N/A
Nature of Damage:	Aircraft destroyed	
Commander's Licence:	Light Aircraft Pilot's Licence (Sailplanes)	
Commander's Age:	71 years	
Commander's Flying Experience:	295 hours (of which 55 were on type) Last 90 days - 13 hours Last 28 days - 13 hours	
Information Source:	AAIB Field Investigation

Synopsis

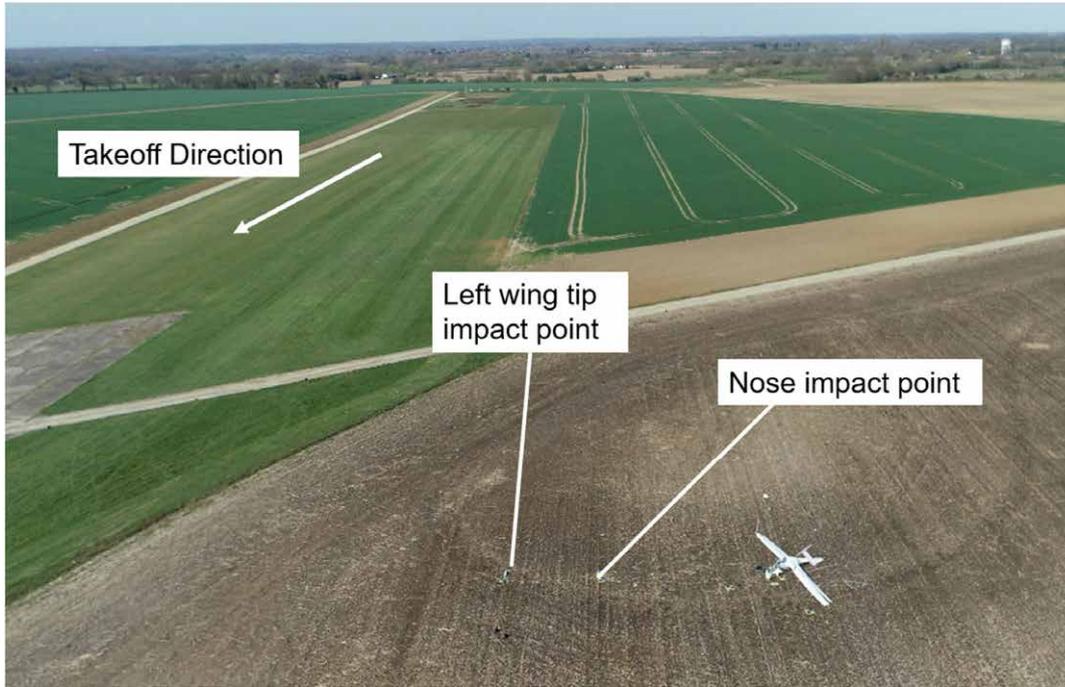
Figure 1
Accident site

At a witness-estimated height of between 50 ft and 200 ft agl, the glider rapidly rolled left and appeared to enter a spin. After rotating between 90° and 180° around the vertical, G-CIRK struck the ground nose first before coming to rest upright, in a field bordering the runway.

The accident site revealed that the aircraft had struck the ground in a steep nose-down attitude, after which the aircraft had yawed to the left and ended up pointing in the opposite direction of its final travel before coming to rest (Figure 1). The aircraft was about 230 m north-east of where it lifted off from the runway. The front of the cockpit was destroyed (Figure 2), the left wing had suffered significant damage and the tail had snapped in half. Both propeller blades had detached at their root and were close to the wreckage.

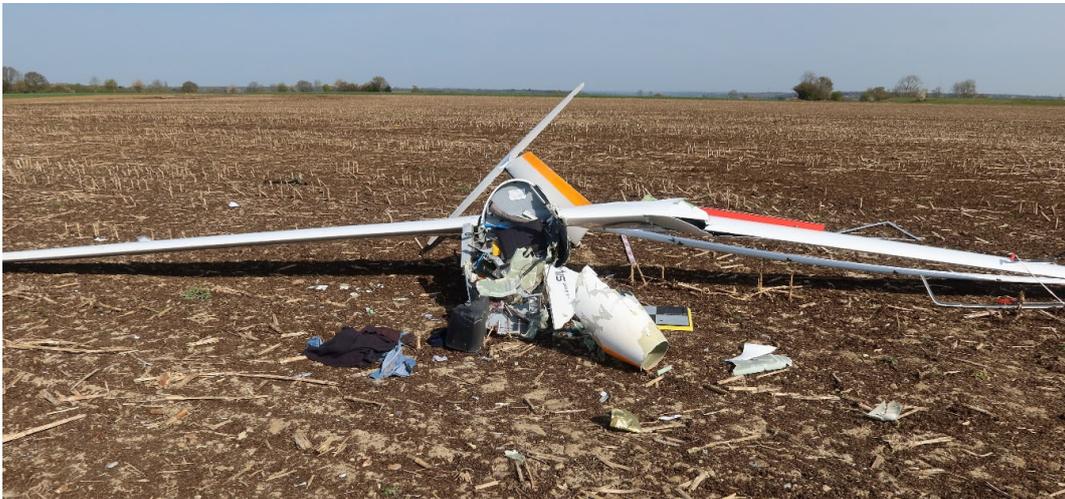
Figure 2
Damage to the aircraft

The aircraft wreckage was recovered to the AAIB facility near Farnborough for a detailed examination. All the damage to the flying controls was consistent with impact damage. The tailplane actuation system operated normally but the broken tail boom had resulted in the actuating cable going slack, so it was not possible to determine the tailplane angle at impact. It was also not possible to determine the flap angle at impact due to damage to the flap control system. No mechanical fault was found that would cause an un-commanded pitch-up. There were no blockages in the pitot tube. The landing gear was in the DOWN position and the BPRS had not been operated. 4.5 kg of nose ballast was fitted.

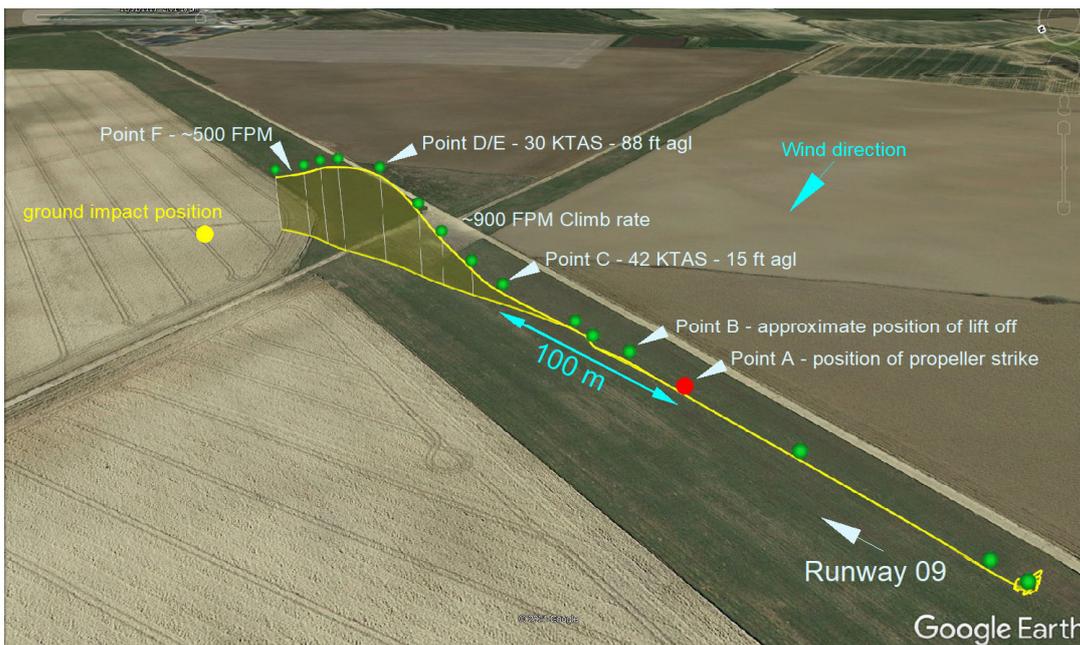
Figure 4
GPS derived data for accident takeoff

A series of 11 propeller slash marks were found on the runway surface near the liftoff point (Figure 4) with an initial spacing of about 10 cm.

Comparison of the accident takeoff and the previous self-launch takeoff showed that the aircraft's acceleration during the takeoff roll, and its airspeed during the first few seconds of the climb, were similar. However, the climb profiles then diverged. During the previous takeoff, the initial rate of climb was maintained at about 200 ft/min (Figure 3 Point G) until the glider's airspeed had reached 50 KTAS, after which, the climb rate increased to about 430 ft/min.

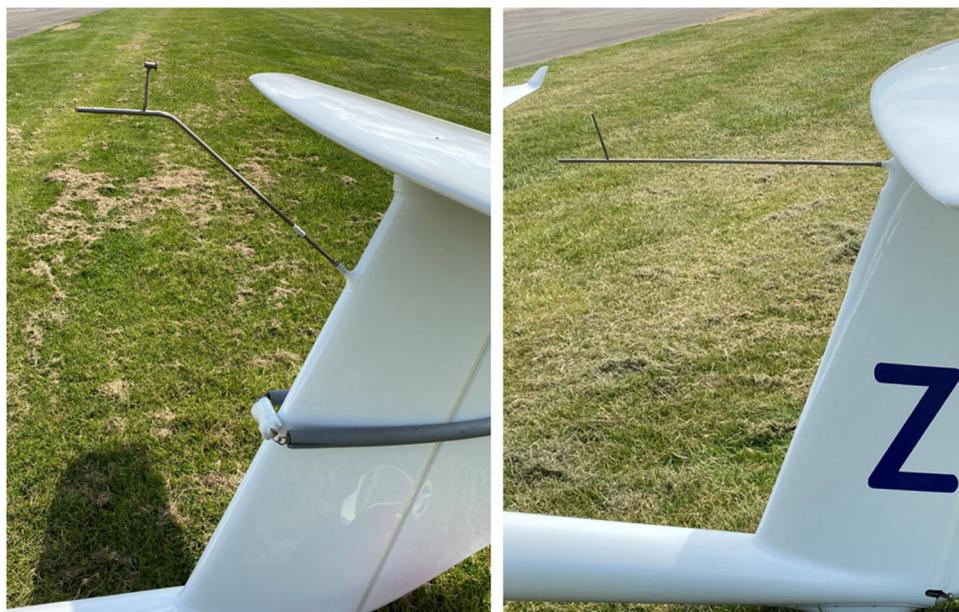
Figure 8

A pitot tube is used for measuring airspeed and G-CIRK was fitted with an angled version attached to the leading edge of the vertical tail (Figure 8, left). This same type of pitot tube was fitted to the Silent 2 Electro that was used for a flight evaluation as discussed later in the report. Later model Silent 2 Electro's have a straight pitot tube (Figure 8, right). It was reportedly changed to reduce aerodynamic drag.

The flight evaluation revealed that the ASI can overread during power-on stalls. This is probably caused by the propeller slipstream hitting the pitot tube on the vertical tail. If the ASI had overread during the takeoff climb this might have caused the pilot to increase the pitch attitude to reduce the speed back to his target. However, the ASI was only seen to overread close to stall, so if it was a factor in the accident, it would probably have occurred late when the pilot had already reached an excessively high pitch attitude for a different reason.

The flight evaluation revealed that during power-on stalls the propeller slipstream impinged on the pitot tube and caused erroneous overreadings on the ASI. The aircraft manufacturer was not aware of this issue and stated that they would investigate it if they resumed production. They believed that the pitot tube had been changed by the original aircraft manufacturer from an angled pitot tube to a straight pitot tube to reduce aerodynamic drag, but it is possible the change was also to address ASI overreadings.

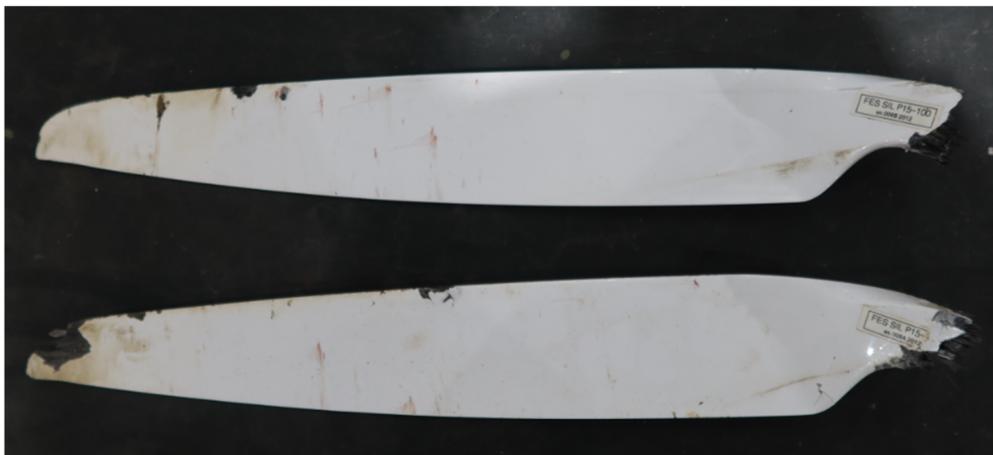
Figure 9
Propeller blade damage

The electric motor was too severely damaged to test, but the separated propeller blades indicated that the motor was rotating at impact. As well as the root damage, the propeller blades had leading edge nicks and one blade had tip damage (Figure 9).

No mechanical fault or defect was found that would explain the aircraft pitching up excessively after takeoff. The 100 ft climb after takeoff indicates that power was applied and that the propeller had only suffered minor damage during the propeller strike. Although the batteries were not fully charged, the recorded data did not reveal a significant difference in the initial acceleration profile compared to the previous takeoff, so this did not appear to have been a factor in the accident.

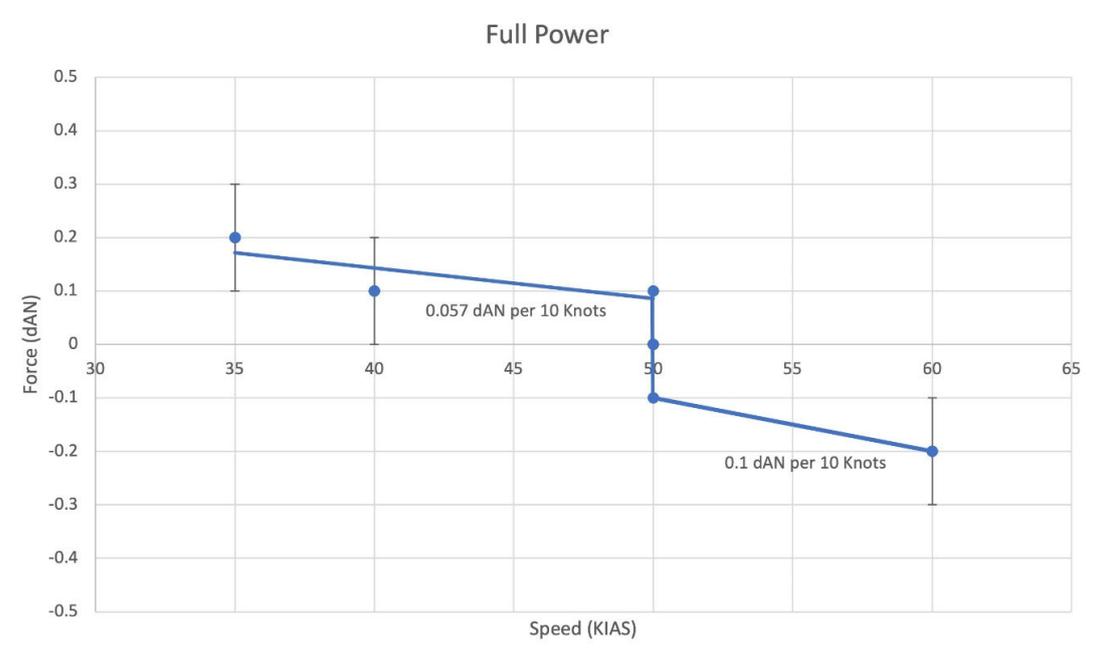
Figure 13

The test pilot reported that the flat stick force gradient and high break-out friction has two effects: it means that the pilot receives minimal feedback through the stick about how the aircraft is manoeuvring or its attitude, and it is difficult for the pilot to feel where the stick needs to be positioned to adopt a specific aircraft attitude or fly the aircraft smoothly and predictably.

The glider had weak positive longitudinal static stability at a CG that was 40 mm forward of the aft CG limit, so the stability would have been even less at the aft limit.

CS 22.173²⁰ on 'Static Longitudinal Stability' states that the slope of the stick force versus speed curve must be positive and *'have a value such that any significant speed change will cause a variation in stick force plainly perceptible to the pilot.'* The 'Acceptable Means of Compliance' (AMC) to this requirement state that: *'Compliance with this requirement can be assumed, if the slope of the curve, stick force versus speed, is at least 1 N per 10 km/h at all speeds up to V_{NE} '* V_{NE} is the 'never-exceed speed' and 1 N per 10 km/h equates to 0.19 daN per 10 kt or 0.19 kgf per 10 kt.

Regardless of the reason for the excessive aft stick input, the aircraft's very light longitudinal stick forces make an excessive aft input more likely. The flight evaluation revealed that a force of 0.3 dAN, relative to a break-out force of 0.1 dAN, was sufficient to cause an excessively high pitch attitude that would lead to a stall from an entry speed of 41 to 44 KIAS. 0.3 dAN is a pull force that can be generated with a 300 g weight. The stick force gradient is also very flat at 0.1 dAN per 10 kt nose-down and 0.06 dAN per 10 kt nose-up

The BGA has published and sent a '*Safety Briefing*' to Silent 2 Electro owners in the UK and to the EGU which provides guidance on operating the Silent 2 Electro (Appendix A). It covers ways to address the aircraft's stick force characteristics, its stall characteristics, recommendations on takeoff handling, takeoff flap and takeoff speeds, as well as recommendations on mentally rehearsing aborted takeoffs.

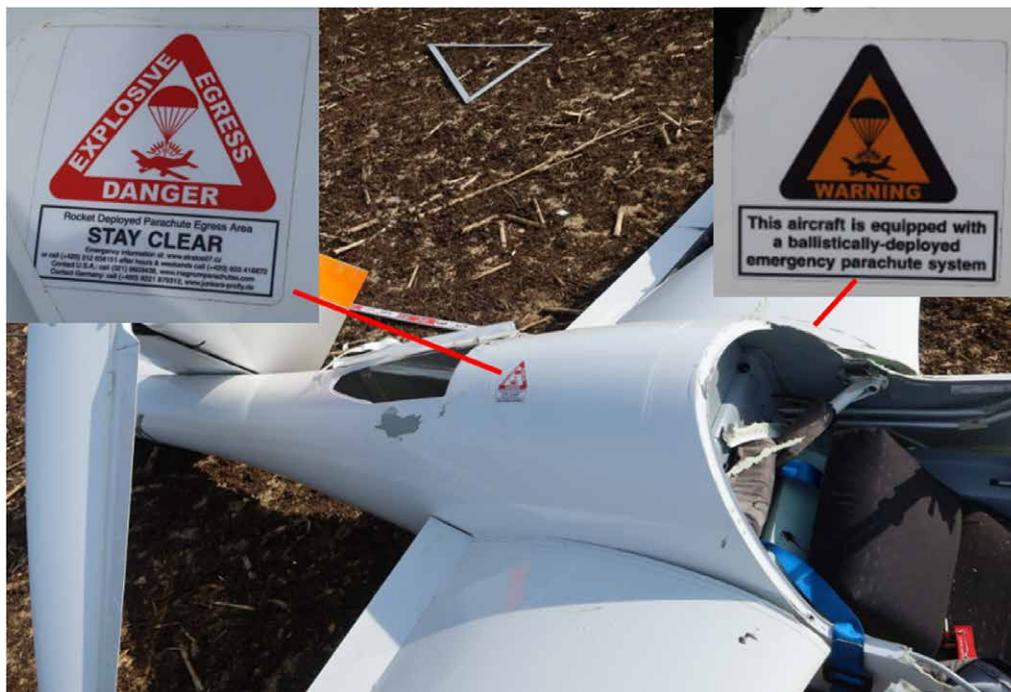
Figure 14
BPRS placards on G-CIRK

The damage to the cockpit of G-CIRK had exposed the activation cable, and the pin was not inserted, so the rocket presented a hazard to the emergency services attending the

Two placards were affixed to the fuselage aft of the cockpit to warn people about the hazards from the rocket and parachute (Figure 14). These placards conformed to the requirements in ASTM F2316-12²⁸. They did not conform to the placard requirements in BCAR Section S²⁹, sub-section K on 'Microlight Parachute Recovery Systems', which require the 'DANGER' placard to be larger than that specified in ASTM F2316-12³⁰, and which also require a double offset black and yellow chequered line to surround the parachute and rocket exit area (Figure 15). As an SSDR the Silent 2 Electro is not required to meet BCAR Section S; however, the CAA published Skywise article SW2021/91³¹ on 29 April 2021 which stated that: 'The CAA strongly recommends that owners of SSDRs fitted with a BPRS comply with the requirements of BCAR Section S, Sub-Section K, to clearly identify the presence of the BPRS to emergency services and first responders in the event of an accident.'

Emergency services first responders attending the accident were initially unaware of the potential risk to life posed by the undeployed BPRS system fitted to G-CIRK. Had the accident occurred in a more remote location without BPRS-aware bystanders emergency services personnel would have only had the BPRS placards to alert them of the hazard. In some accidents the placards can be obscured as a result of structural damage, wreckage orientation or due to fire. An additional layer of safety would be to have an information system that can be used by the emergency services to identify aircraft fitted with a BPRS before the emergency services arrive at the scene. As a result the CAA have updated the aircraft register, G-INFO, to indicate if an aircraft is fitted with a BPRS or other ballistic recovery system such as an ejection seat. The CAA are also planning to contact the registered owners of SSDR aircraft, which are fitted with a BPRS device, to inform them of the BPRS placard types and sizes that should be fitted.

The CAA are planning to contact the registered owners of SSSR aircraft, which are fitted with a BPRS device, to inform them about Sky Wise article SW2021/91 which strongly recommends that owners of these aircraft comply with the requirements of BCAR Section S, Sub-Section K, to clearly identify the presence of the BPRS.

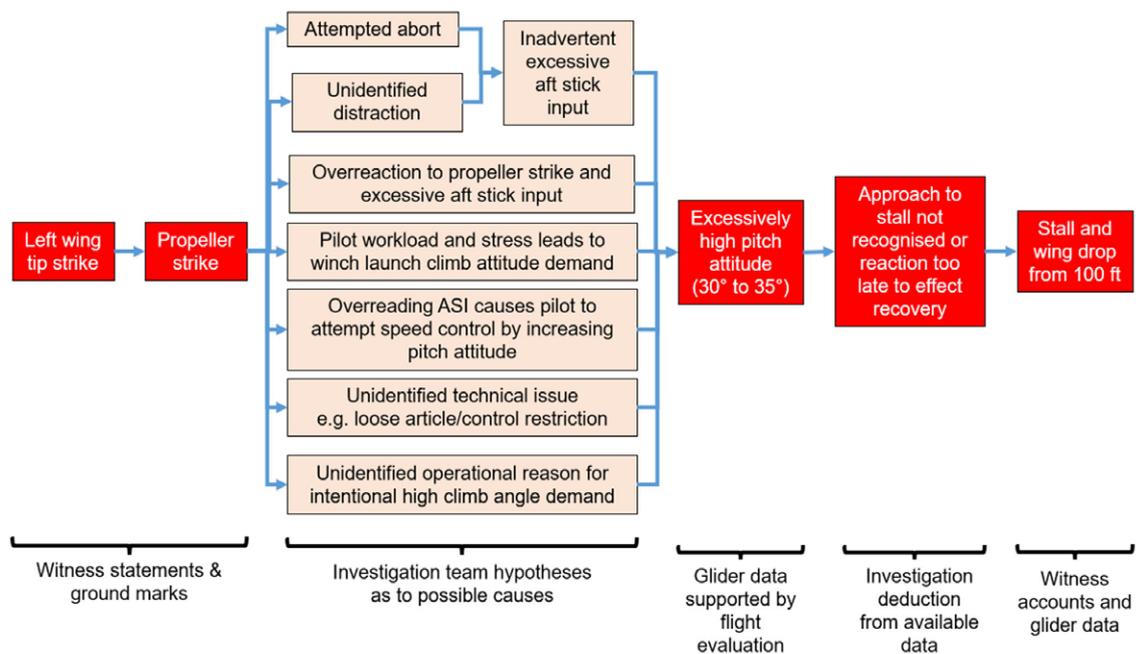
While the investigation could not determine the reason for the steep climb it considered that it most likely resulted from a single or combination of factors outlined in Figure 16 and explained below.

The accident was the result of an excessively steep climb after takeoff which resulted in a stall that was not recognised or the reaction to it was too late to effect recovery. No mechanical fault or defect was found that would explain the aircraft pitching up excessively after takeoff. The steep climb was most likely the result of an excessive aft stick input that was not corrected.

While the investigation could not positively identify the cause of the aft stick input, it is likely that distraction, pilot workload or stress were factors in the accident. These factors coupled with the aircraft's characteristics of low stick forces with low sensory feedback, and poor stall warning indications made the accident more likely to occur.
