ACCIDENT

Aircraft Type and Registration:	Grob G103C Twin III Acro, G-CFWC	
No & Type of Engines:	N/A	
Year of Manufacture:	1990 (Serial no: 34154)	
Date & Time (UTC):	13 June 2021 at 1200 hrs	
Location:	Usk Airfield, Monmouthshire	
Type of Flight:	Private	
Persons on Board:	Crew - 2	Passengers - None
Injuries:	Crew - 2 (Serious)	Passengers - N/A
Nature of Damage:	Aircraft destroyed	
Commander's Licence:	BGA Assistant Instructor Rating	
Commander's Age:	60 years	
Commander's Flying Experience:	906 hours (of which 400 were on type) Last 90 days - 40 hours Last 28 days - 22 hours	
Information Source:	AAIB Field Investigation

Synopsis

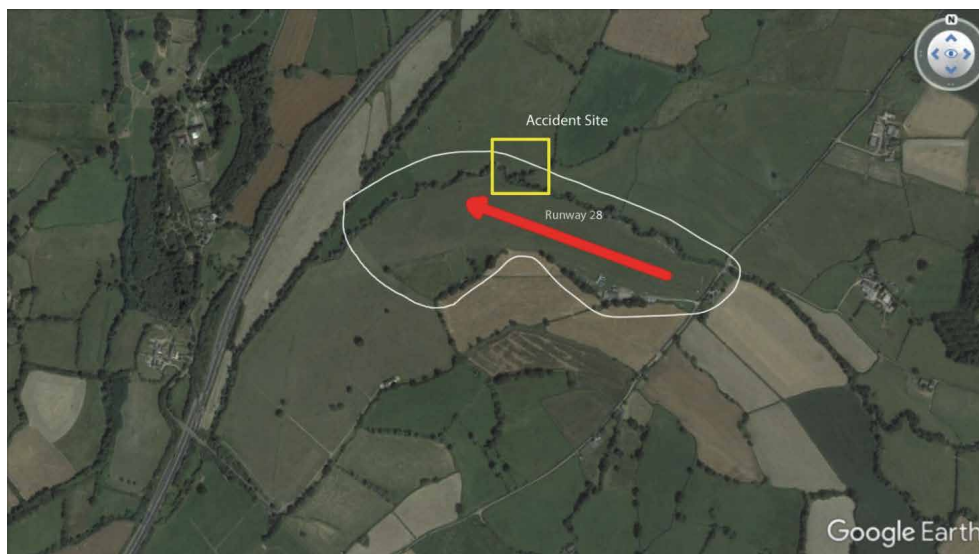
Figure 1

The pilot did not believe he had sufficient distance to land safely straight ahead, but that he did have sufficient distance to land the glider in an area of the airfield extending to the left (south) of the end of Runway 28 (Figure 1). He turned the glider to the right, flying away from the airfield to position it for a landing across the airfield at the end of Runway 28.

Usk Airfield outlined in white - Runway 28 marked in red - accident site in yellow

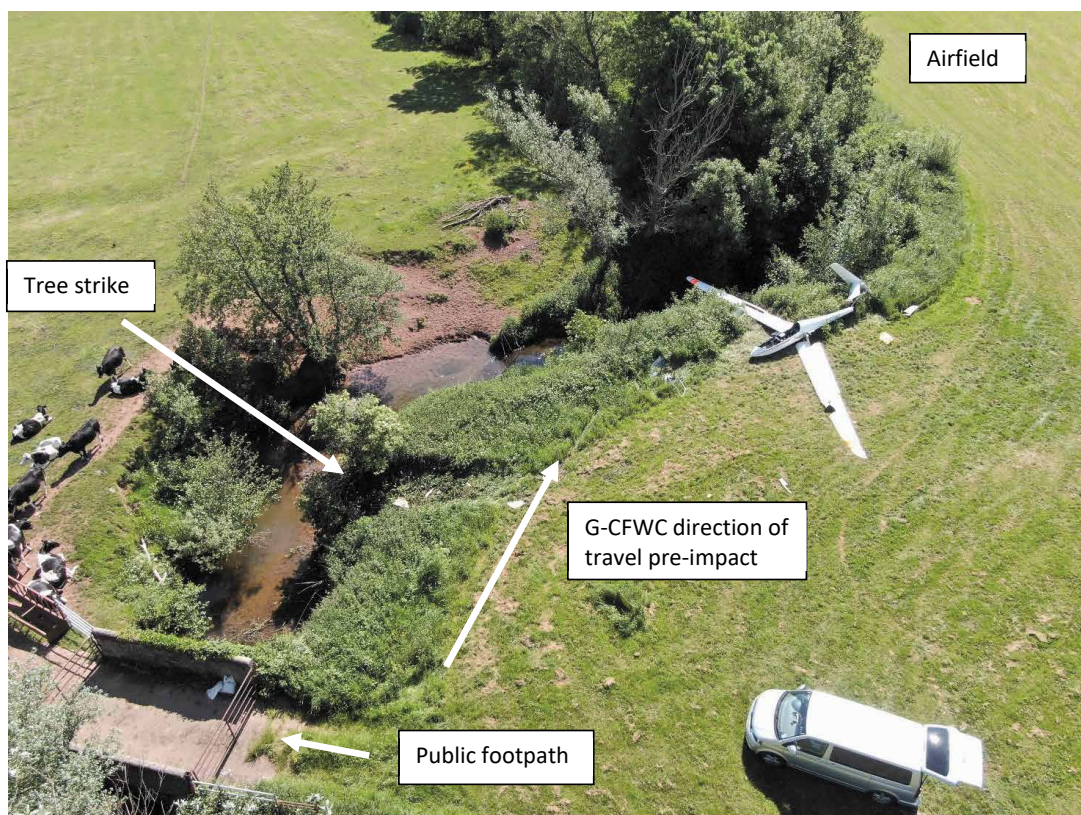
Figure 2
Accident site

The glider had come to rest against a fence on the northern edge of the airfield, with the right wing overhanging the bank of an adjacent stream. Damage to the leading edge of the left wing at approximately two thirds span was consistent with it having struck a small elder tree on the bank of a stream at the edge of the airfield (Figure 2).

A flattened area of vegetation on the stream bank corresponded to the shape of the left wing and debris in the vicinity of the tree was matched to the left wing leading edge. Corresponding strike marks on the tree indicated that the glider was approximately at ground level when it struck the tree. The impact caused the glider to pivot sharply around the tree before coming to rest in its final position.

The left wing had separated from the fuselage such that it remained attached only by the aileron and airbrake control rods. The right wing was intact, with the exception of damage to the trailing edge where the wing had struck a fence post as it came to rest.

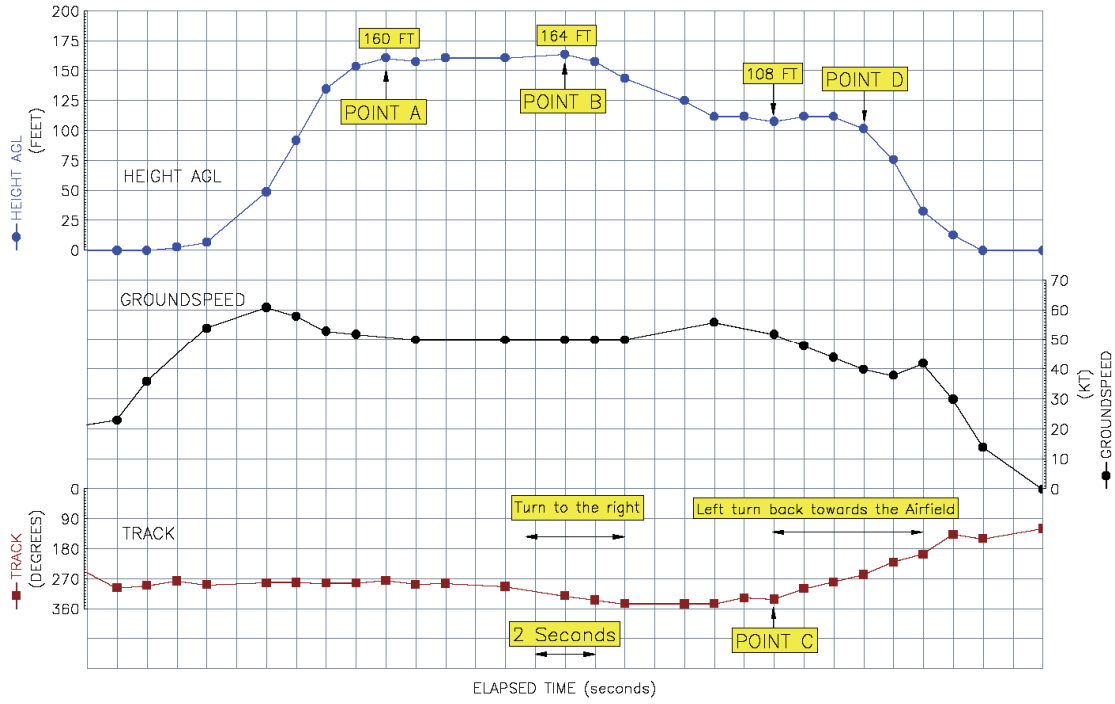
Figure 3
Recorded GPS data

The recorded data indicates that the aircraft had reached a height of about 160 ft agl (Point A - Figures 2 and 3) whilst initially maintaining the runway track, but after a few seconds the aircraft made a right turn onto a track of 350° (Point B - Figures 3 and 4) whilst also starting to descend.

When the aircraft was at a height of about 110 ft agl and 80 m beyond the airfield's northern boundary, a left turn, back towards the airfield, was initiated (Point C - Figures 3 and 4). At this point the glider flew approximately level for several seconds with the groundspeed starting to reduce. Shortly after entering the turn and from a height of 100 ft agl, the aircraft's descent rate suddenly increased to about 2,000 fpm (Point D - Figures 3 and 4).
