TECHNICAL INSTRUCTION NO.90

SLINGSBY T53B AND LATER VARIANT YS53

IMMEDIATE INSPECTION OF ATTACHMENT OF WING CENTRE

SECTION TO FRAME 6

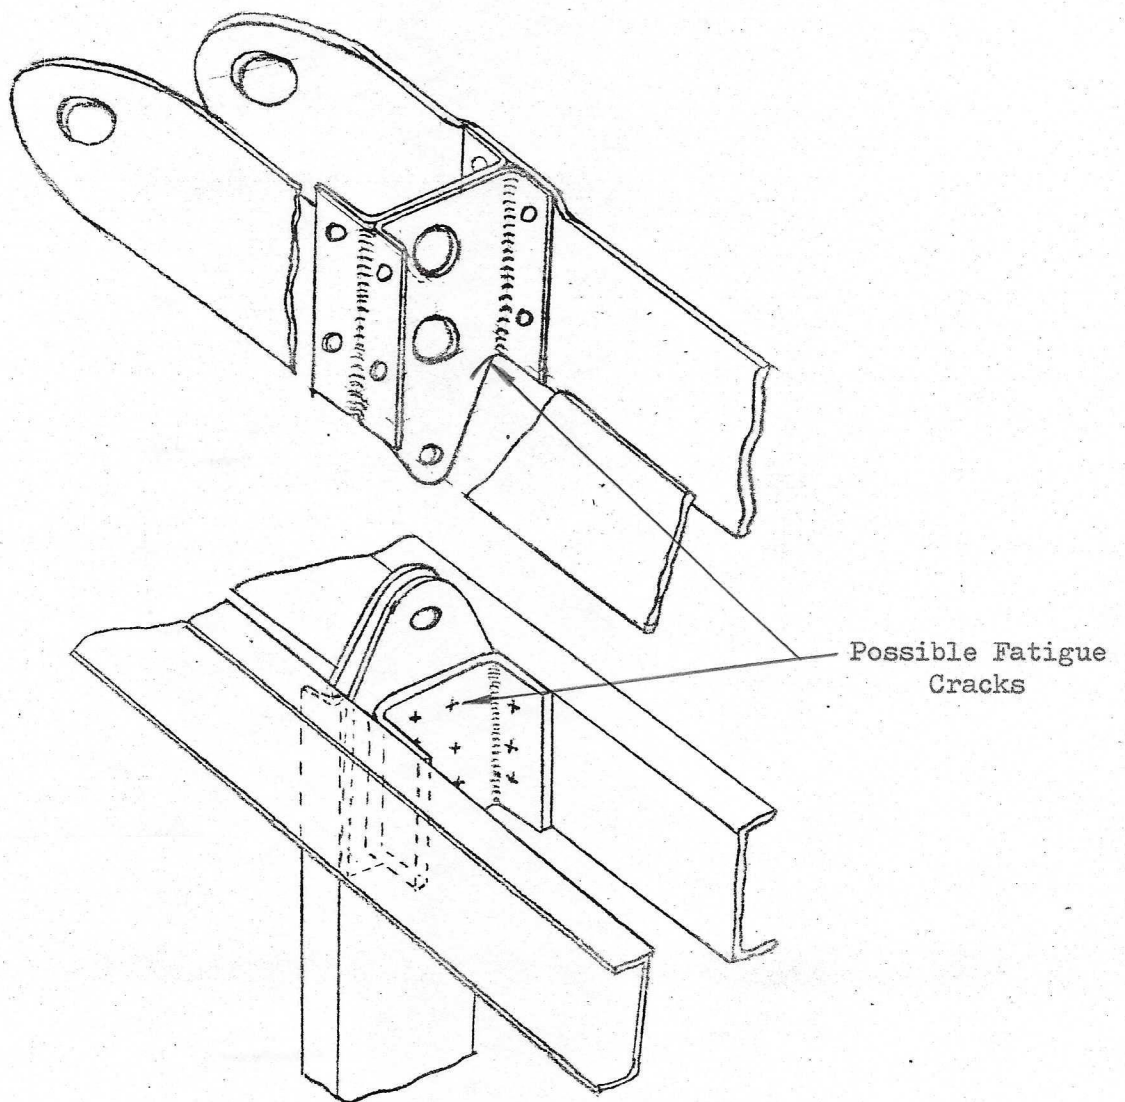
A case has recently been reported of a fatigue crack occurring in the welded bracket which holds the rear spar member of the centre section to the fuselage frame 6. This is a recurrence of the type of failure described in Slingsby Sailplanes Technical Instruction No.69 which has reoccurred on a modified aircraft.

Inspect the welded bracket which holds the rear spar member of the centre section to the fuselage frame 6. Cracks have occurred at the corner of the fitting where the attachment flanges begin.

Also inspect the metal lugs and channel section on frame 6 which are attached to this fitting (see attached sketch).

If any cracks are found the aircraft is to be grounded. All findings are to be reported to Slingsby Engineering Limited marked for the attention of the Chief Designer.
