CAA and EASA Airworthiness Directives (ADs) all owners notified.

Safety Information

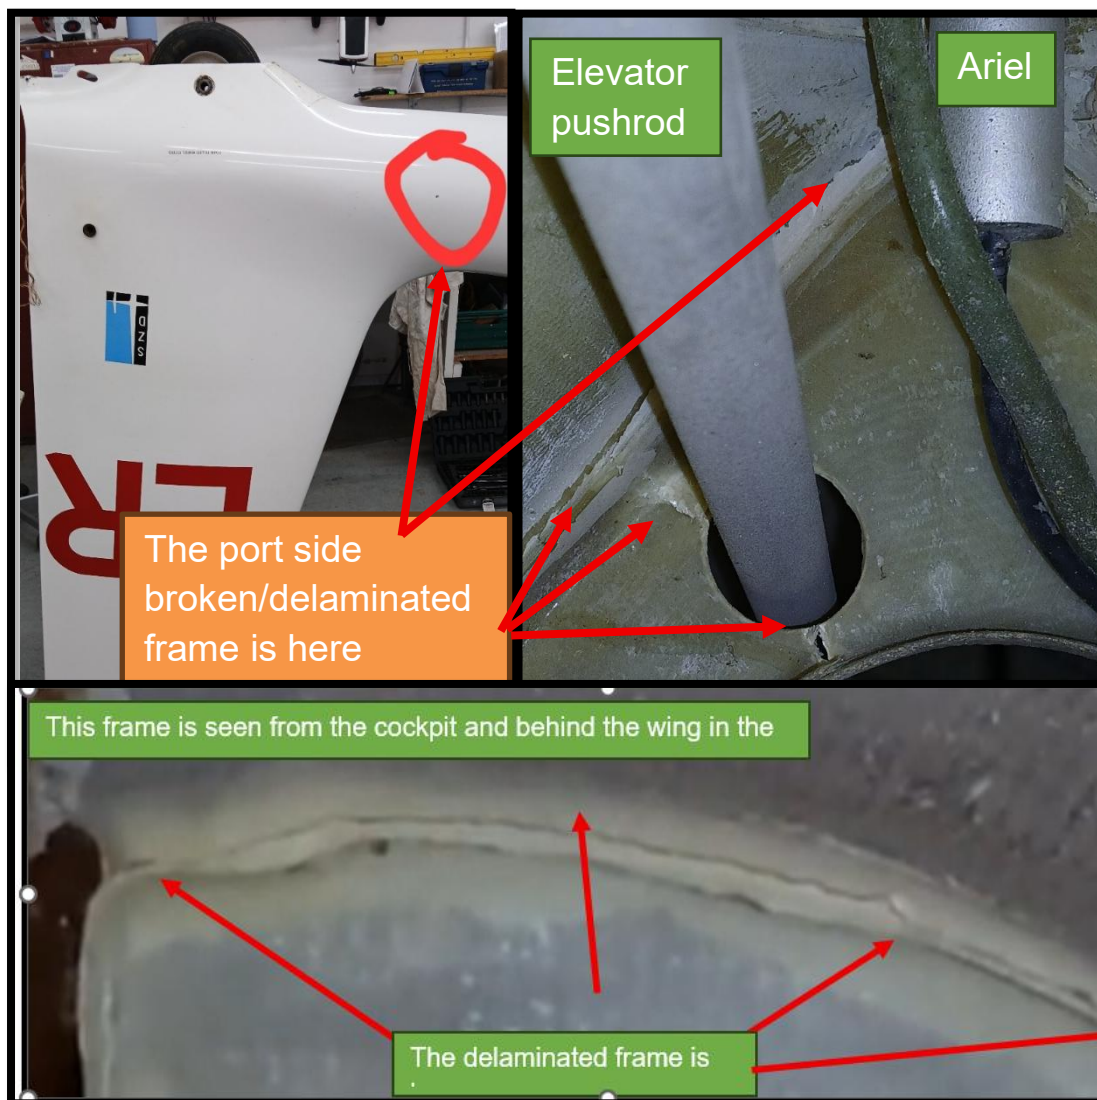
| <p>07 BGA Fleet inspection of SZD 51 Junior fleet by next Annual.</p> <p>We had 2 reports of damage found on SZD 51 juniors, when there have been no reported heavy landings. The inspectors who found the problems, were very diligent and made use of modern cameras on leads that can be found cheaply on amazon.</p> | <p>Advisory</p> |

This is sufficient knowledge, to question if this is a trend of damage that was missed on daily inspection and potentially easily missed annual inspections when not specifically looking for heavy landing damage.

The easiest way to find this damage is shown in the images and video damage is with the glider rigged, wings trestle level, rudder removed, long camera on a stick and good lighting. On the Junior powerful lights shined through the GRP from the outside often make it light enough to see problems on the inside.

In the Junior you need to look at every frame in the fuselage while the fuselage is having a 10 KG force flexing load applied to the top of the fin sideways (see video below).

The BGA are asking all owners to get inspectors to perform a SZD 51 Junior BGA fleet inspection for damage. We currently have 25 airworthy juniors in the BGA fleet, most of which are operated by clubs. Please report any problems found to the BGA by email.

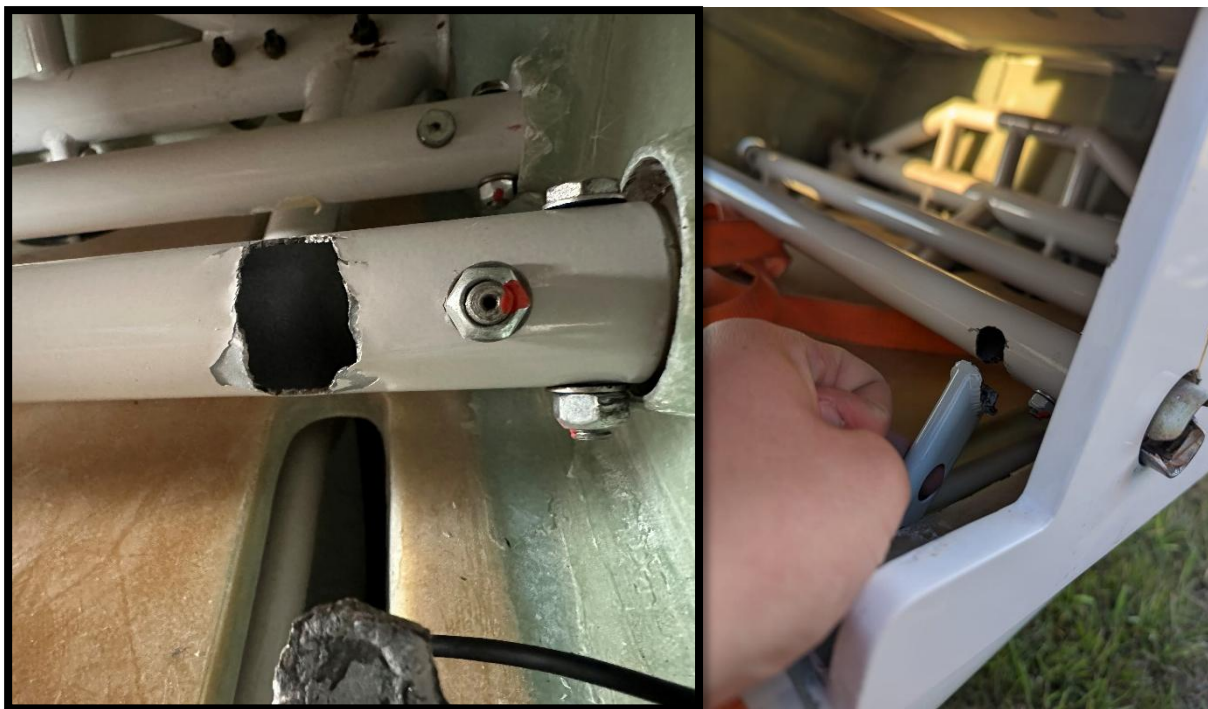
We have had 1 failure of the airbrake torque rod (behind the wings) and another report of a crack. A MOR has been filed with EASA and its possible this will become an AD shortly. Frequent inspections of this are advised. Communicate with Allstar for latest information.

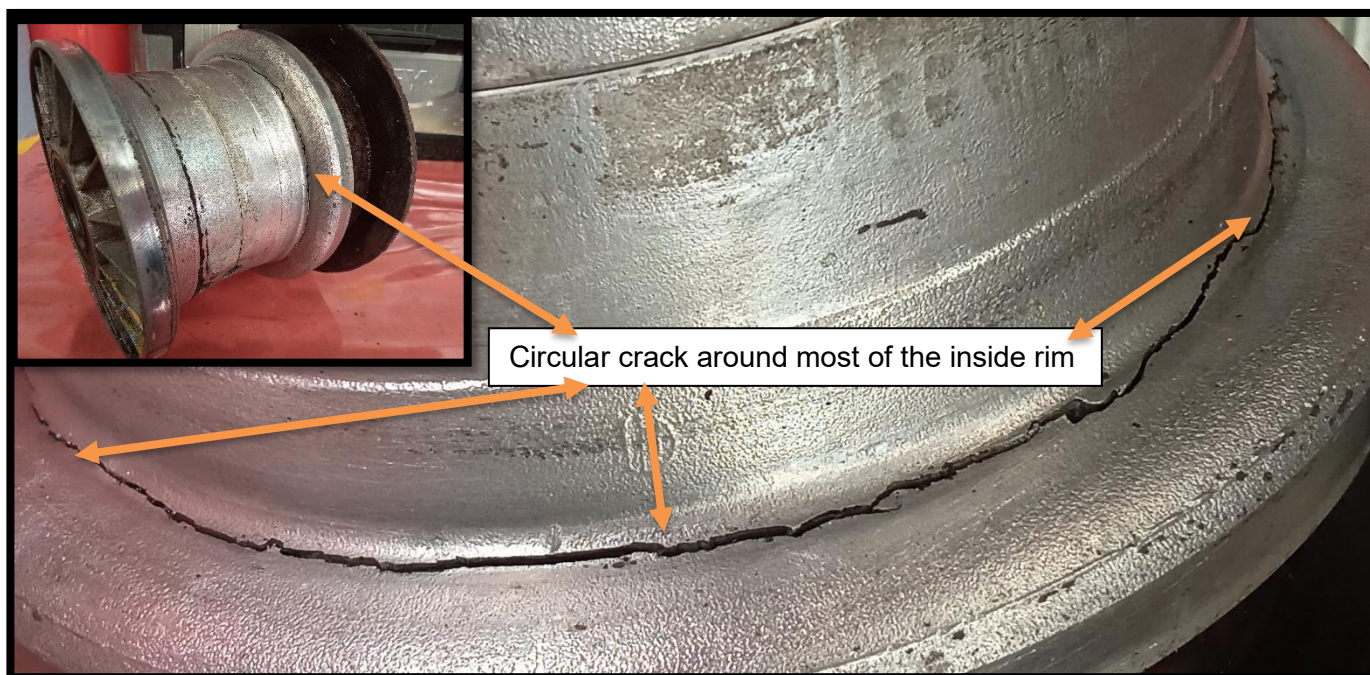
07 Tost Wheel failure found on a Nimbus 3Dt during a tyre change Reported by Navboys

This was found during annual maintenance tyre change. it can only be found with the tyre off. I have never seen a wheel broken like this. Investigations are ongoing to see how it failed. The lesson being always thoroughly inspect the wheel and bearings when changing tyres.

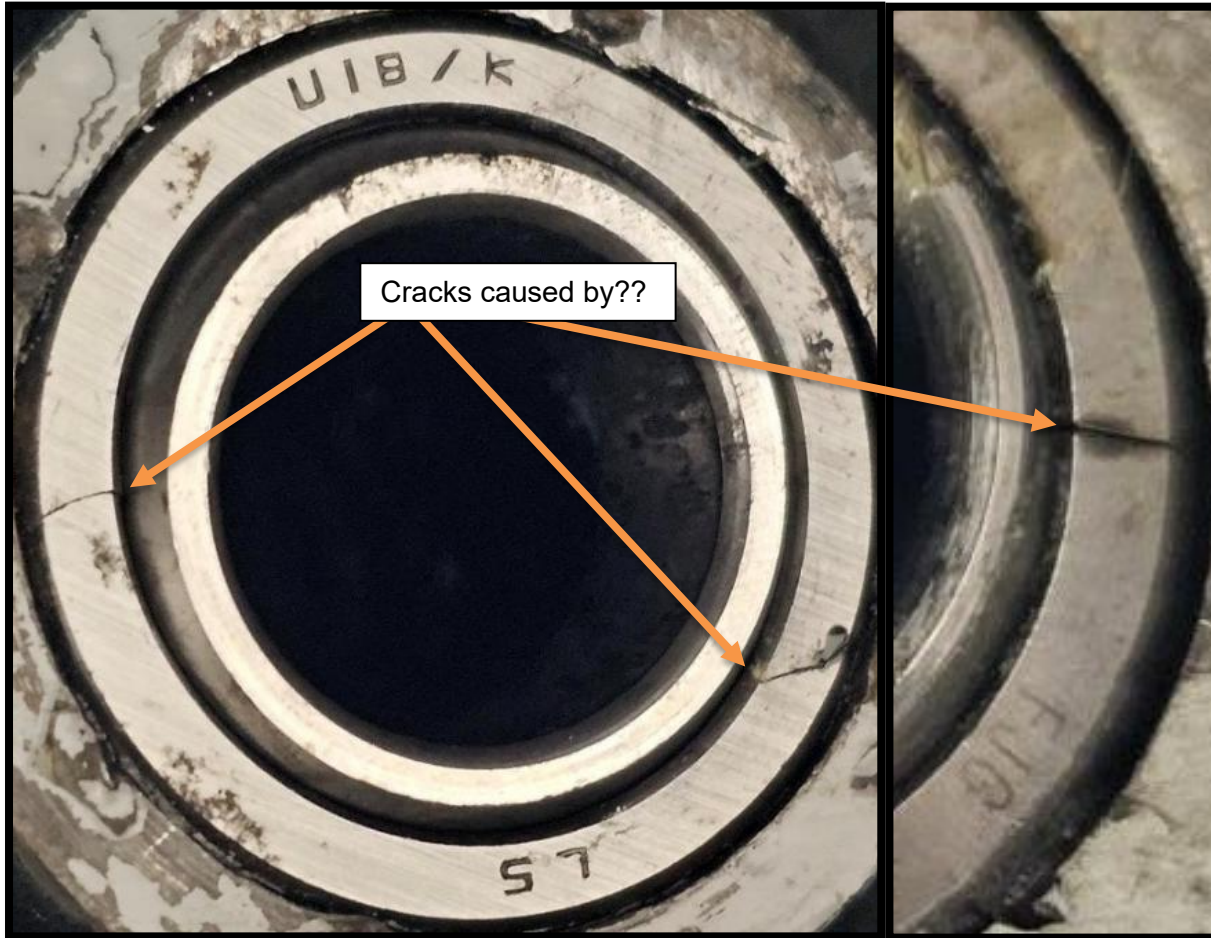
08 Wing root bearing failures reported by Navboys

Would you spot this at every annual? Do a full ground loop/heavy landing check if you ever find bearings like this.

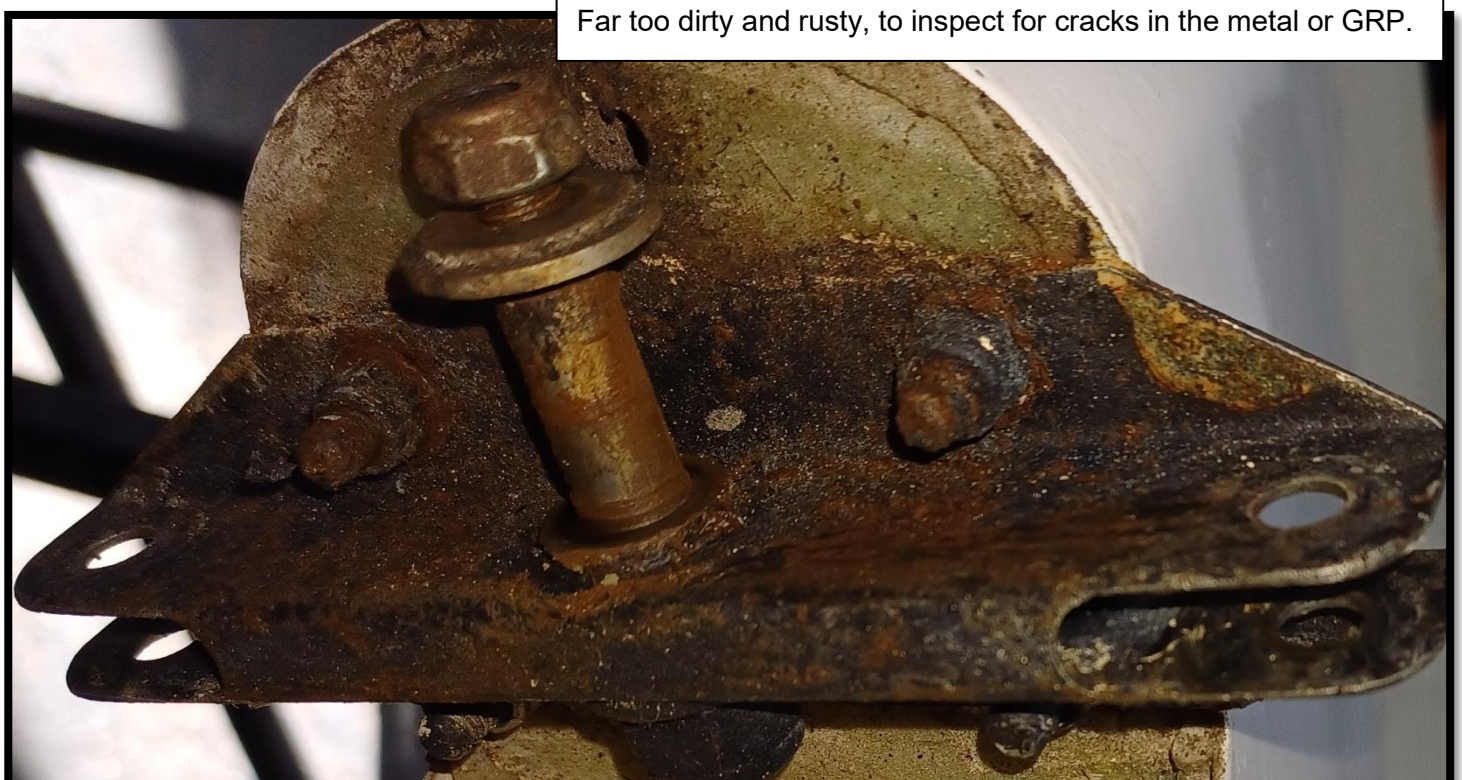
09 LS3 lower rudder hinge corrosion (applies to many other LS types)

If you see anything like this during an annual/ARC, it's not acceptable to leave it. If treated early the hinge would not have needed changing.

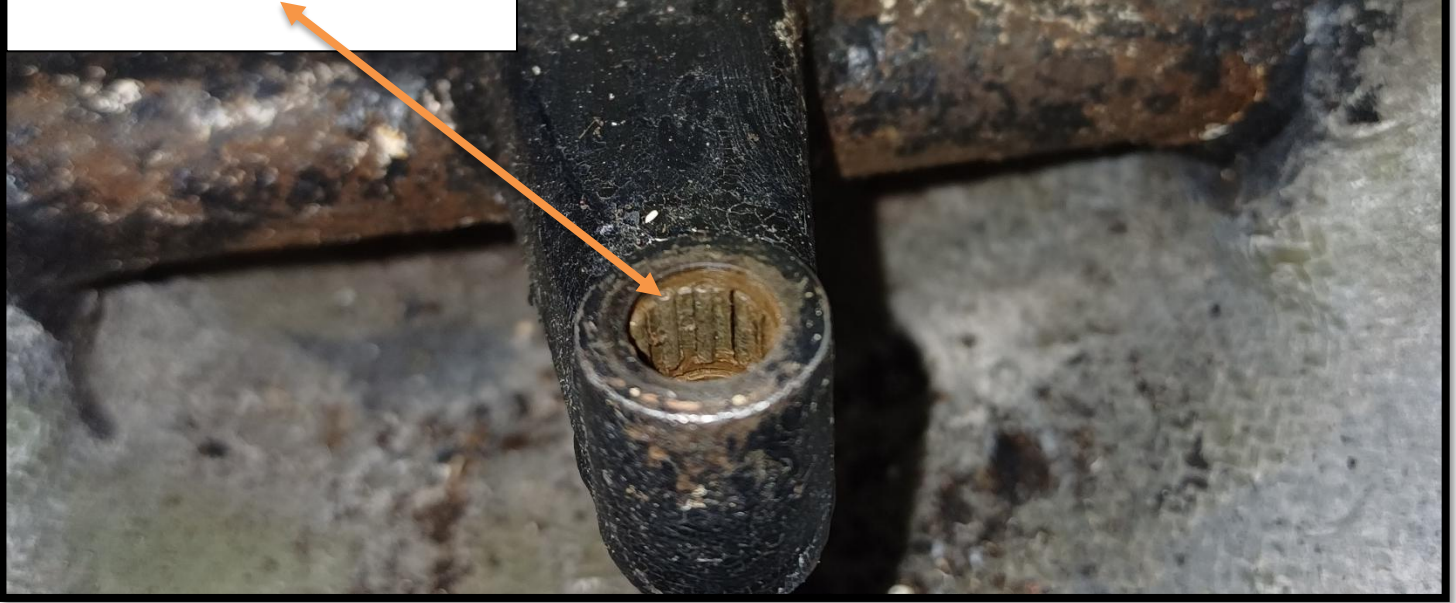
Needle bearing requires very regular lubrication, otherwise it goes rusty and seizes. The lubrication requires rudder removal

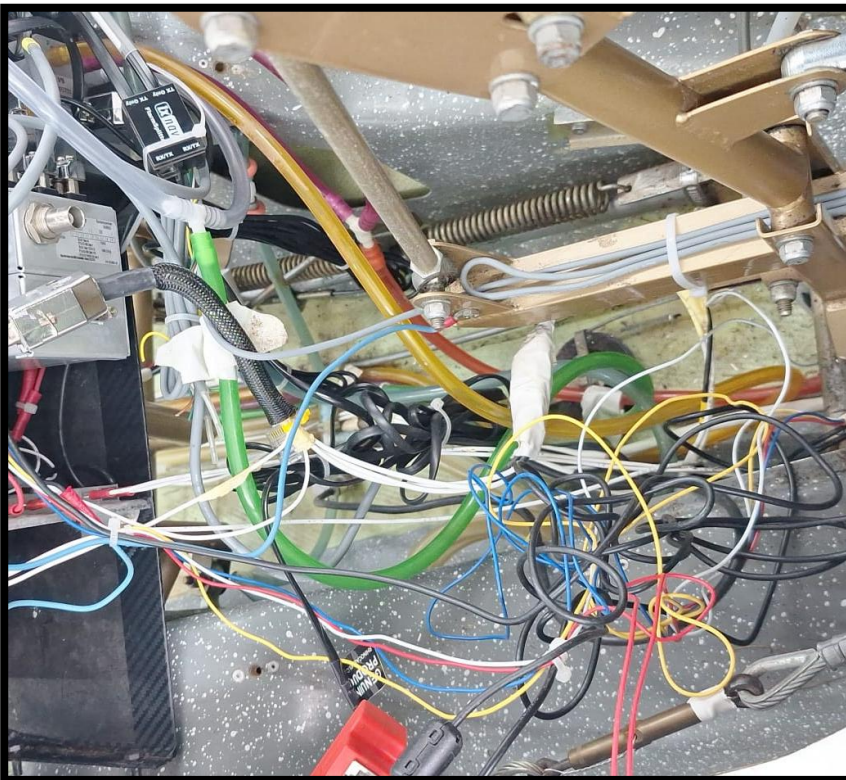
10 Electrics and instrument tubing

There comes point where you must stop adding wires and repackage the entire electrical and pneumatic tubes as a neat and tidy installation. This is within the realm of pilot owner maintenance. LS glider.

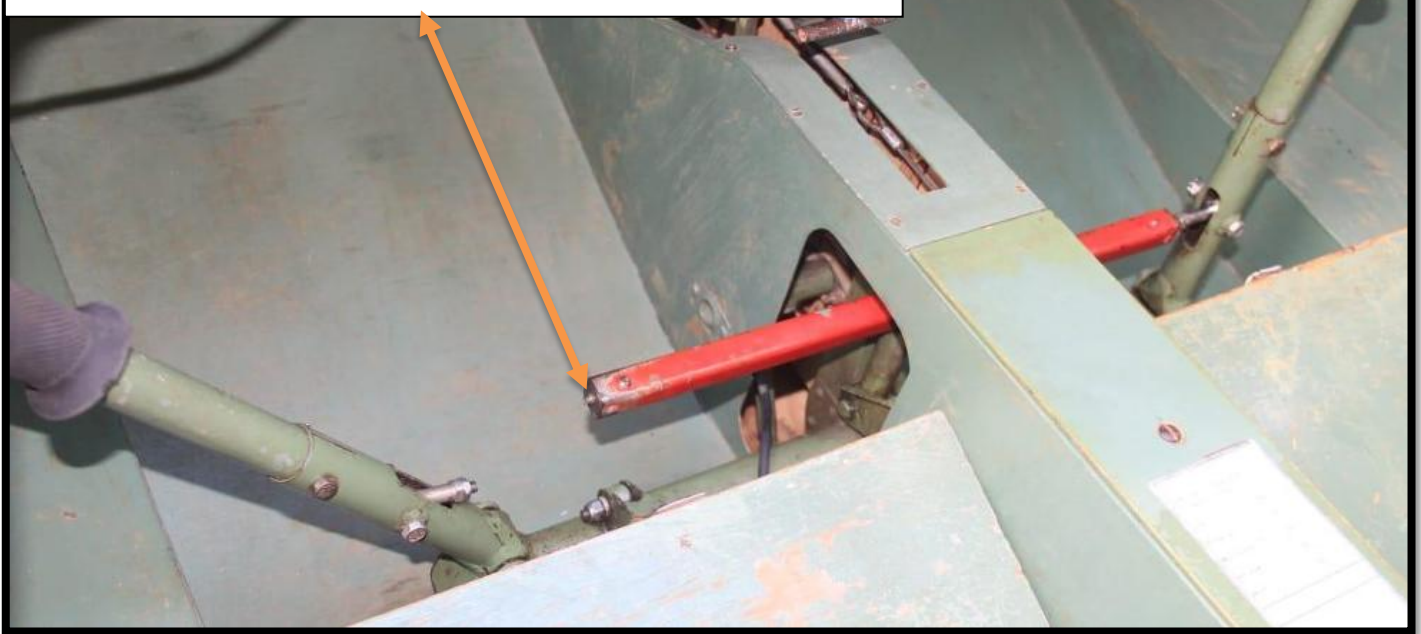
14 T21 damaged

Look at the image below. The red tie rod between stick is very susceptible to being broken when trod on.

Snapped rod end. Remind all crew/passengers they must **never** step on Red tube. Put a 'no step' placard would be helpful.

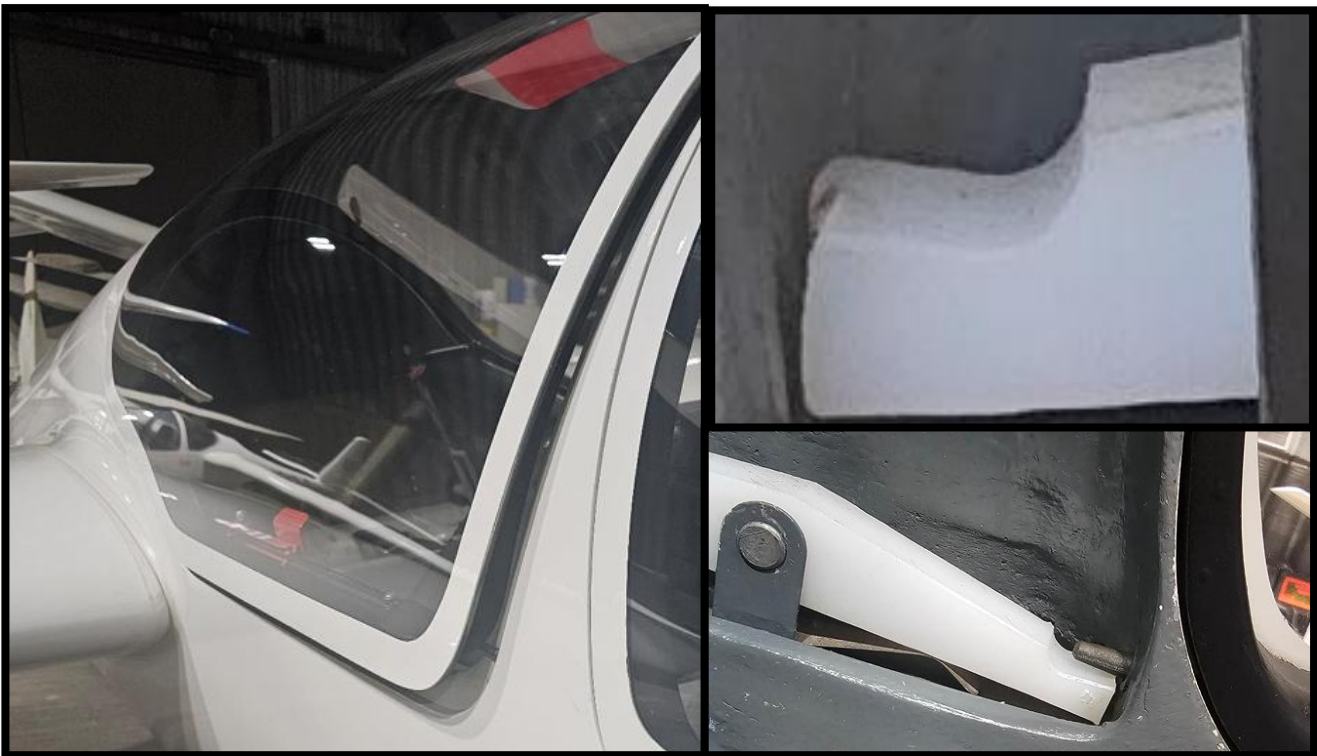
15 K21 Nylon canopy interlock should be replaced with Aluminium interlock

Schleicher Technical Note 36 published in 20212 details the issue of the nylon front/rear canopy interlock wearing out. When enough forced is used, it simply does not work. This is not an Airworthiness directive, but it's a really good product improvement that might prevent rear canopies opening in flight.

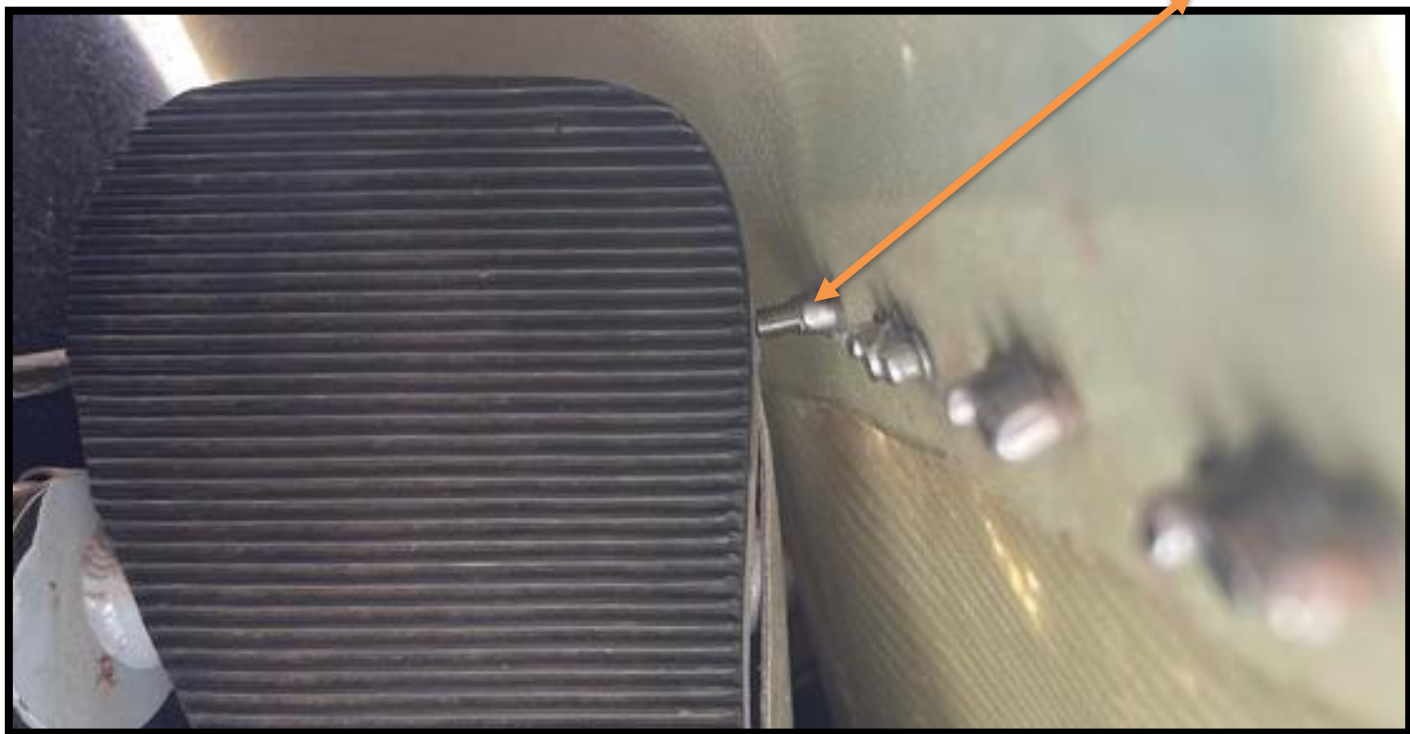
16 Duo Discus (possibly could apply to other Schempp Hirth 2 seaters)

Discus rear rudder pedal was restricted by a screw that was too long in the cockpit cover above it. Make sure you look in these areas (with camera) after you have fitted it to check for clearance.

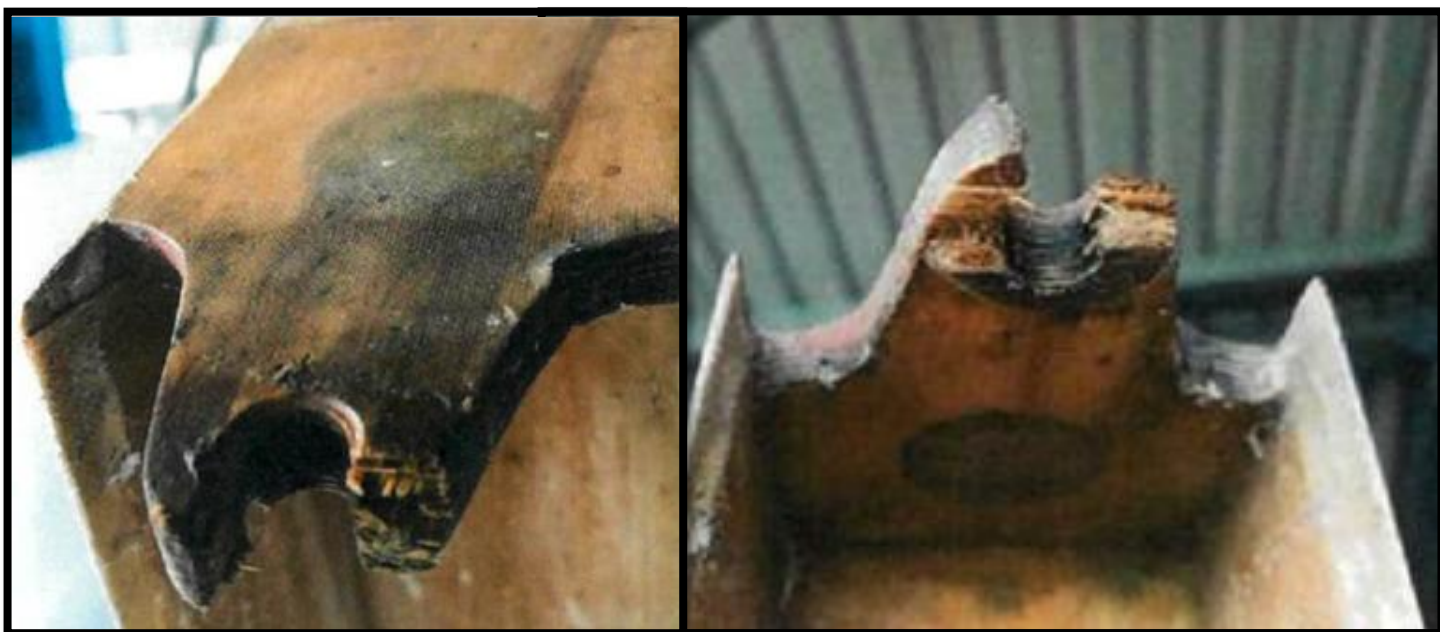
17 Puchacz broken top rudder hinge after very heavy landing

still investigating this. But there is little doubt that the wooden parts in a Puchacz (also Jantars and Juniors) are not aging well. In this case, potential oil contamination made the wood weaker. Allstar now supply a Nylon bush that does not require oil. If your hinge is looking tatty, is losing density (early signs of dry rot) and has oil contamination, you are going to need change the hinge. Use GL1 plywood and thoroughly weatherproof it.

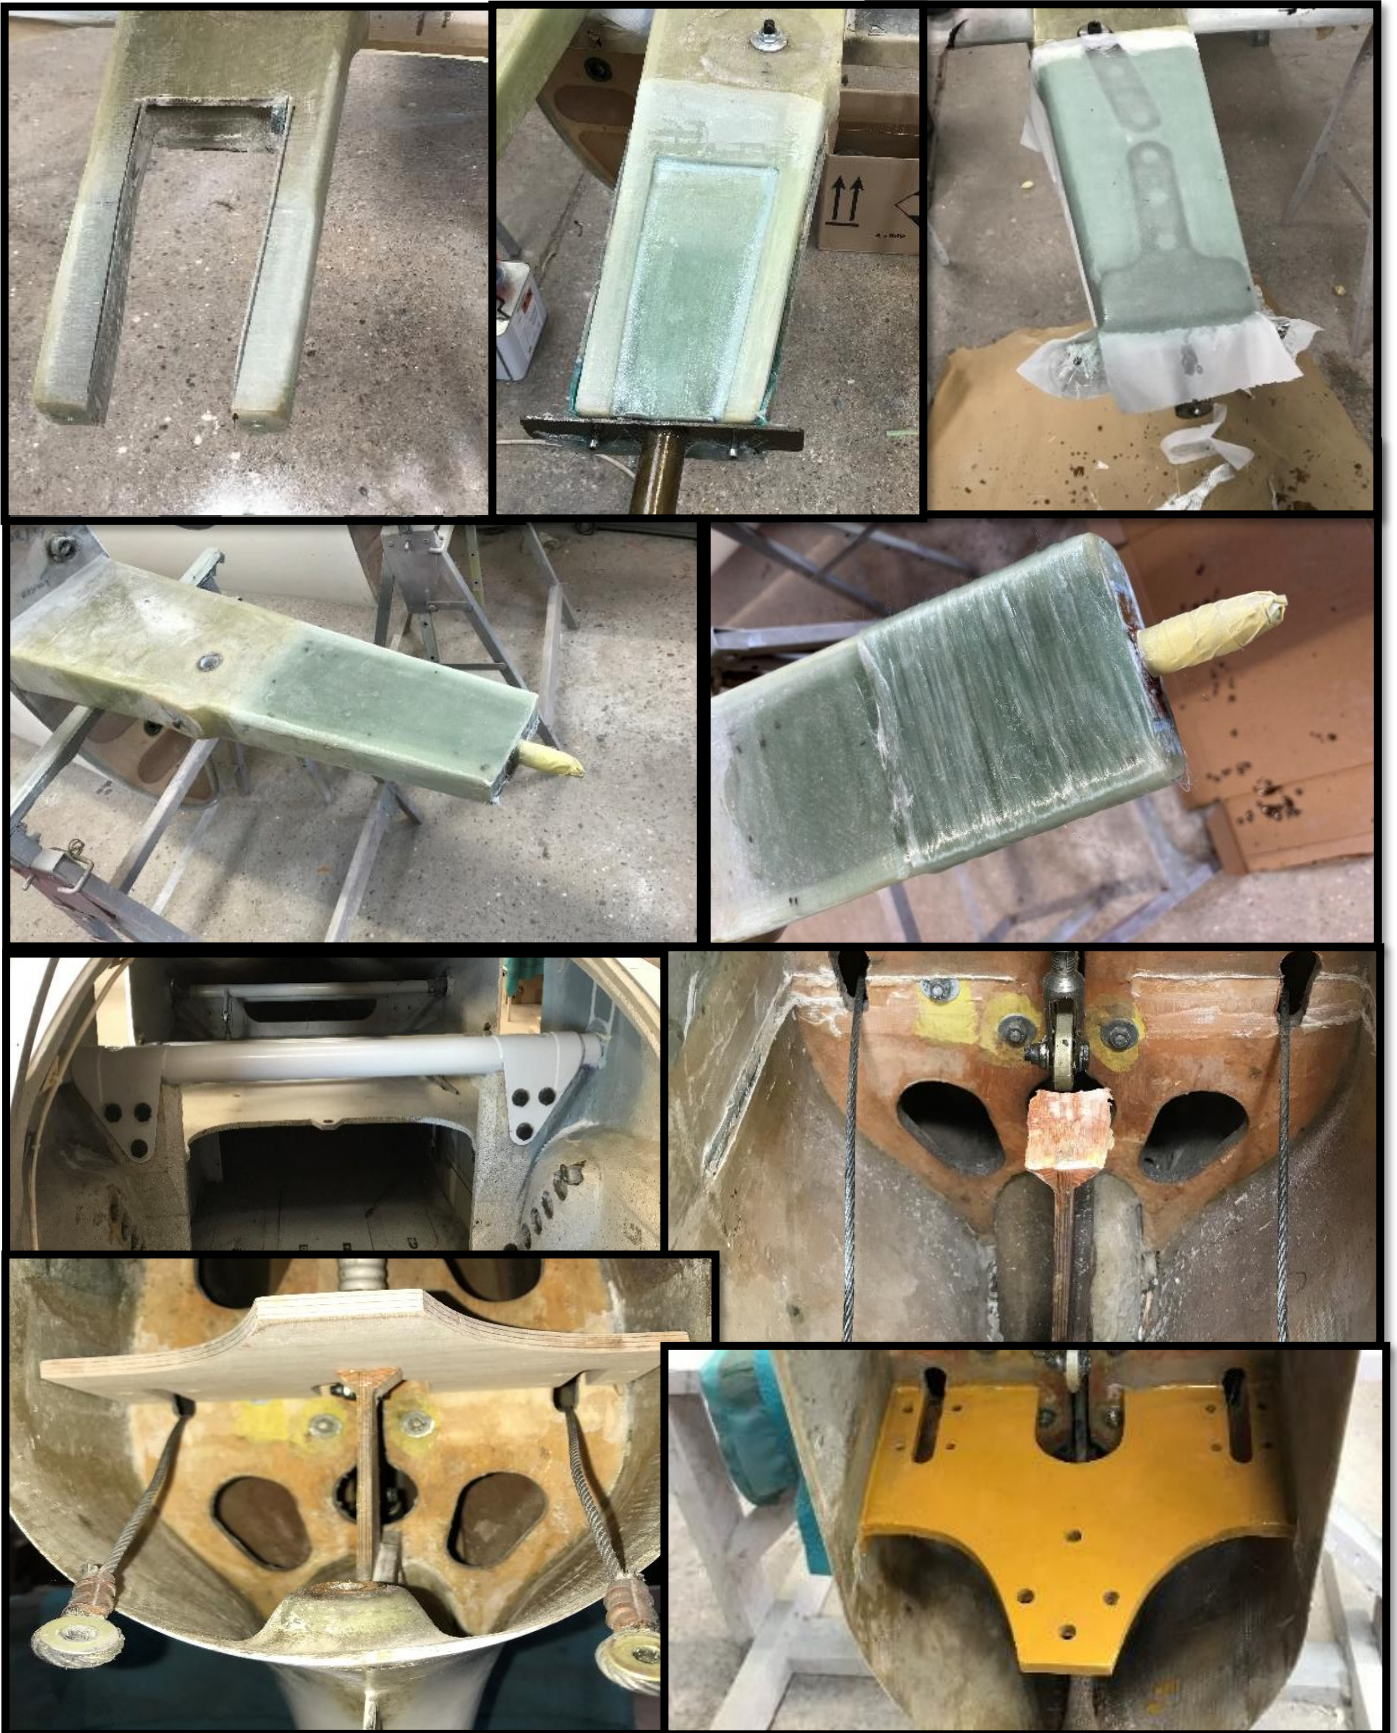
18 Puchacz relief to 12000 hours

These are the first to be done outside of Poland. A few of these are now underway and one is complete. Some of the composite work is quite complex, but a lot of the work is mechanical. photos Dave Mason

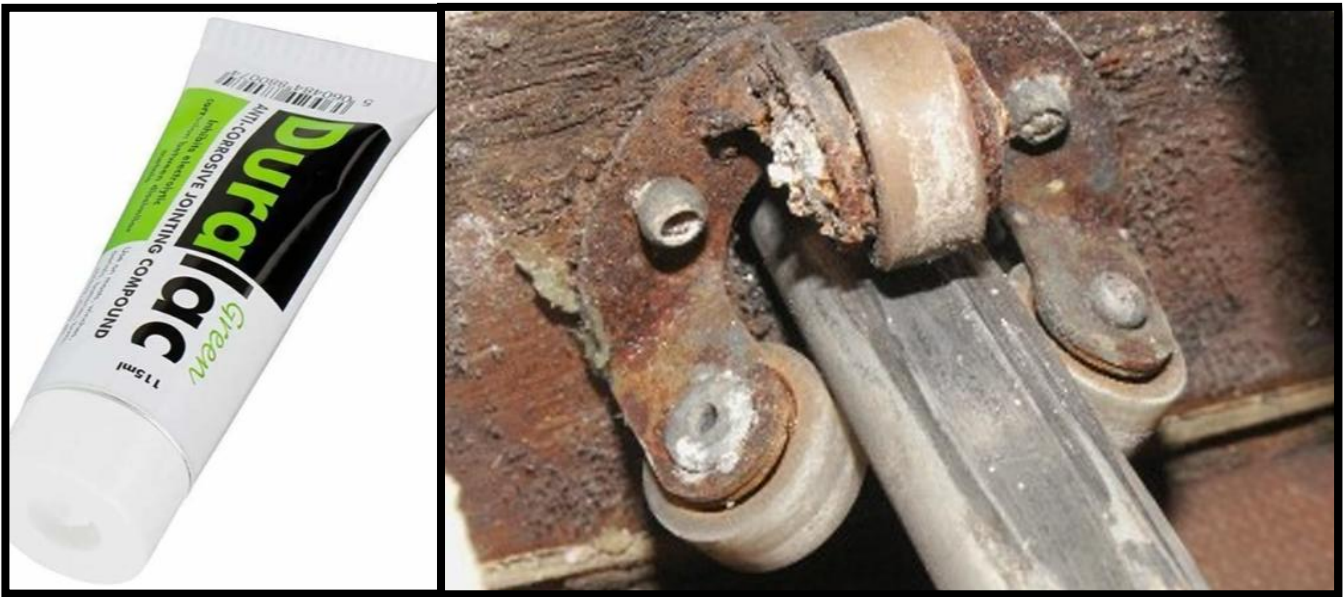
20 Wood and metal incompatibility

If you bolt metal to wood, they are not chemically compatible, the metal will rot the wood, and wood will corrode the metal. Low humidity storage slows this down but does not stop it entirely. If you ever work on most Slingsby wooden aircraft, if you remove a 65-year-old bolt, normally it has minor surface corrosion that can be treated and re used.

But a German sailplane bolt after 65 years, will often be too corroded to reuse. 70 years ago, Slingsby used Duralac. It's still used to prevent corrosion on metal to metal and wood to metal joints. Bolts and fittings may be coated with this material before assembly. Duralac to specification DTD369B is supplied in small tubes or tins. This compound will harden over a period.
