# BGA ENGINEERING NEWS

Number 8, September 2001

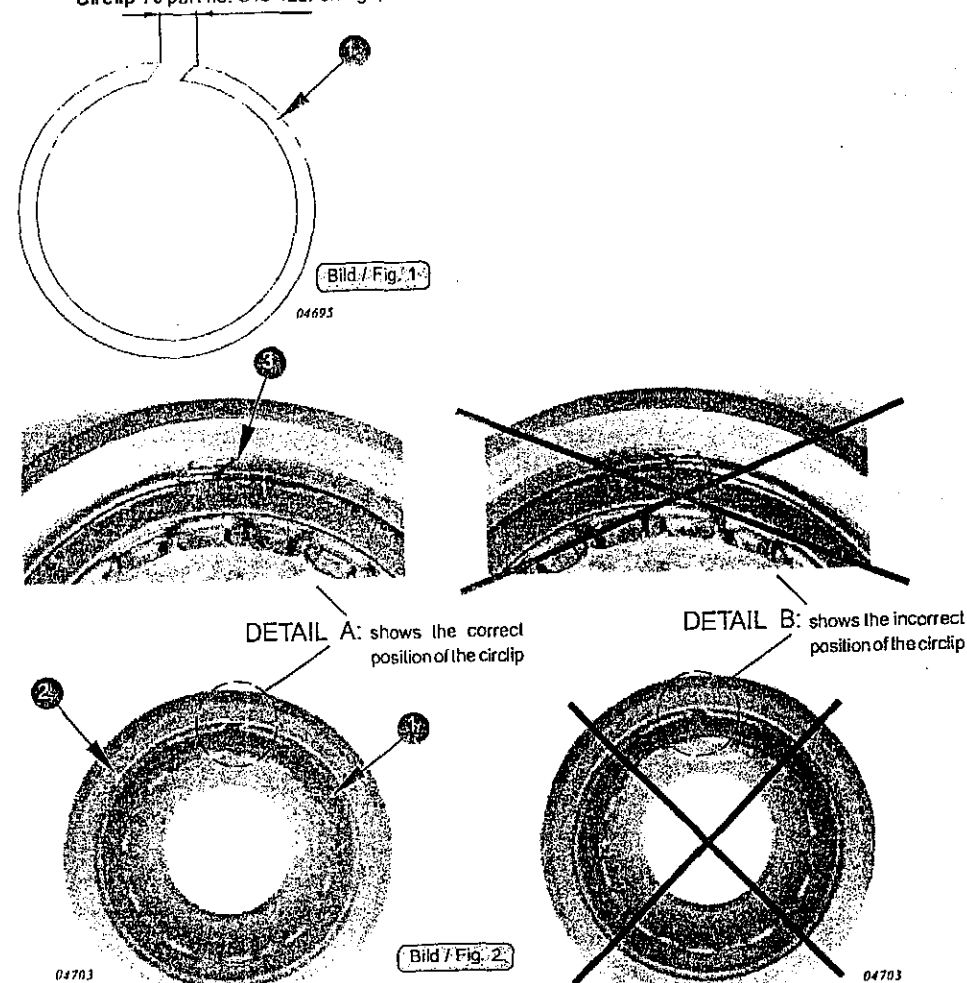
On repair work on sprag clutch (2) or at engine overhaul the circlip 68 part no. 845 420 has to be replaced by the circlip 70 part no. 845 425. Verify by inspection if the new circlip 70 is already fitted. See fig. 1

Circlip 68 part no. 845 420: end gap when fitted = 11mm (0.433 in)

Circlip 70 part no. 845 425: end gap when fitted = 5 mm (0.197 in)
