**ACCIDENT**

<b>Aircraft Type and Registration:</b>	LS1F Glider, BGA4665	
<b>No &amp; Type of Engines:</b>	None	
<b>Year of Manufacture:</b>	1976	
<b>Date &amp; Time (UTC):</b>	9 August 2005 at 1725 hrs	
<b>Location:</b>	Near Husbands Bosworth Airfield, Leicestershire	
<b>Type of Flight:</b>	Private	
<b>Persons on Board:</b>	Crew - 1	Passengers - None
<b>Injuries:</b>	Crew - None	Passengers - N/A
	Others - 1 (Fatal)	
<b>Nature of Damage:</b>	Extensive damage to the left wing, left aileron separated from the wing and damaged right winglet	
<b>Commander's Licence:</b>	BGA Glider Pilot's Certificate (Gold and Three Diamonds)	
<b>Commander's Age:</b>	24 years	
<b>Commander's Flying Experience:</b>	692 hours (of which 317 were on type) Last 90 days - 111 hours Last 28 days - 46 hours	
<b>Information Source:</b>	AAIB Field Investigation

**Synopsis**

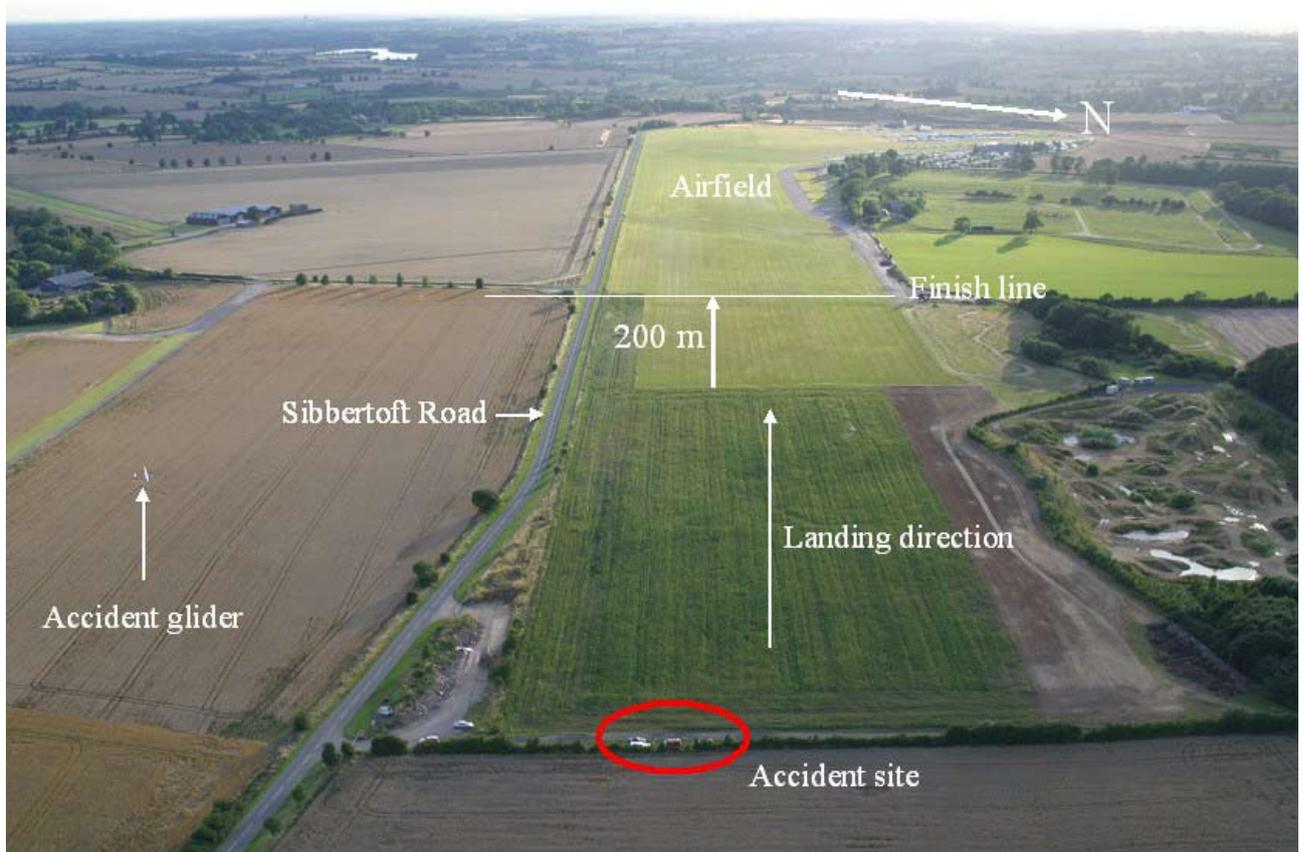
**Figure 1**

Accident site relative to Husbands Bosworth Airfield

The accident occurred outside the eastern boundary of Husband's Bosworth Airfield. The photographer's vehicle had been parked on a grass area to the right of a farm track that ran north from Sibbertoft Road. The position of the vehicle was roughly 350 m from the airfield's eastern boundary and 900 m east of the start of the landing area. In addition to the photographer's vehicle, there were four other vehicles parked in the vicinity. A red van and a black car were both parked to the north of the photographer's car and a black car and a silver car were parked alongside each other to the west. At the time of the accident the photographer was standing on his vehicle, giving a combined height of approximately 11 ft. There were also four spectators on the red van with a maximum height (with the spectators standing) of about 12 ft. A hedge ran north-south just to the east of the vehicles.

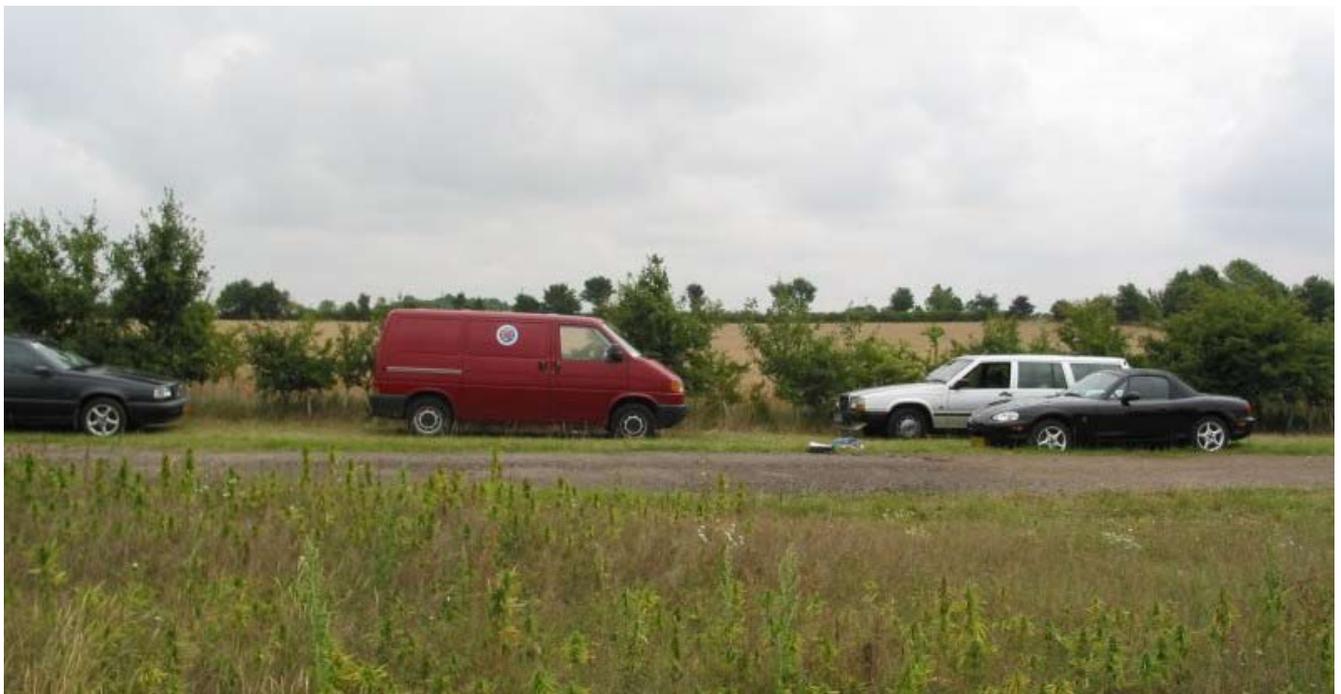
**Figure 2**

View looking east of vehicles parked in the lane

The height of the hedge varied along its length but in the area of the cars it extended to a maximum height of about 15 ft.

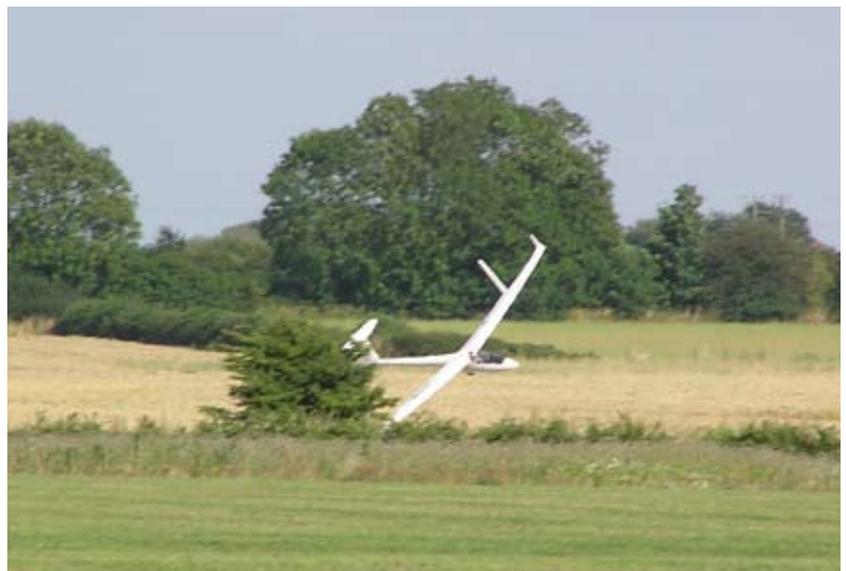
**Figure 3**

Glider just before ground impact

The glider came to rest in a standing crop of wheat, about 400 m to the south-east of Husband's Bosworth Airfield and to the left of Sibbertoft Road. Figure 3 is a picture of the glider just before it struck the ground. Inspection of the glider revealed extensive damage to the left wing, with pronounced damage about 3 ft inboard from the wing tip. The left aileron had completely detached and was found lying against the fuselage. The only other noticeable damage was to the right winglet, consistent with contact with the wheat. Detailed examination of the glider did not reveal any pre-accident defects with its structure or flying controls.

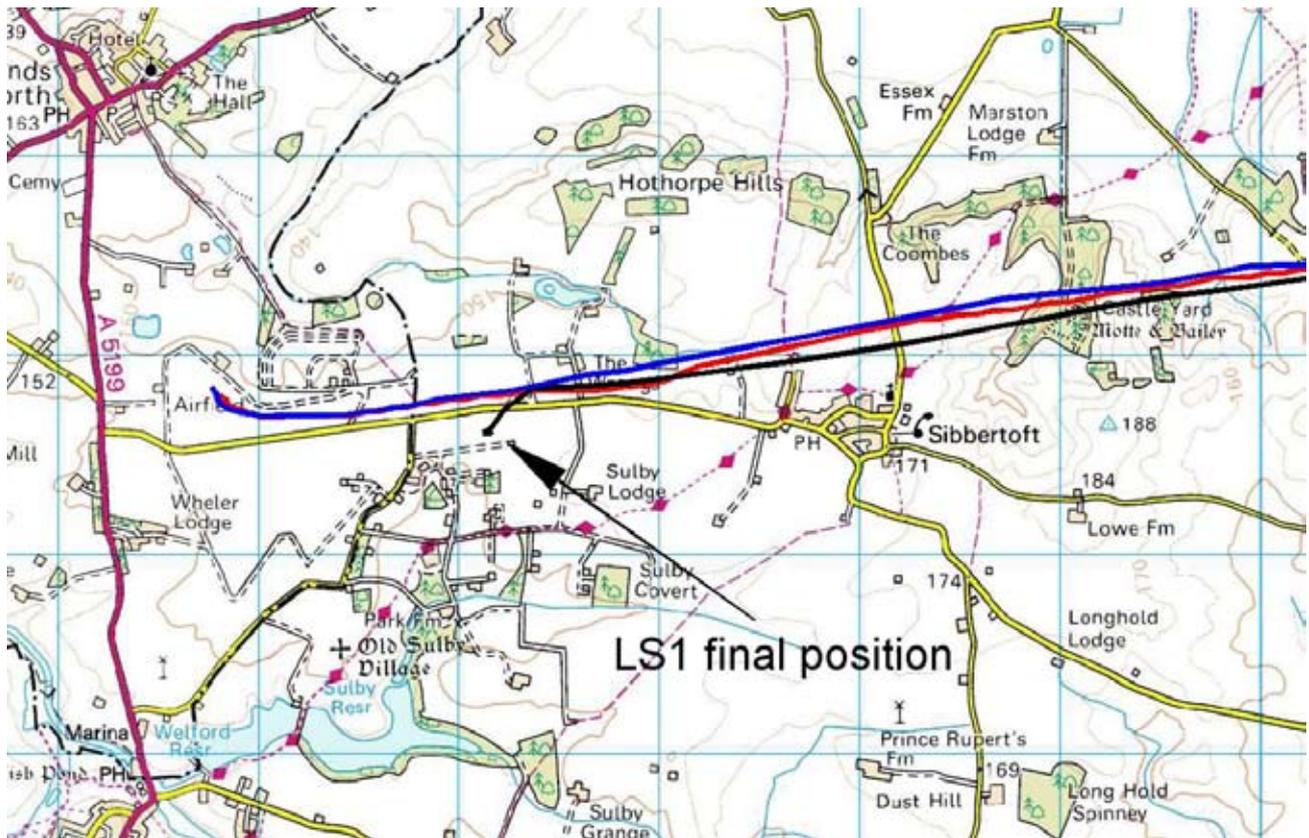
**Figure 5**

Ground tracks of gliders approaching the airfield

Analysis of the information recorded for the race during which the accident occurred indicates that the club class gliders were all below 500 ft agl some 2 nm (3,704 m) before finishing the race, and in one case 3 nm (5,562 m). It further indicates that the majority of gliders were below 250 ft agl at least 1.5 nm (2,778 m) prior to crossing the finishing line.

Using the recorded data, a plot was created of the accident glider's track and that of the two preceding gliders as they approached the airfield (Figure 5).

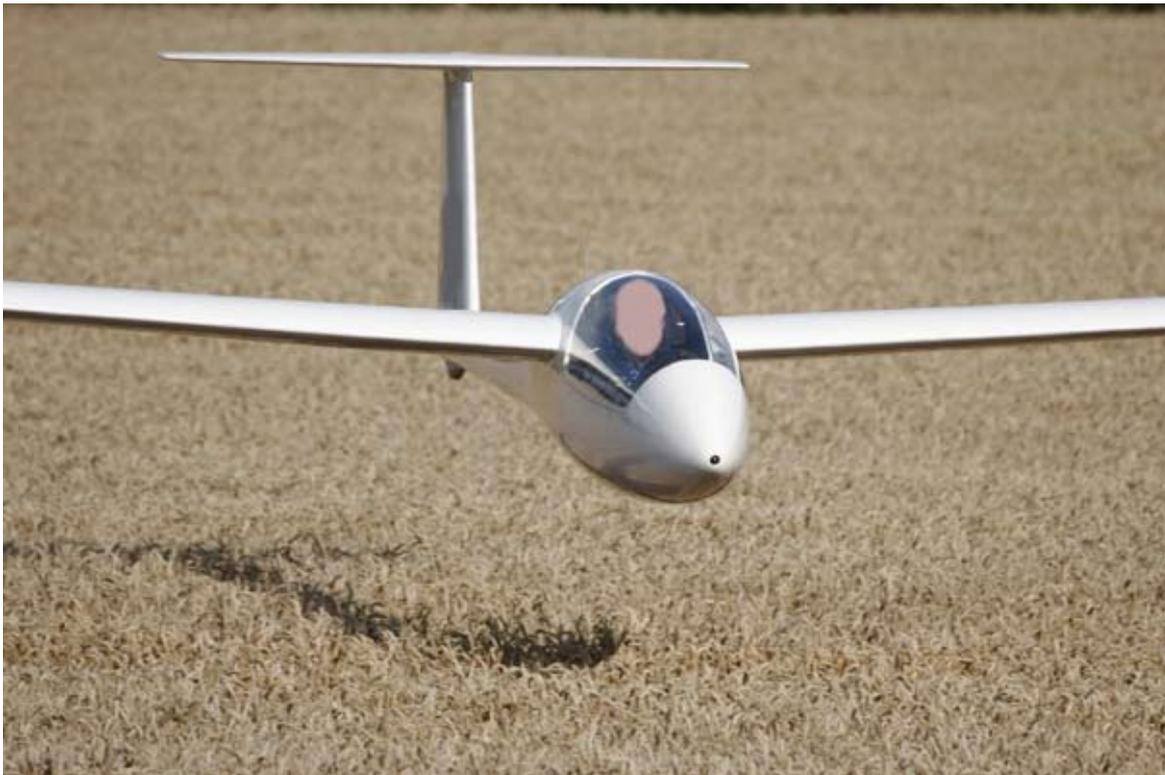
**Figure 6**

Photograph of an approaching glider

The last two photographs on the photographer's camera are of the glider that struck him. These, together with other video imagery, showed that he had the camera up to

his eye whilst the glider crossed the field in front of him. Video evidence showed the photographer was standing upright, ducking at the last moment before being struck by the glider's left wing.

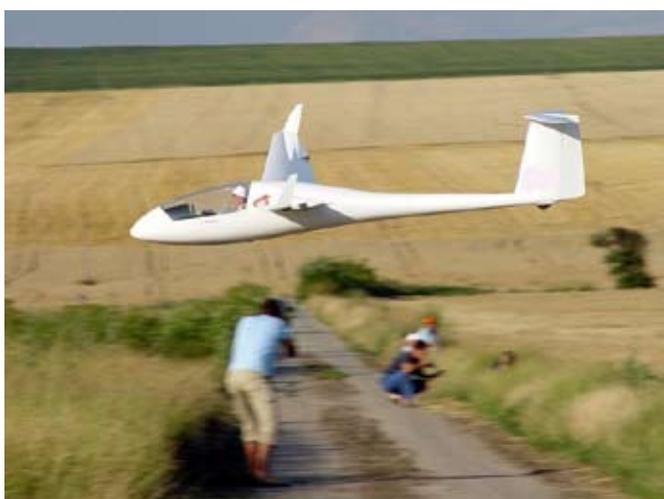
**Figure 8**

Glider and spectators

On the day of the accident, no attempt was made to control or influence the presence of spectators beneath the final approach path. Moreover, evidence was found of low flying in close proximity to people during the final approach phase of other international competitions. For instance, photographs published on the Internet of the 2005 FAI European Championships held overseas show spectators close to gliders in the late stages of the final glide to the finishing line. Two examples are shown in Figures 8 and 9 below; the gliders and their pilots in these examples have been deliberately disidentified.

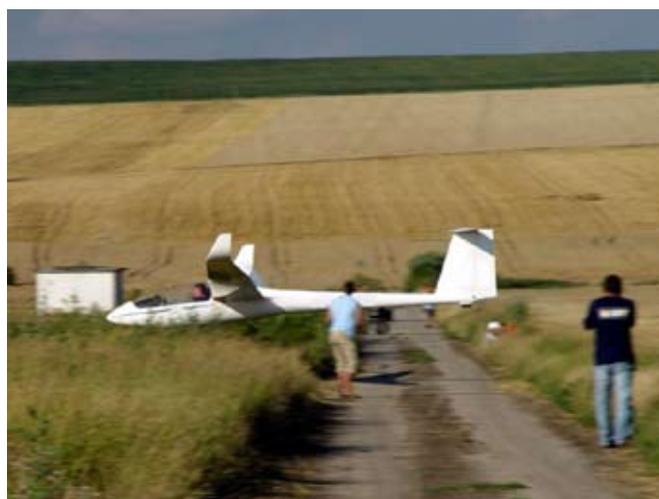
**Figure 9**

Glider and spectators
