BRITISH GLIDING ASSOCIATION

TECHNICAL NEWS-SHEET 2/3/4/76

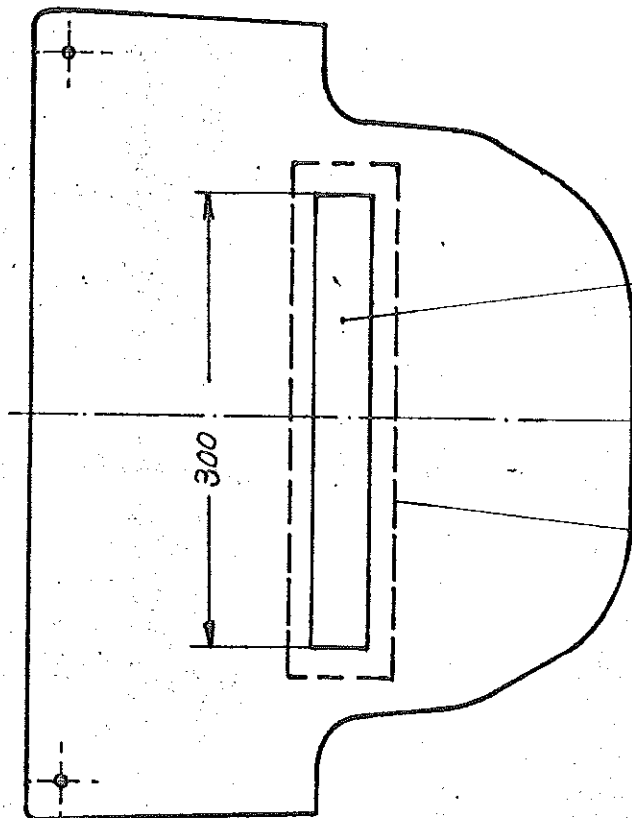
Versteifung der Sitzwanne  
Reinforcement of the seat

- 1.5 Cirrus Seat. - Possible fouling of tow release lever. LBA 76-7 and Technical Note 278-18, requires re-enforcing of the seat. BGA Compliance required not later than C of A Renewal 1977.

Versteifung

stiffening material

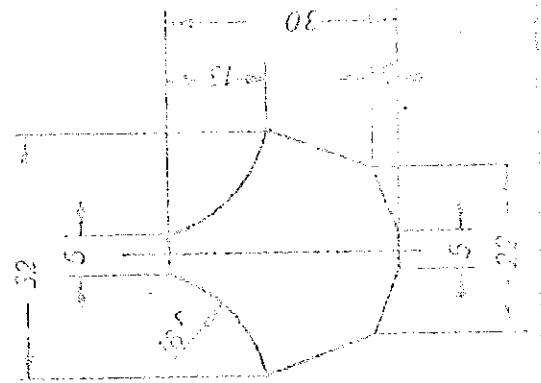
Abb 1

3. A check must be made to see whether the metal cover plate (1mm metal) is laid round the entire spar tube (see Sheet 3 Figs: 1 and 2).

- 1. = Fig: 1.    1.1 = Metal sheet 1 mm not laid completely round the spar tube.
- 2. = Fig: 2.    2.1 = Metal sheet 1 mm completely encircling the spar tube.
- 2.2 = Application of the sheet of reinforcing metal
- Material: 1 mm sheet metal 1.7214.4
- 3. = Fig: 3.    3.1 = Operating lever with reinforcement.
- 4. = Fig: 4.    4.1 = Wooden plug 1 mm
- 4.2 = Frise edge bar
- 4.3 = Position of cut in frise edge bar

4. If cracks are observed or if the cover plate does not completely surround the the spar tube, then the reinforcement illustrated in Fig: 3 is to be fitted. (Material: Sheet metal 1 mm 1.7214.4).

Abwicklung des  
 Verstärkungs-  
 Bleches

Abwicklung  
 Blech 1 mm  
 1. 7214 4
