BGA TECHNICAL COMMITTEE

Technical Newsheet. TNS2/3/78.

PART 1. AIRWORTHINESS "AGGRO". (Please add to the 1978 "Pink" Compendium).

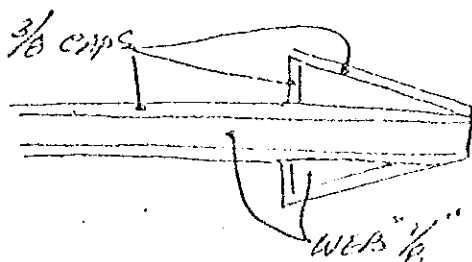
MANDATORY FIN & RUDDER MODIFICATION - Jan 12-78 H.E. PIER

A structural weakness in the fin attachment has come to light which makes the fin susceptible to damage in case of hard landing loads or dropping of the tail during ground-handling. Skin delamination or glue separation between the fuselage deck and the fin root-rib is possible which can in turn cause catastrophic vertical tail flutter at speeds as low as 60 knots. The structural damage as described may be visible only after very close inspection, and all owners who are presently flying their DUSTERS are advised to make an immediate inspection of fin root-rib area.

- A. Install a partial bulkhead which ties the fin leading-edge into the fuselage structure. (see enclosed dwg)
- B. Replace skin doubler at elevator control-horn slot in fuselage deck with 1/4"x3/4" wide doubler, extending it behind the fin leading-edge extension.
- C. Install access-hole cover (smaller and relocated downward) on left side of fuselage aft of sta. 185.5 .
- D. Install 1/8"x3/4" wide skin doubler inside fuselage skins at rudder cable exit points.
- E. Install 3/8" capstrip bracing on top side of fin root-rib.
- F. Replace rudder with redesigned fabric-covered and balanced unit.
- G. Lower  $V_{ne}$  to 100 knots.

The above modifications will necessitate removal of the left-side fuselage skin aft of sta. 185.5 . A standard (ten x t) scarf joint is called for, centered over the bulkhead at sta. 185.5, so take care when removing the discarded skin piece that the area to be scarfed remains intact on the fuselage.

*DUSTER PLANS HAVE BEEN CHANGED TO SHOW FIN LEADING EDGE WEB AND CAP STRIPS RUNNING FULL DEPTH INTO FUSELAGE TO FORM A LEADING EDGE SPAR-WEB/BULKHEAD.*

HOLLOW OUT FOAM-GLASS FAIRING & FILL W/ LEAD SHOT POTTED IN RESIN. BALANCE RUDDER AS CLOSE TO HINGE LINE AS POSSIBLE.

REPLACE EXIST'G SKIN DOUBLER W/ 1/2" X 3/4" WIDE
