BGA Technical Committee

TNS/11/12/79

- 1.0. Airworthiness "Aggro" - The last for 1979. These items will be included in the 1980 GREEN pages.
- 1.1. Bocian Elevator Final Drive. Rod-end fatigue failure. The attached BGA Tech. Note was mailed to registered owners 31/10/79.

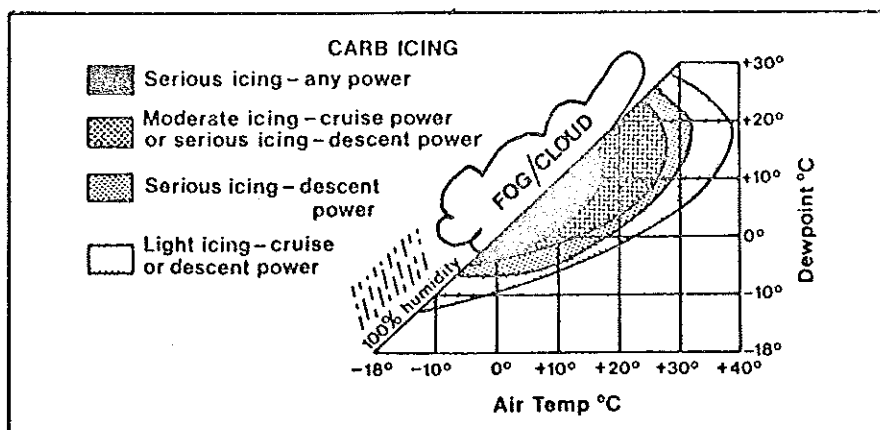
- j. The chart below shows when carburettor icing is most likely to occur.

CARB-
ICING!!

- i) Ensure the carb heat works during the pre-take off checks
 - ii) During flight monitor engine instruments for loss of rpm (fixed pitch) or manifold pressure (constant speed), which could mean carb ice is forming.
 - iii) Apply full carb heat early - and keep it on. The engine may continue to run roughly for a short period until the ice melts.
 - iv) Use full carb heat for several minutes before a descent, and periodically warm the engine during a closed throttle descent.
- k. Have warm clothing available in case of heater failure, or a forced landing.
 - l. After flight in heavy rain ensure pitot-static and intake drains are clear. Trapped water may freeze in winter.
