BRITISH GLIDING ASSOCIATION

TECHNICAL COMMITTEE

TNS 5/6/80

Please add to the 1980 Green Pages.

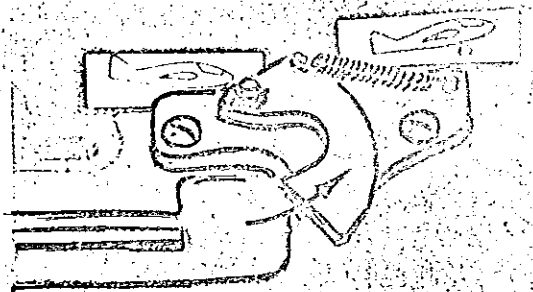
LOCK  
POSITION.

LOCKS DOWN  
AUTOMATICALLY.

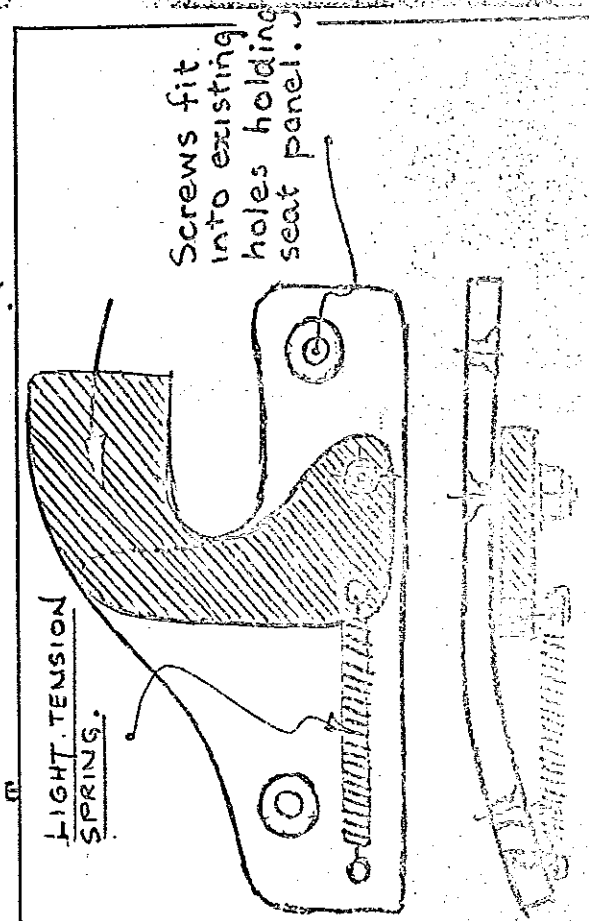
RELEASE WITH  
THUMB FOR  
UNDERCARRIAGE  
UP.

Screws fit into existing holes holding seat panel.

LIGHT TENSION  
SPRINGS.
