BRITISH GLIDING ASSOCIATION

TECHNICAL COMMITTEE

TNS 4/5/81

1. AIRWORTHINESS AGGRO (Please add to 1981 Pink Pages).
  - 1.1. ASW 19/20 Aileron Hinge-Pins NOT secured. AD/81-74 (herewith) requires inspection for missing rivets.

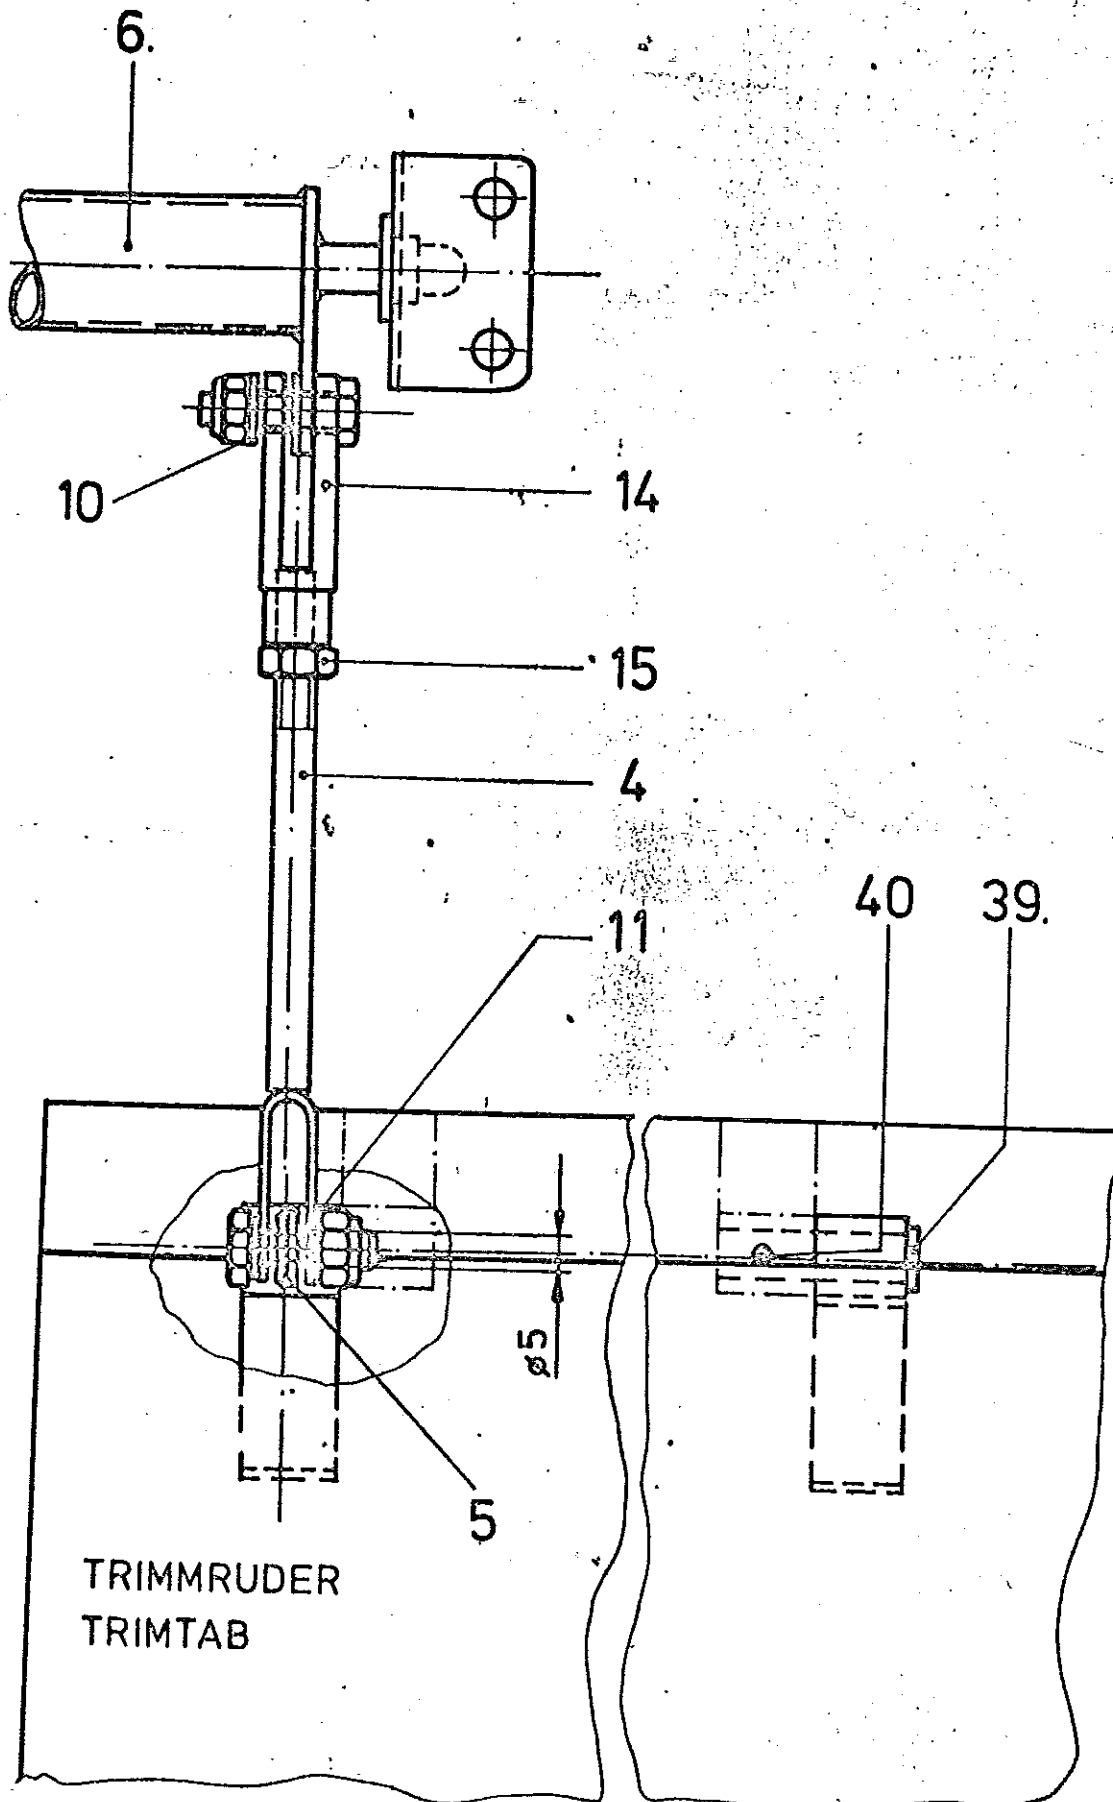
- 1.3. GROB ASTIR G103 'TWIN II' & 'TWIN II ACCRO'. Serial Numbers as listed in TM 315-13 (herewith), requires 'Exchange of the Trim Tube in the Elevator' (incorrect welding).

**Instructions:** This exchange should be taken in accordance to the repair instructions of TM 315-13.
