TNS 12/82

PART 1 AIRWORTHINESS "AGGRO" (These items will be included in the 1983 list).

From:	Subject <b>GROB TWIN ASTIR SPEED - BRAKE</b>	Date:
To:		Reply Address:

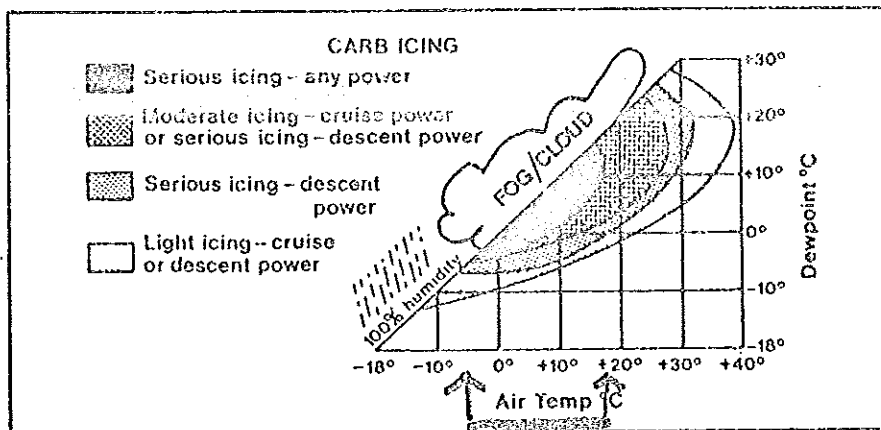
Carburettor ice is one of the worst enemies. The chart below shows when it is most likely to occur.

Ensure the carb heat gives a good rpm drop during the pre-take-off checks.

During flight monitor engine instruments for loss of rpm (fixed pitch) or manifold pressure (constant speed), which may mean carb ice is forming.
