B.G.A. TECHNICAL COMMITTEE

TECHNICAL NEWSHEET

TNS 5/6/83

PART 1 AIRWORTHINESS 'AGGRO' Please add to the 1983 Pink Pages

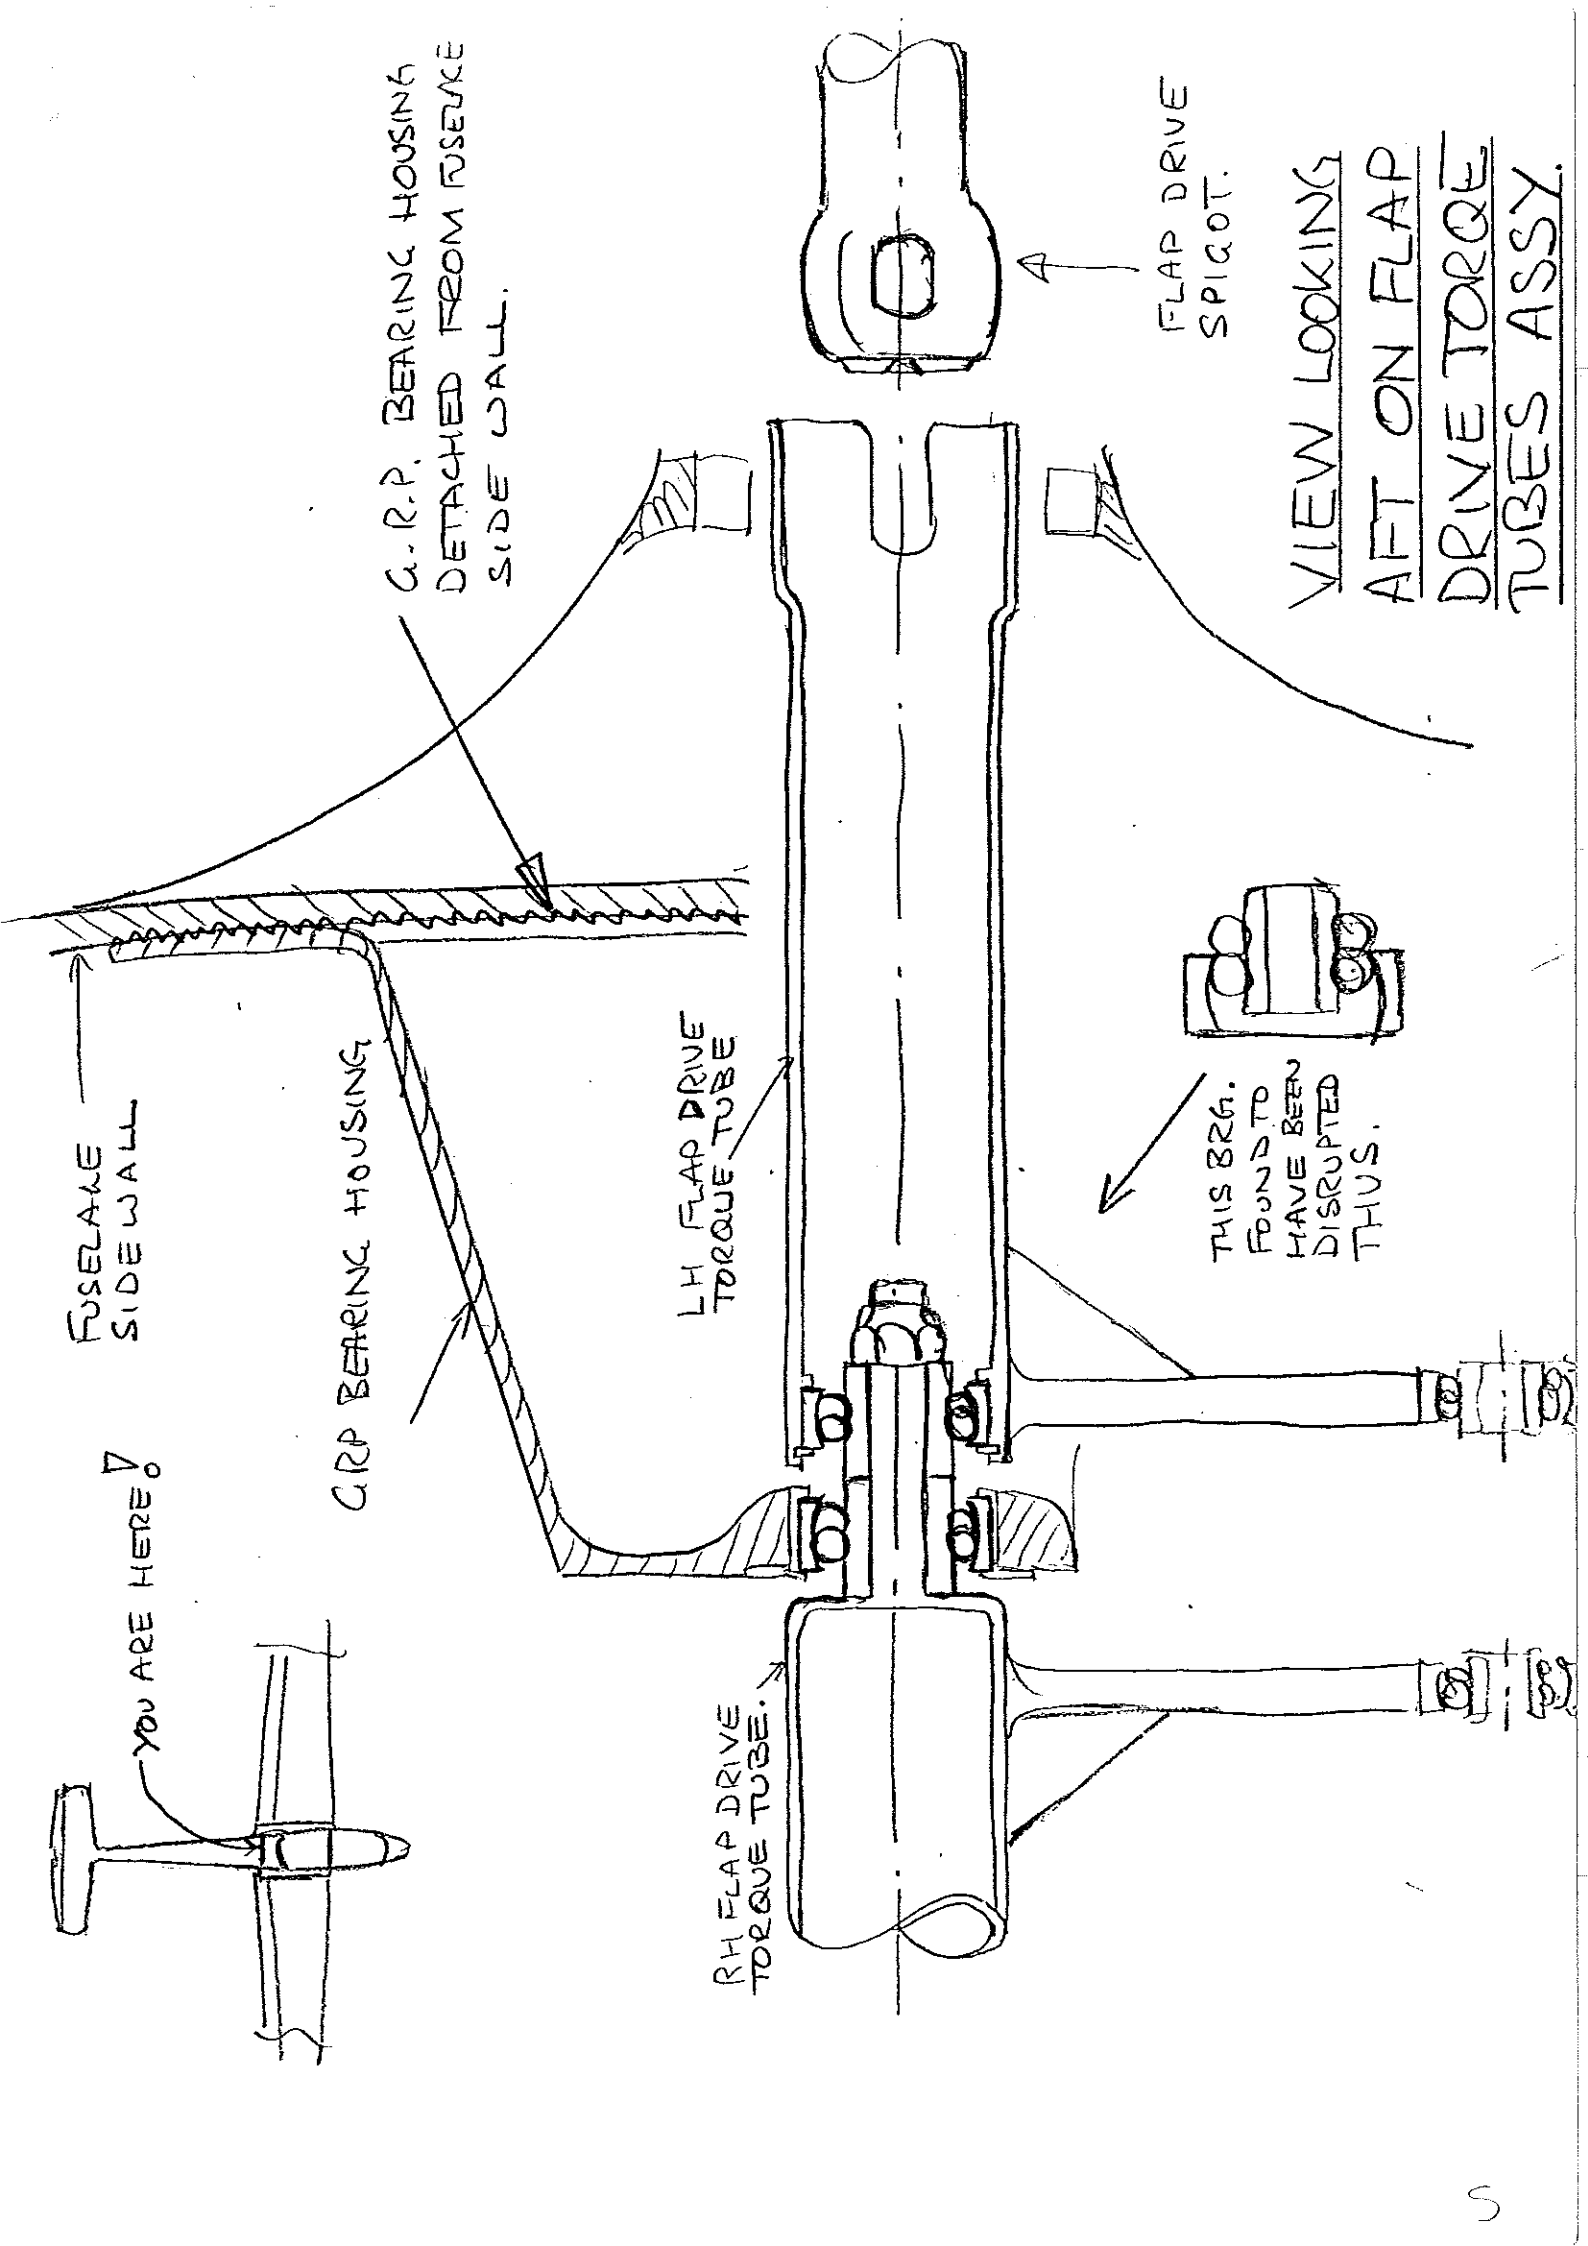
VIEW LOOKING AFT ON FLAP DRIVE TORQUE TUBES ASSY.

After the event the g.r.p. moulding which provides the flap torque shaft bearing was found to be almost completely detached from the inside of the fuselage. The resulting flexibility provided enormous flap backlash. On dismantling the mechanism the double row self aligning bearing at the end of the L.H. torque tube was found to be disrupted as shown in sketch.

The L.H. flap drive bearing has received a substantial overload in the inwards direction to cause the outer ring to spring over the ball array. This load can only be reacted by the g.r.p. moulding carrying the centre bearing in a direction which will "unpeel" it from the fuselage wall. It is suggested that the L.H. wing was entered to the fuselage with the flap in a different position to that of the cockpit lever. The flap drive spigot then abutted the slotted end of the torque tube instead of entering the slot. The resulting end load disrupted the bearing and dismounted the g.r.p. bearing housing.

In view of the detail design of the mechanism it is surprising that this has not occurred on an aircraft previously. Other Kestrels have been seen to have the g.r.p. mounting partially peeled from the fuselage sidewall, indicating that they have been loaded during rigging, but their level of attachment has still been satisfactory. A fairly major re-design of the mechanism would be required to overcome this mode of failure. In view of the absence of other reported incidents, and the major but not catastrophic nature of the flutter, it is concluded that a design change is unnecessary.

THIS BRG. FOUND TO HAVE BEEN DISRUPTED THUS.

1. That owners be alerted to the risk of damage during rigging.
2. That inspectors be made aware of the possibility that such damage could exist.
